PROPELLER SHAFT

TIVOLI 2015.06

The propeller shaft is a thin steel pipe which transfers the power from the transmission to the E-coupling, and has high resistance to torsion and bending. The propeller shaft is used at the AWD vehicle only. The specifications such as length are same for both the propeller shaft installed to the vehicle with M/T and one to the vehicle with A/T.

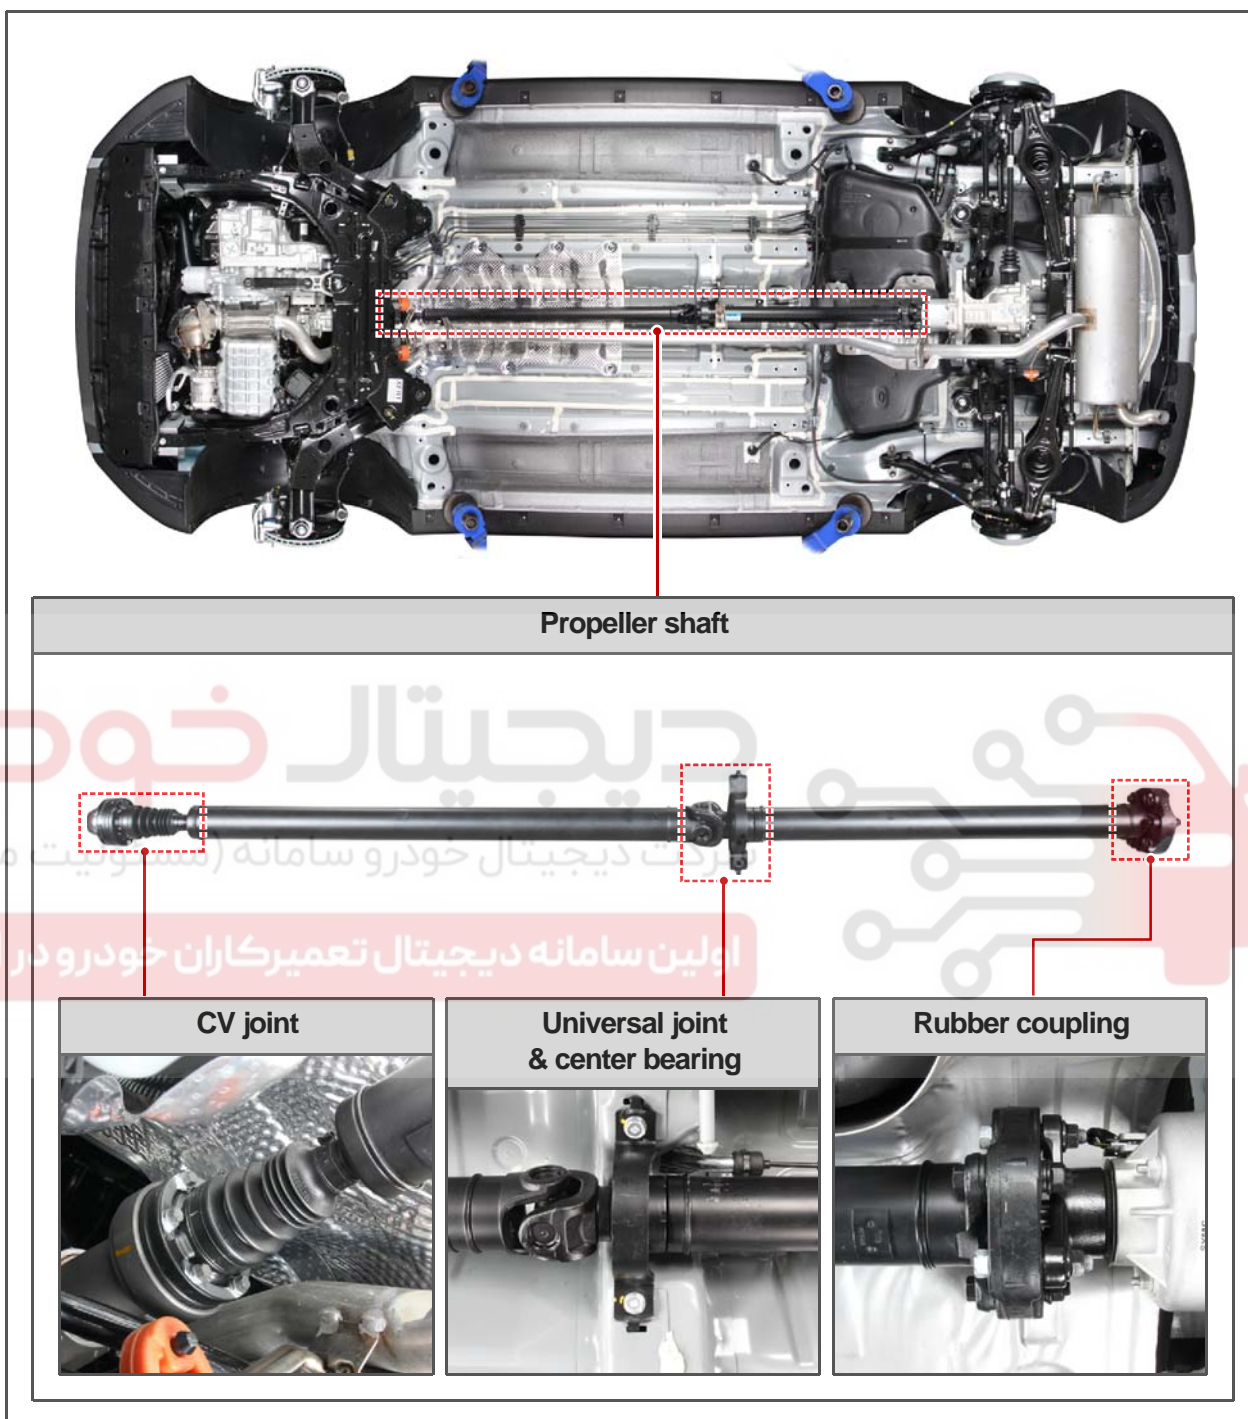
2) Mounting Location and Components

The propeller shaft has the constant velocity joint to compensate for the angle and length in order to accommodate the height and length changes which occur as the shaft rotates at high speed. And the rubber bushing for center bearing in the center of the propeller shaft keeps the balance of the shaft and absorbs its vibration.

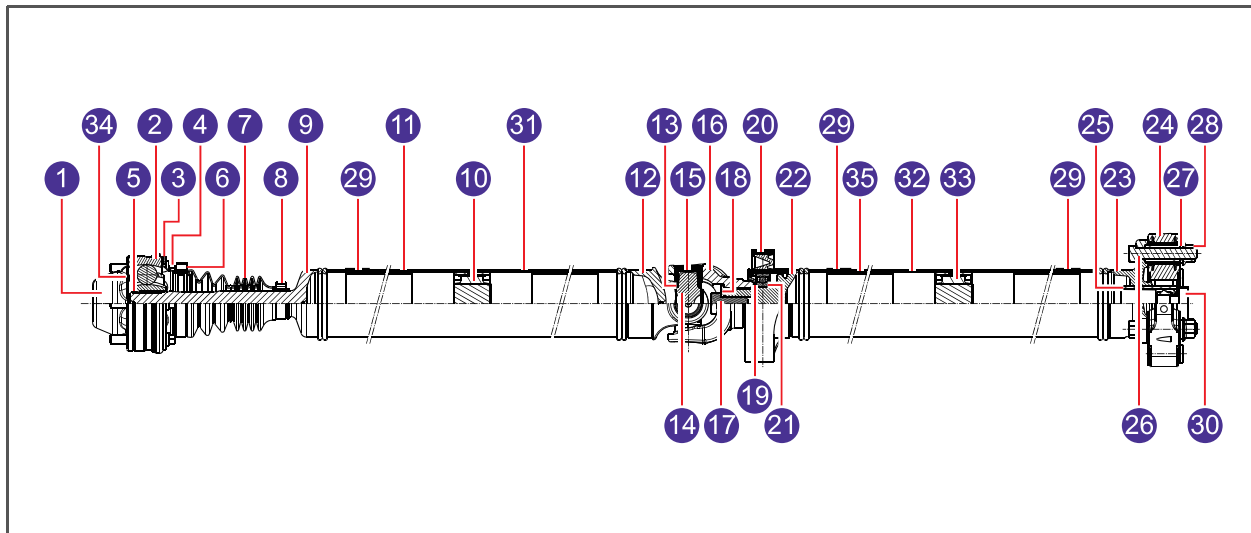
► Configuration diagram

| 1. End cap | 19. Dust shield |
| 2. VL joint assembly | 20. Center bearing assembly |
| 3. Washer | 21. Ball bearing |
| 4. Bolt | 22. Intermediate shaft |
| 5. Circlip | 23. Fork yoke |
| 6. Clamp (Big end) | 24. Rubber coupling |
| 7. Boot | 25. Aligning support |
| 8. Clamp (Small end) | 26. Bolt |
| 9. Stub shaft | 27. Washer |
| 10. Bending absorber | 28. Lock nut |
| 11. DEADENER | 29. Balance weight |
| 12. Tube yoke | 30. Protector |
| 13. Oil seal | 31. Tube |
| 14. Spider | 32. Tube |
| 15. Bearing cap | 33. Bending absorber |
| 16. Intermediate yoke | 34. Gasket |
| 17. Bolt | 35. DEADENER |
| 18. Flat washer | |

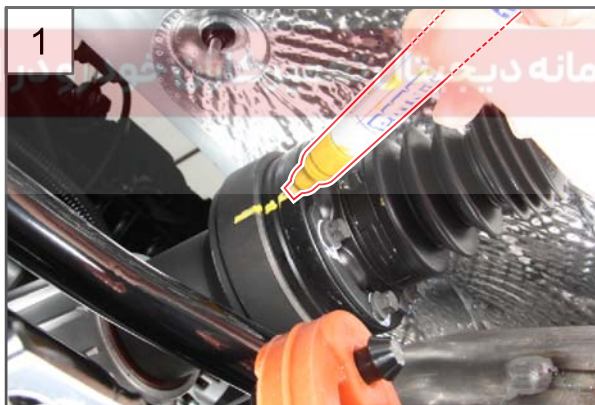
1. Make a paint mark on the CV joint part and flange part of the propeller shaft.

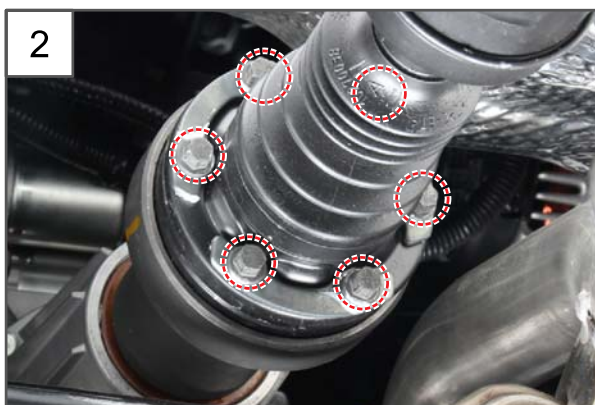
2. Unscrew the 6 CV joint mounting bolts (8 mm).

Tightening torque 29.4 ~ 39.2Nm

Check all washers are not missing and tighten the bolts and nuts in two or three steps diagonally.

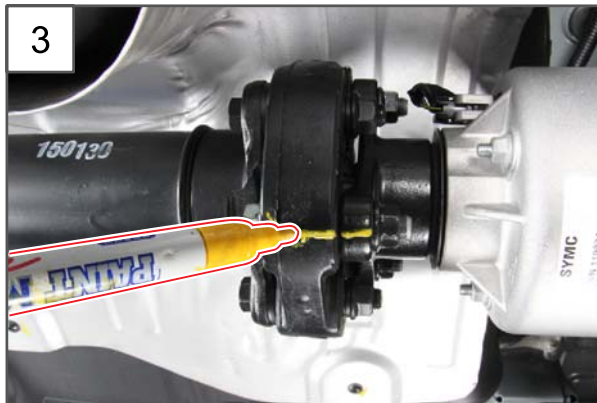
3. Make a paint mark on the rubber coupling at the rear and the yoke of the E-coupling side.

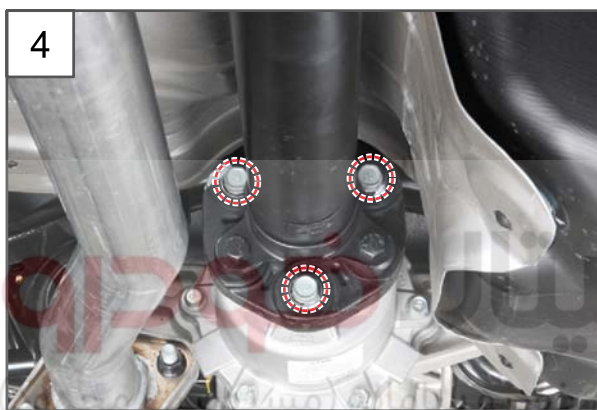
4. Unscrew the 3 mounting bolts/nuts (14 mm) on the rubber coupling.

Tightening torque 39.2 ~ 49Nm

Do not remove the rubber coupling when removing the propeller shaft. (vibration balance does not match when reassembling)

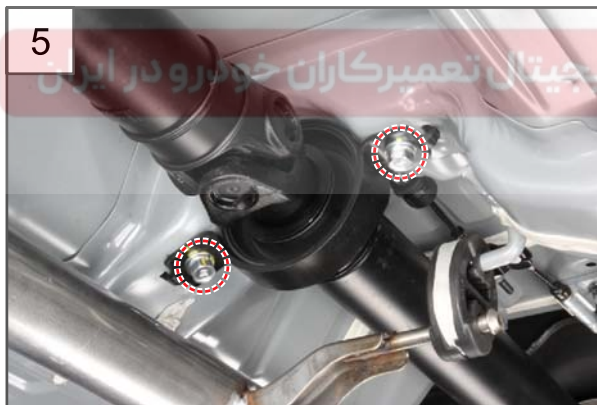
5. Unscrew the 2 mounting bolts (14 mm) on the center bearing.

Tightening torque 58.8 ~ 68.6Nm

Support the propeller shaft with one hand in order not to drop it before unscrewing the mounting bolt completely.

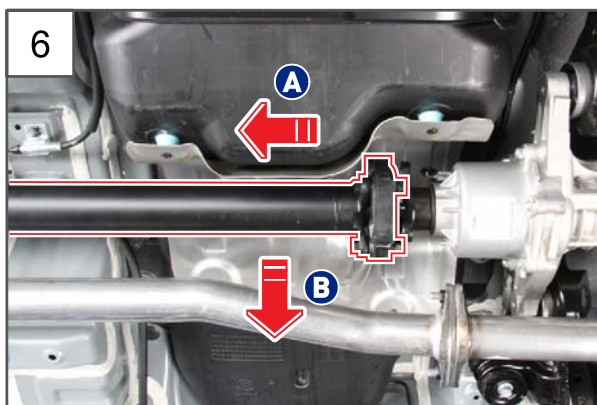
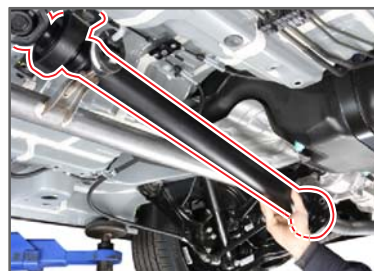
6. Remove the rubber coupling from the E-coupling's yoke by pushing the propeller shaft to the arrow direction (A) and pulling to the arrow direction (B) at the same time.

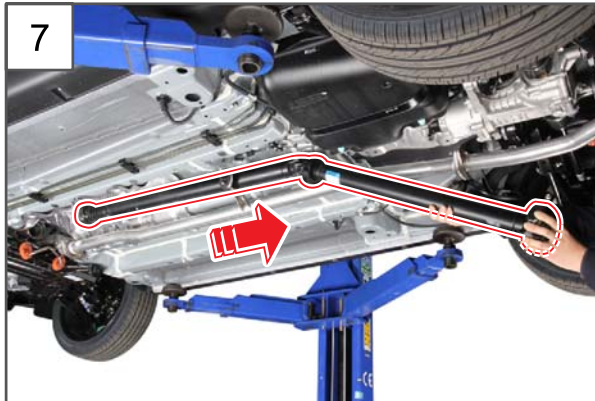
7. Remove the propeller shaft to the arrow direction while paying attention to interference of the center muffler.
