DRIVE SHAFT AND AXLE

INDEX

TIVOLI 2015.06

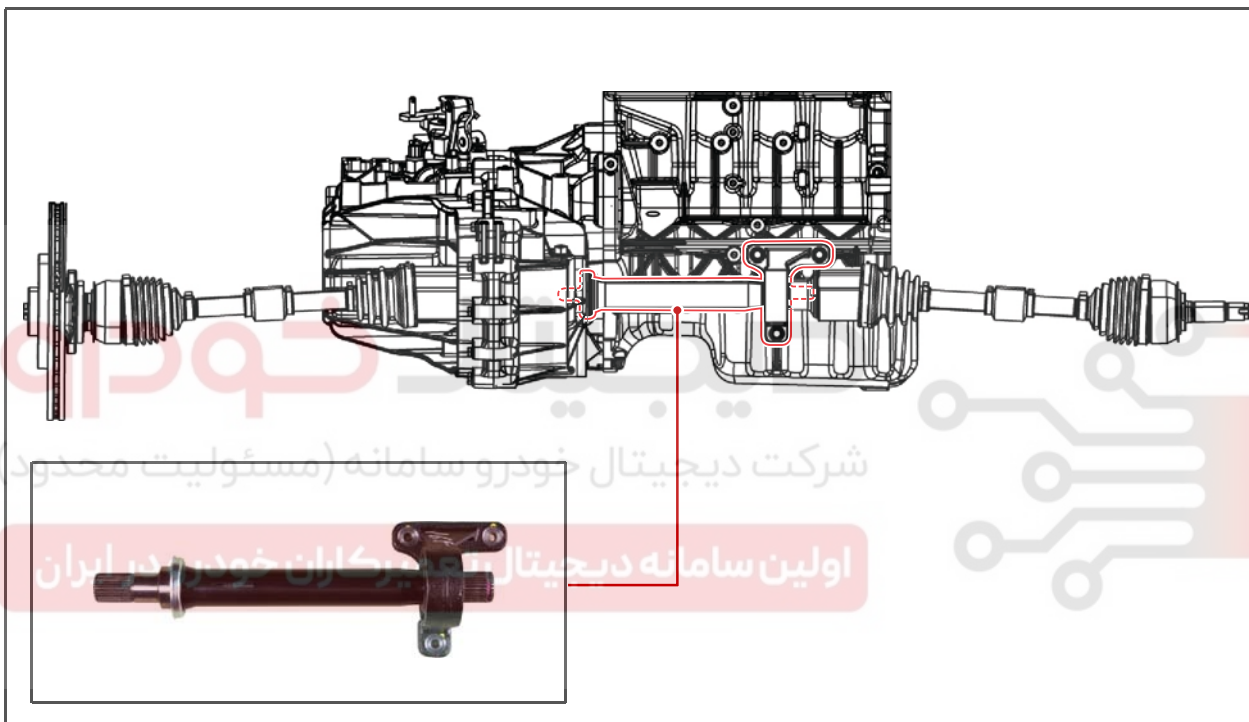
To prevent this, the intermediate shaft, called equivalent length shaft, is employed so that the bending angle and the length are kept constant for both sides.

Torque steer is a condition in which a vehicle pulls to either side because of an inequality of traction between the left and right driving wheels when a large torque is applied to the front wheels of a FWD or 4WD vehicle.

Especially for a FWD vehicle, this mechanical condition can cause the steering effect because of the output torque (rotational force) produced by the gyroscope. This rotational force is due to the difference in distance between the left/right front wheels and the transaxle, which leads to the change of the shaft bending angle.

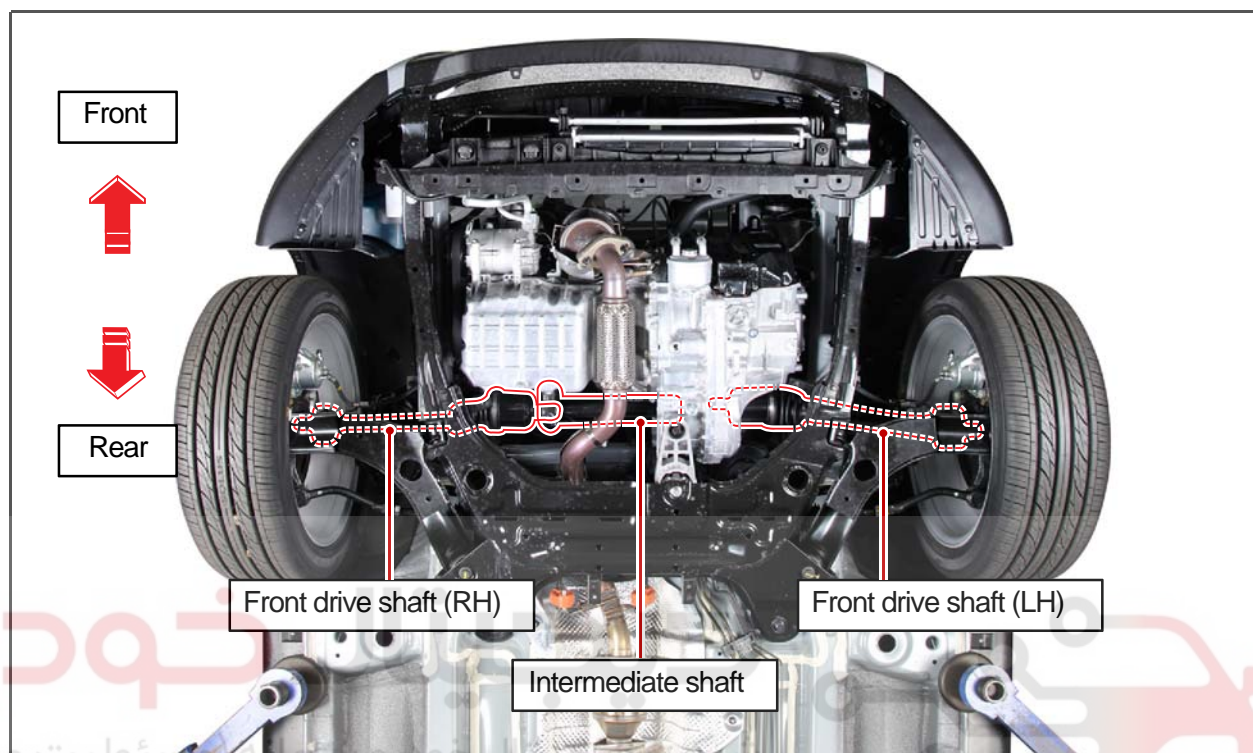
4110-01 FRONT DRIVE SHAFT ASSEMBLY

► Gasoline engine

Classification	Drive shaft (LH)	Intermediate shaft	Drive shaft (RH)
M/T (2WD & AWD)			
A/T (2WD)			
A/T (AWD)

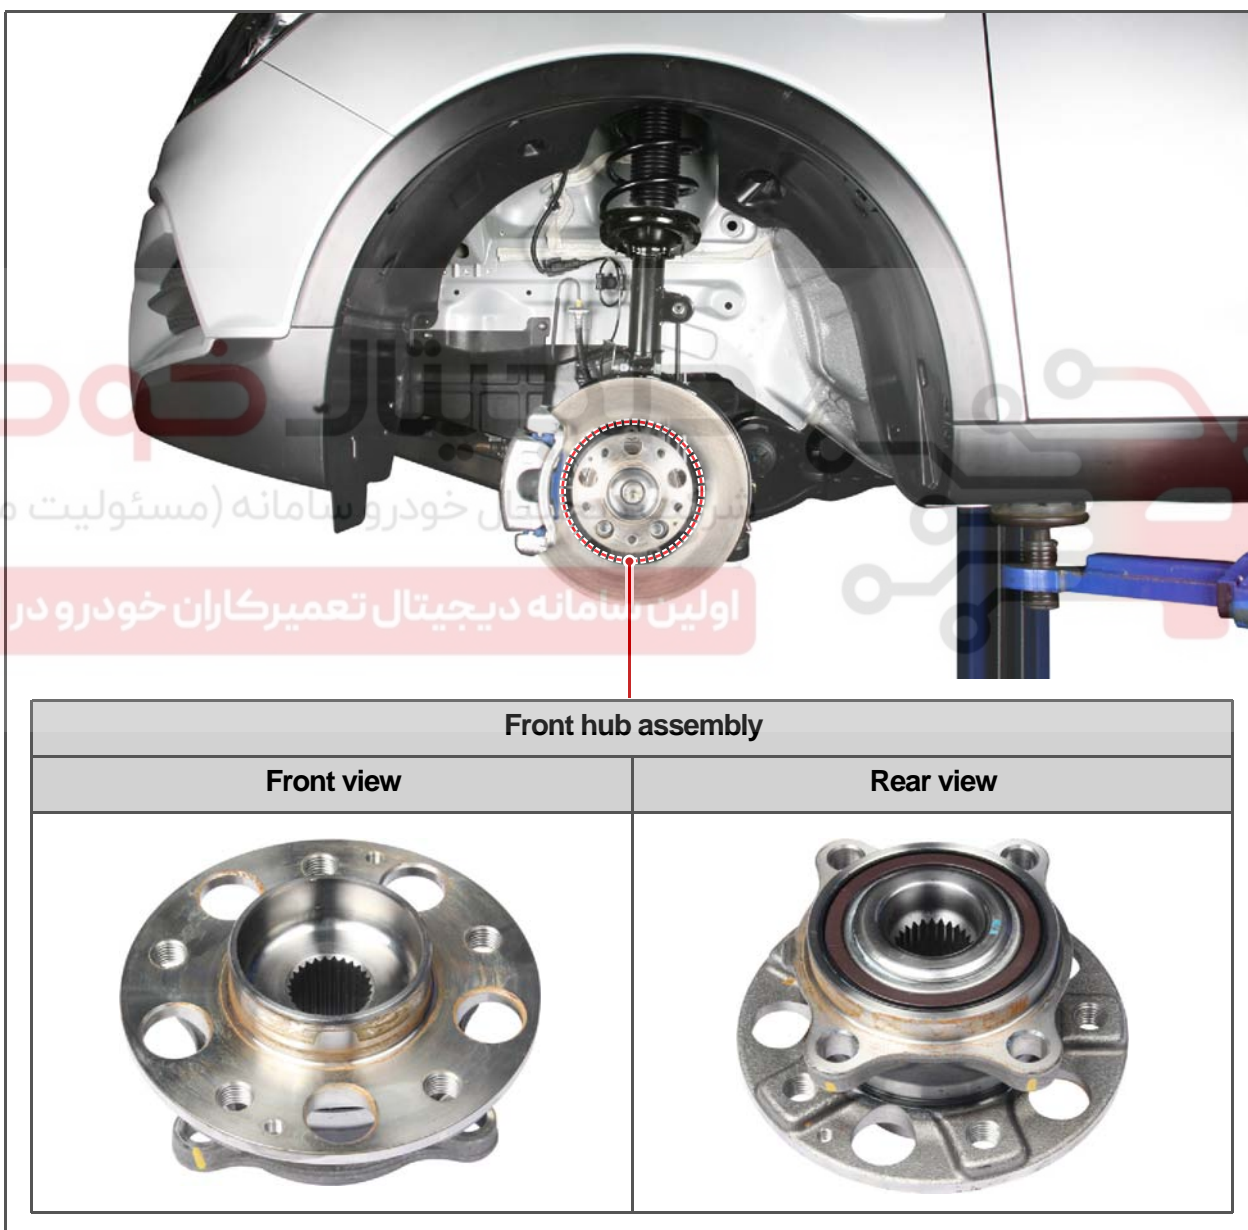
2) Mounting Location

The front hub assembly has the wheel and disc brake. They are connected through the drive shaft and spline gear.

The power from the engine is transmitted to the wheel through the drive shaft.

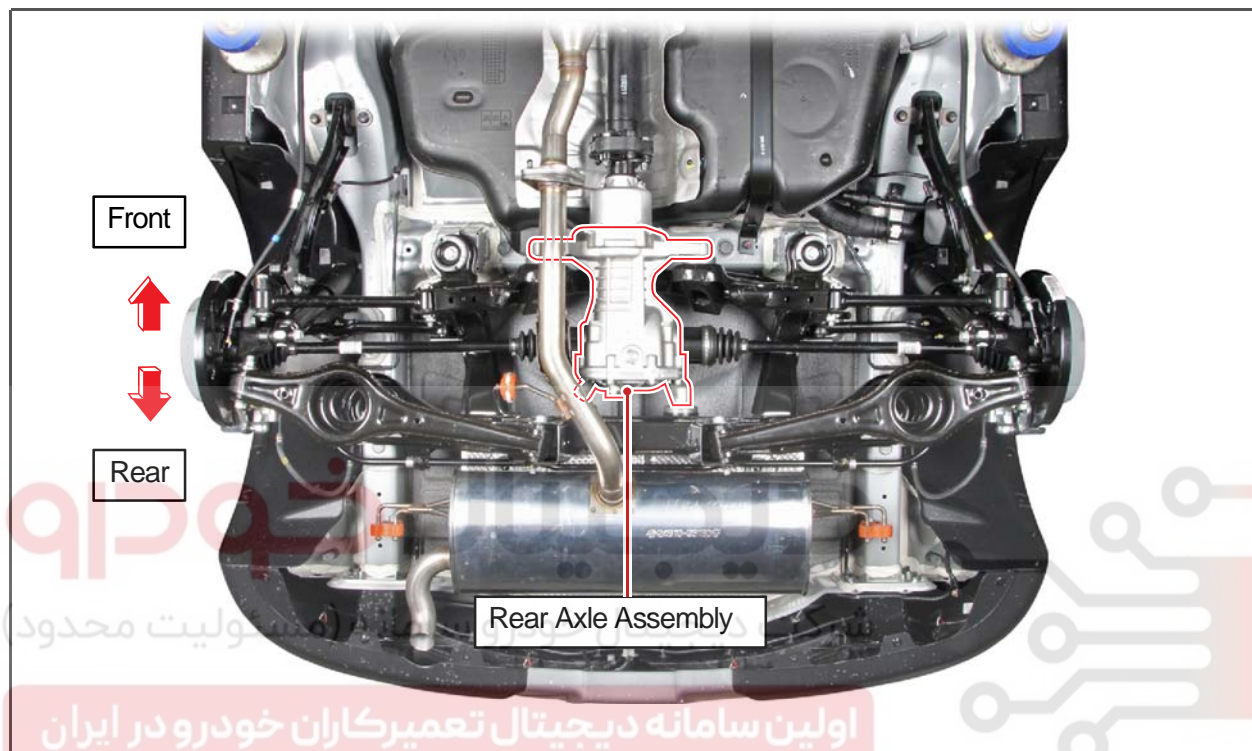
The rear axle is of the split axle type, IRDA (Independent Rear Drive Axle). It changes the direction of driving force from the E-coupling using a hypoid type gear and transmits the driving force to the rear hub connected directly to the wheel through the rear drive shaft.

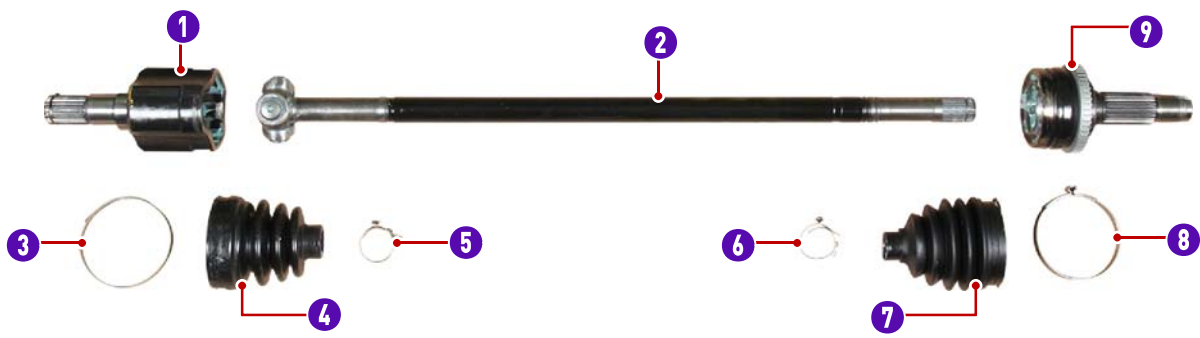
Exploded view

1. Inner cap	6. Outer boot shaft clamp
2. Shaft	7. Drive shaft outer boot
3. Inner boot housing clamp	8. Outer boot housing clamp
4. Drive shaft inner boot	9. Outer cap
5. Inner boot shaft clamp

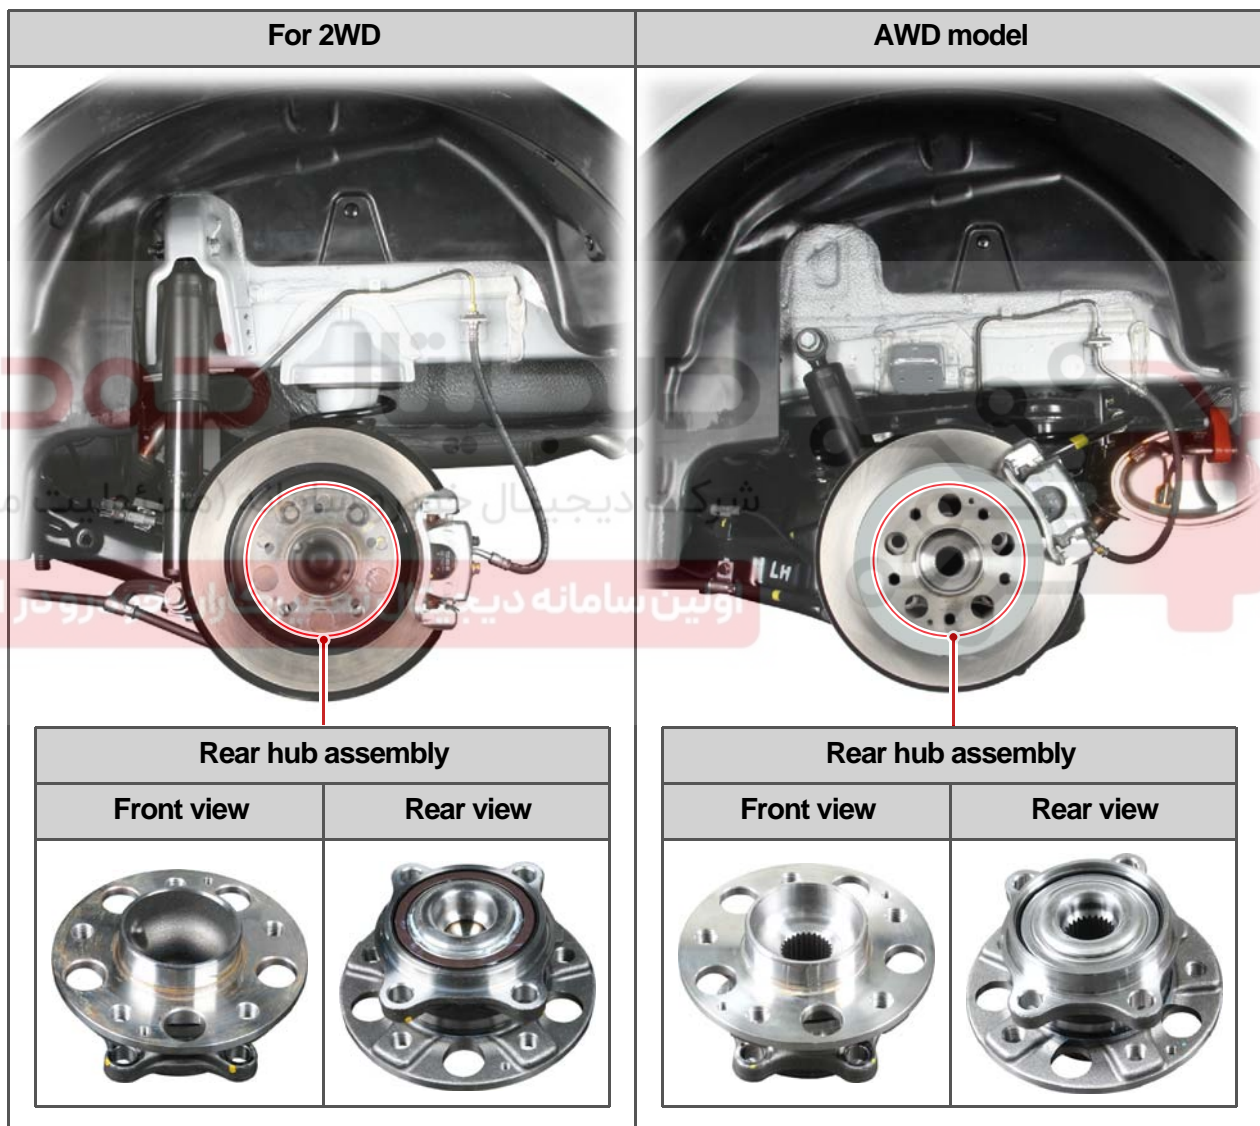
2) Mounting Location

The rear hub assembly has the wheel and disc brake. The disc brake transmits the power. The 2WD model in which driving force is not transmitted directly uses a non-driven hub. The AWD model uses a driven hub such as the front hub since the driving force is transmitted directly to the rear hub.

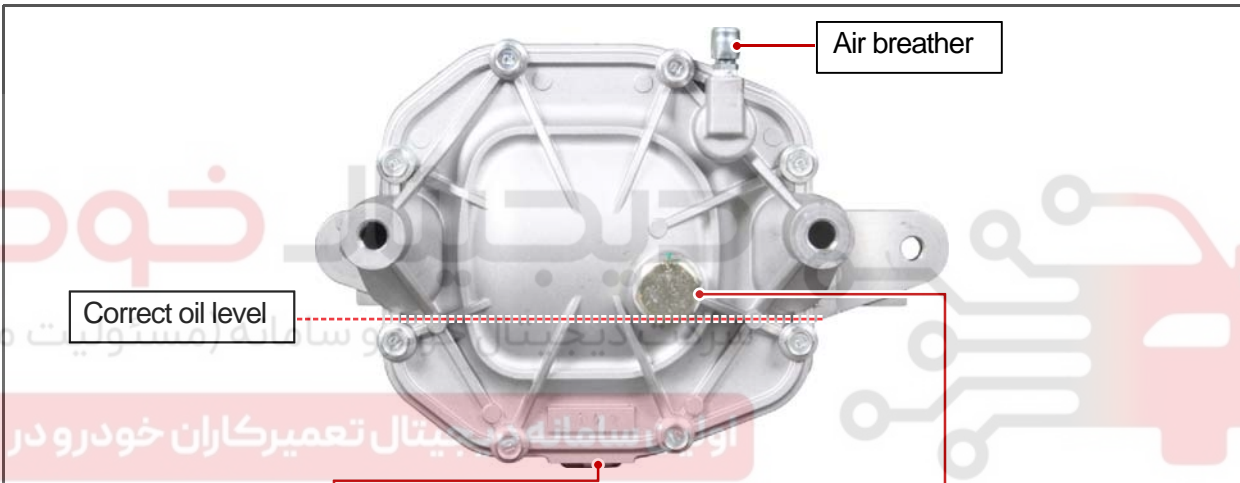
Air breather

Correct oil level

Drain plug

Remove the drain plug (27 mm), drain the rear axle oil and tighten the drain plug to the specified torque.

Tightening torque 49.0 ~ 68.6Nm

Filler plug

Remove the filler plug (27 mm), check or top up the rear axle oil and tighten the filler plug to the specified torque.

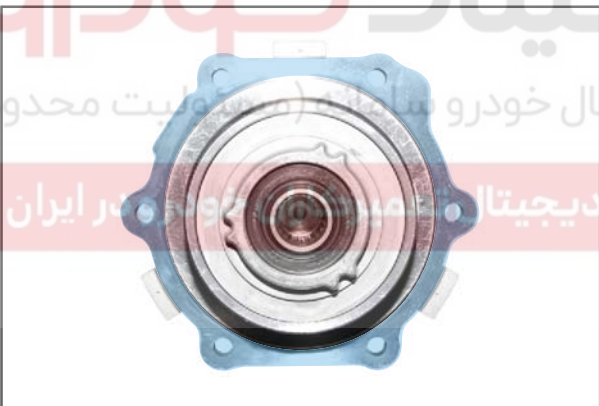
1. Apply the extreme pressure grease to the rear axle's input shaft spline part (A) and E-coupling's spline groove (B).

Extreme pressure grease: grease for KLUBER MICROLUBE GNY 202 or transmission (MS 511-55, TMG-2)

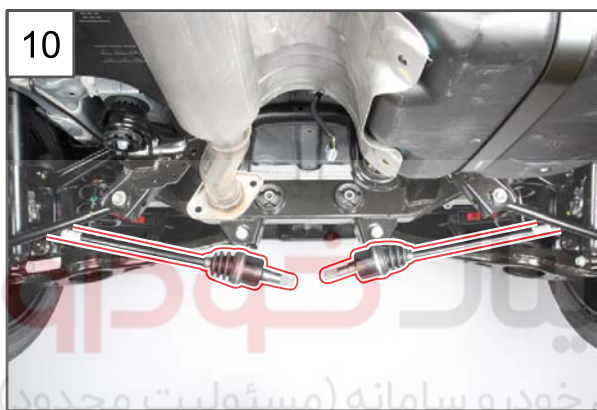
9. Separate the rear LH/RH drive shafts from the rear axle in order to remove the rear axle while lowering the jack slowly.

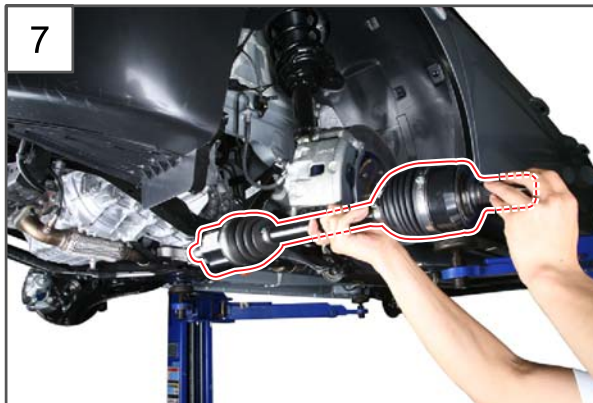
6. Remove the drive shaft from the transmission using a flat bladed screwdriver.

- Be careful not to damage the oil seal when removing the drive shaft from the transmission.
- Do not pull the drive shaft from the outside with an excessive force. It causes the boot to tear or bearing to damage.

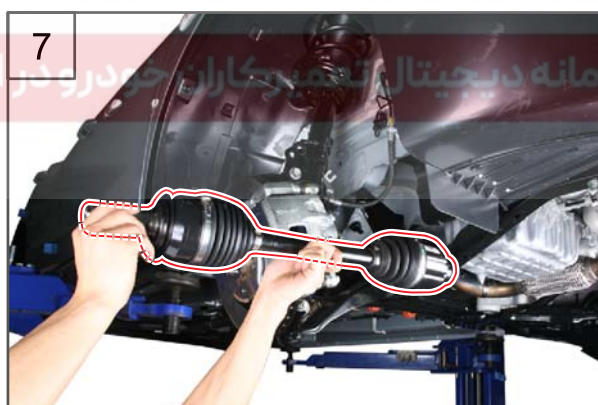
6. Separate the drive shaft from the intermediate shaft in the direction of the arrow using a special tool.

Do not pull the drive shaft from the outside with an excessive force. It causes the boot to tear or bearing to damage.

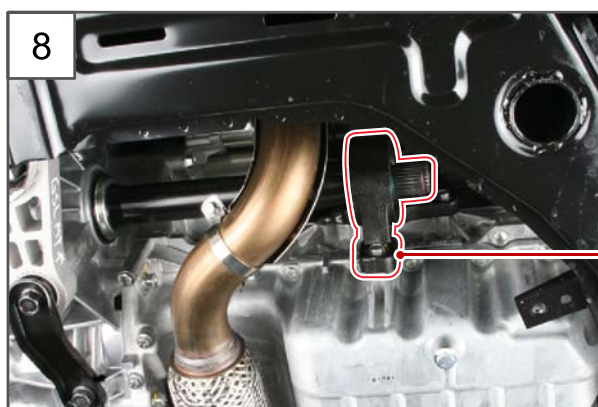
7. Remove the drive shaft (RH).

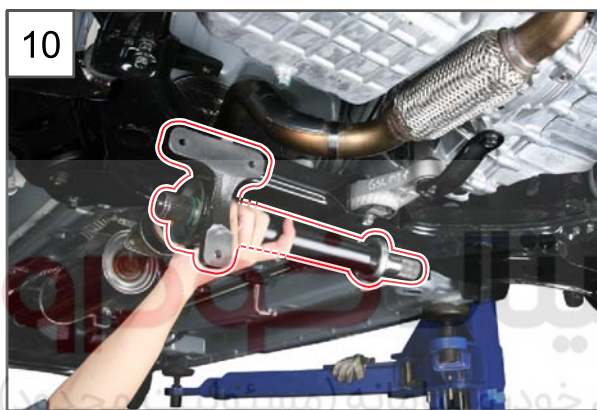
Be careful not to damage the oil seal when removing the intermediate shaft from the transmission.

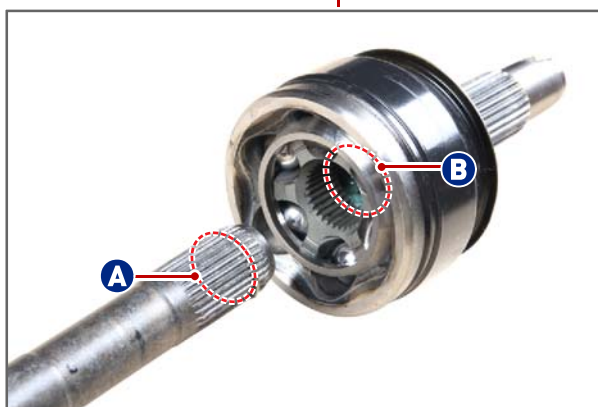
6. Apply the grease inside the outer cap and fit the cap to the shaft.

The snap ring (A) of the shaft should be seated to the groove for snap ring (B) of the outer cap correctly.

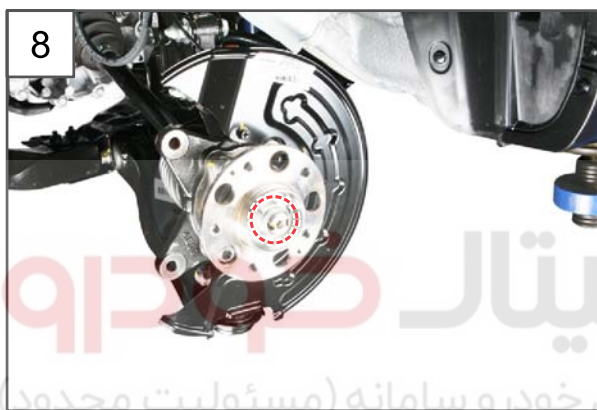
7. Release the caulking of the front hub nut in the direction of the arrow shown in the picture.

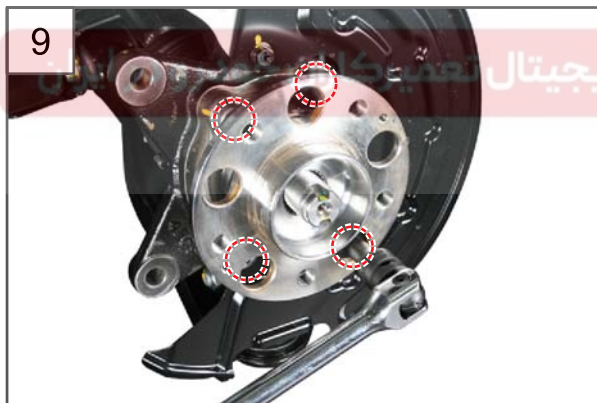
8. Unscrew the front hub nut (30 mm) to remove the hub assembly.

Tightening torque 245 to 343 Nm

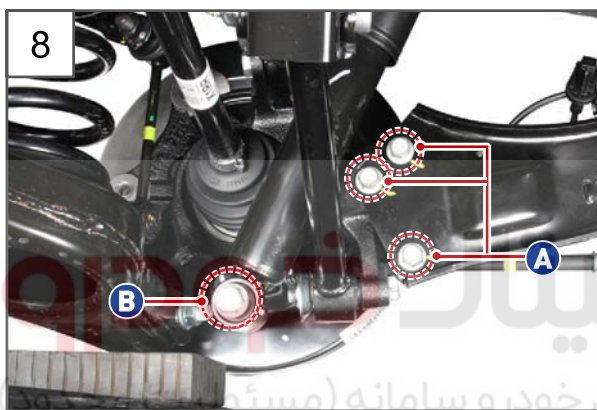
8. Unscrew the 3 mounting bolts (A, 14 mm) for the trailing arm on the knuckle side and mounting bolt (B, 17 mm) on the bottom of the shock absorber.

Tightening torque (A) 49.0 ~ 68.6 Nm

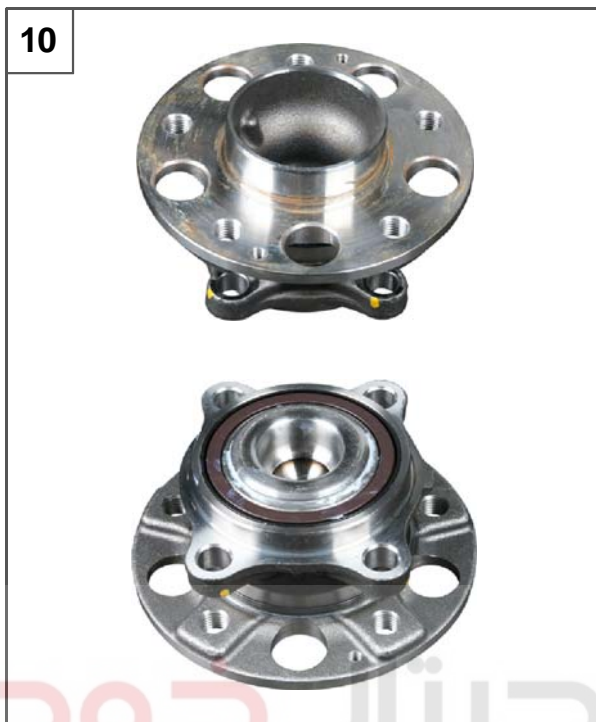
10. Install in the reverse order of removal.
