## BODY INTERIOR

### BODY INTERIOR

TIVOLI 2015.03

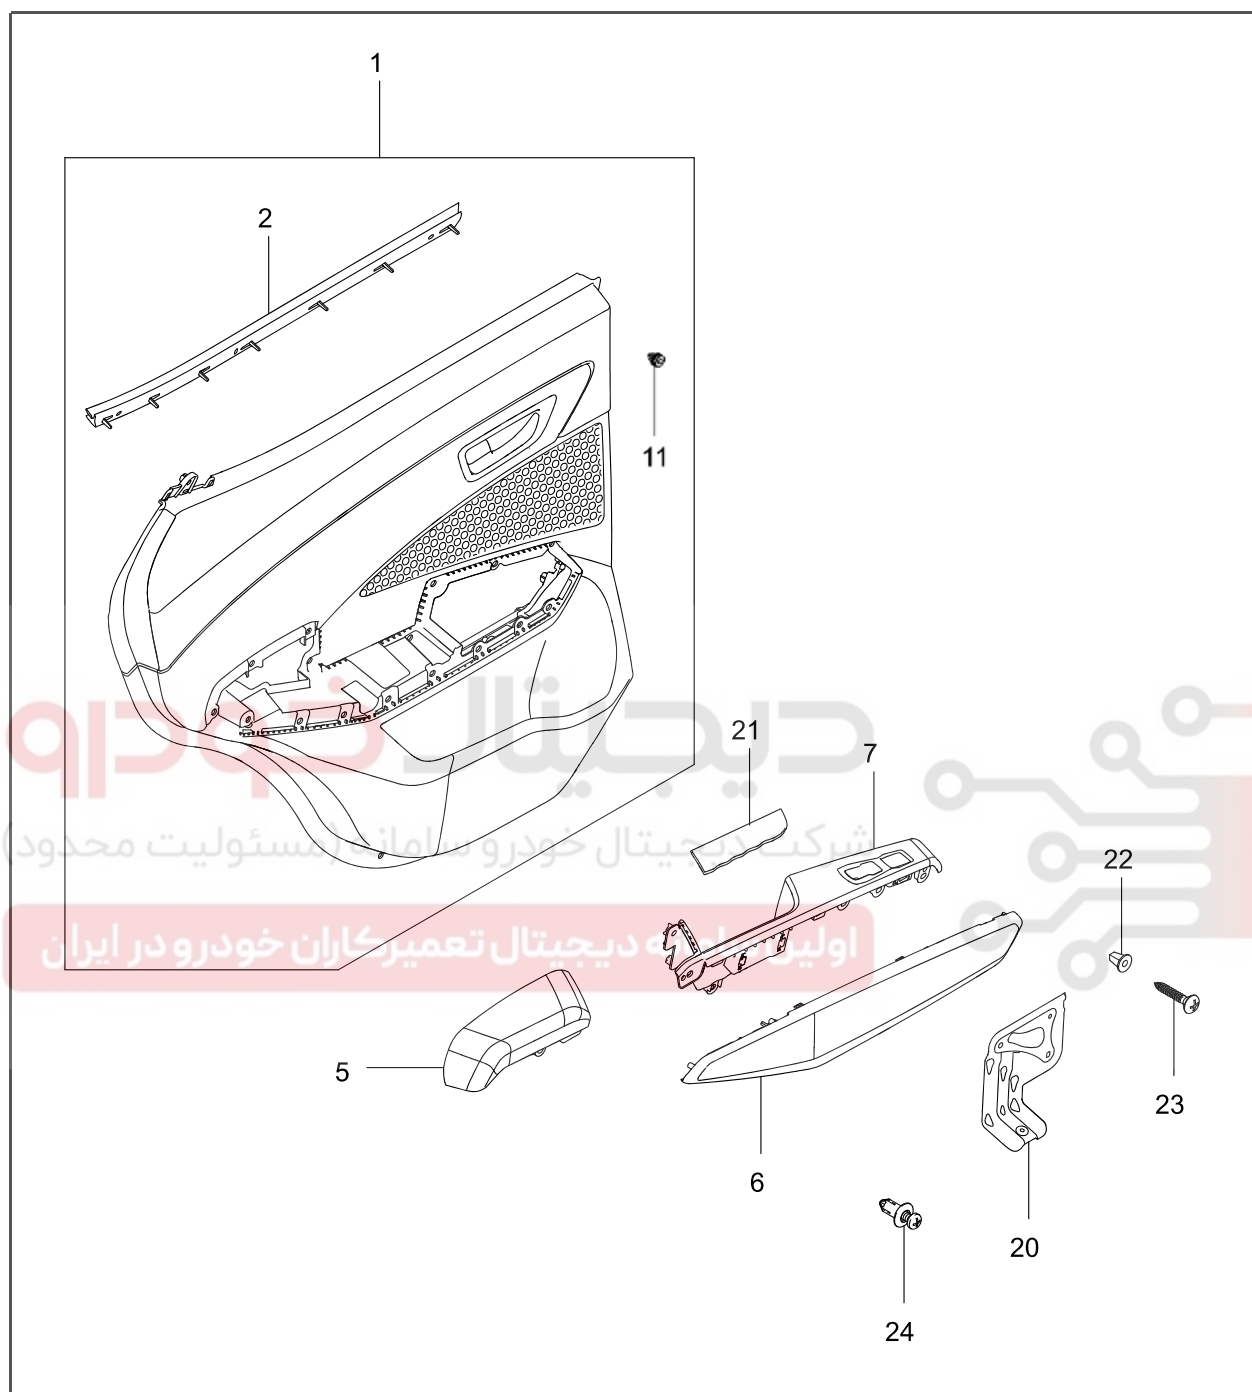
**7215-00 REAR DOOR TRIM**

- 1. Rear door trim assembly
- 2. Rear door belt weatherstrip
- 5. Armrest rear door trim panel assembly
- 6. Rear door trim molding assembly
- 7. Rear door trim bezel assembly
- 11. Clip

- 20. Front pull handle bracket assembly
- 21. Rear pull handle cover
- 22. Screw grommet
- 23. Screw
- 24. Screw rivet

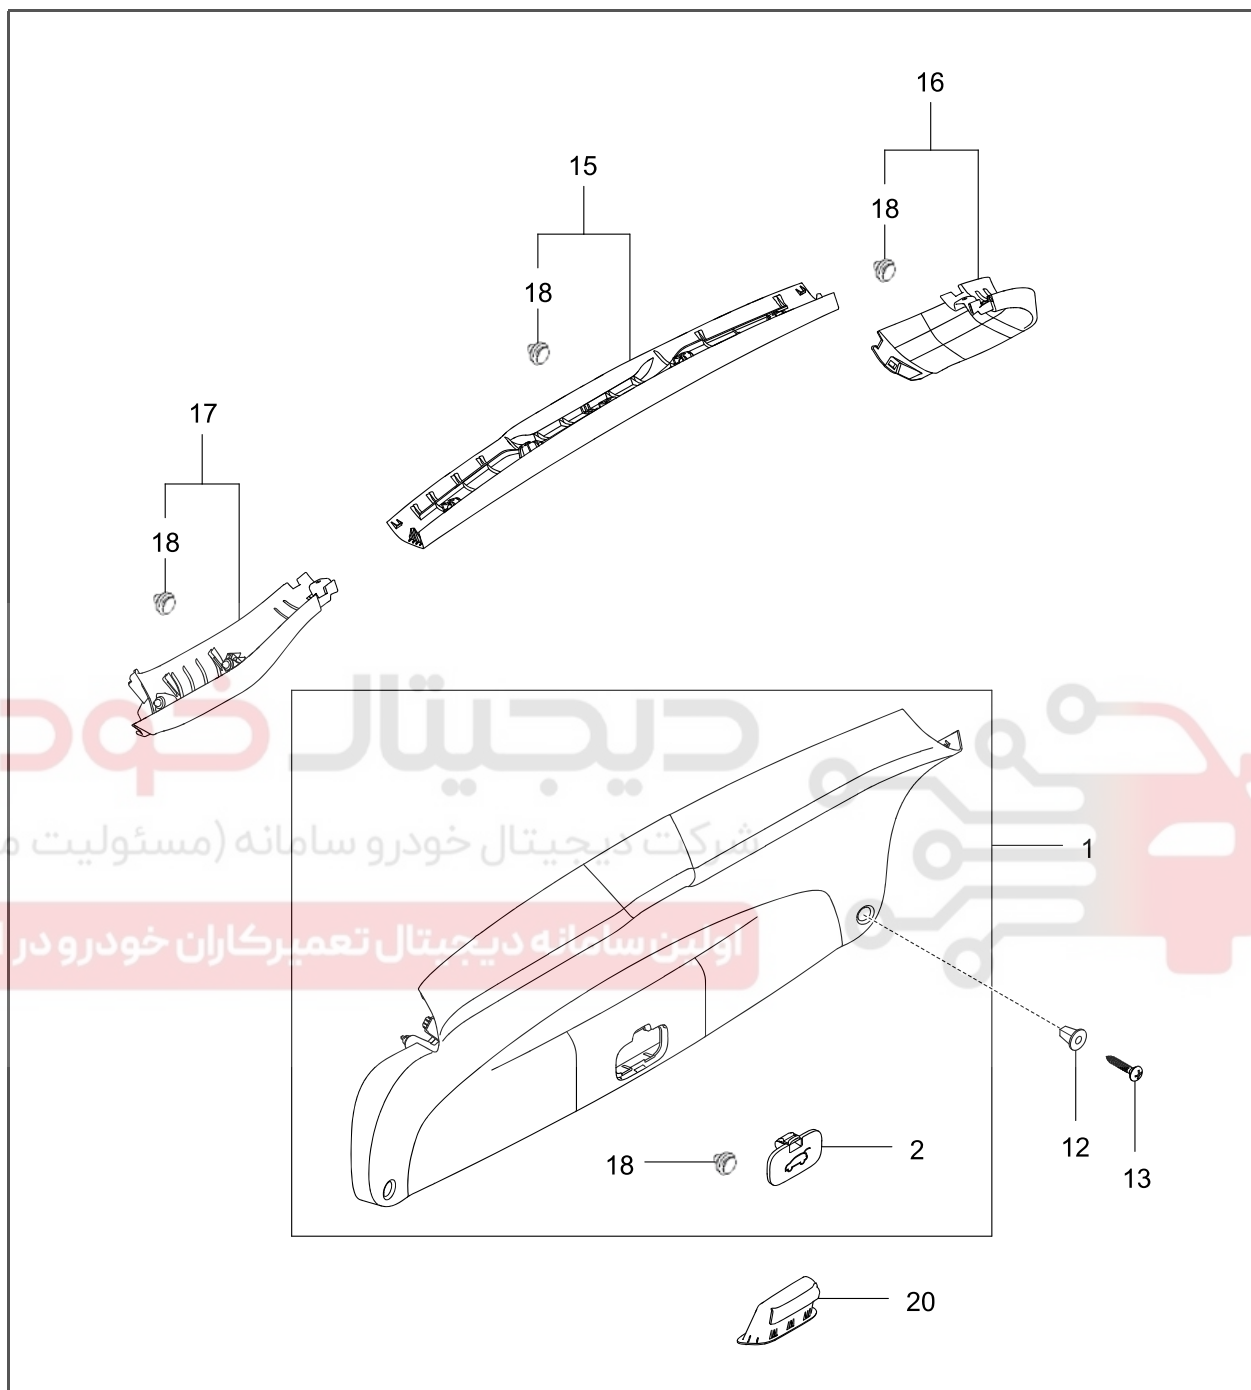
**7321-00 REAR END TRIM**

- 1. Tailgate lower trim assembly
- 2. Latch cover
- 12. Screw grommet
- 13. Screw
- 15. Tailgate upper trim assembly

- 16. Tailgate side LH trim assembly
- 17. Tailgate side RH trim assembly
- 18. Clip
- 20. Tailgate inner handle assembly

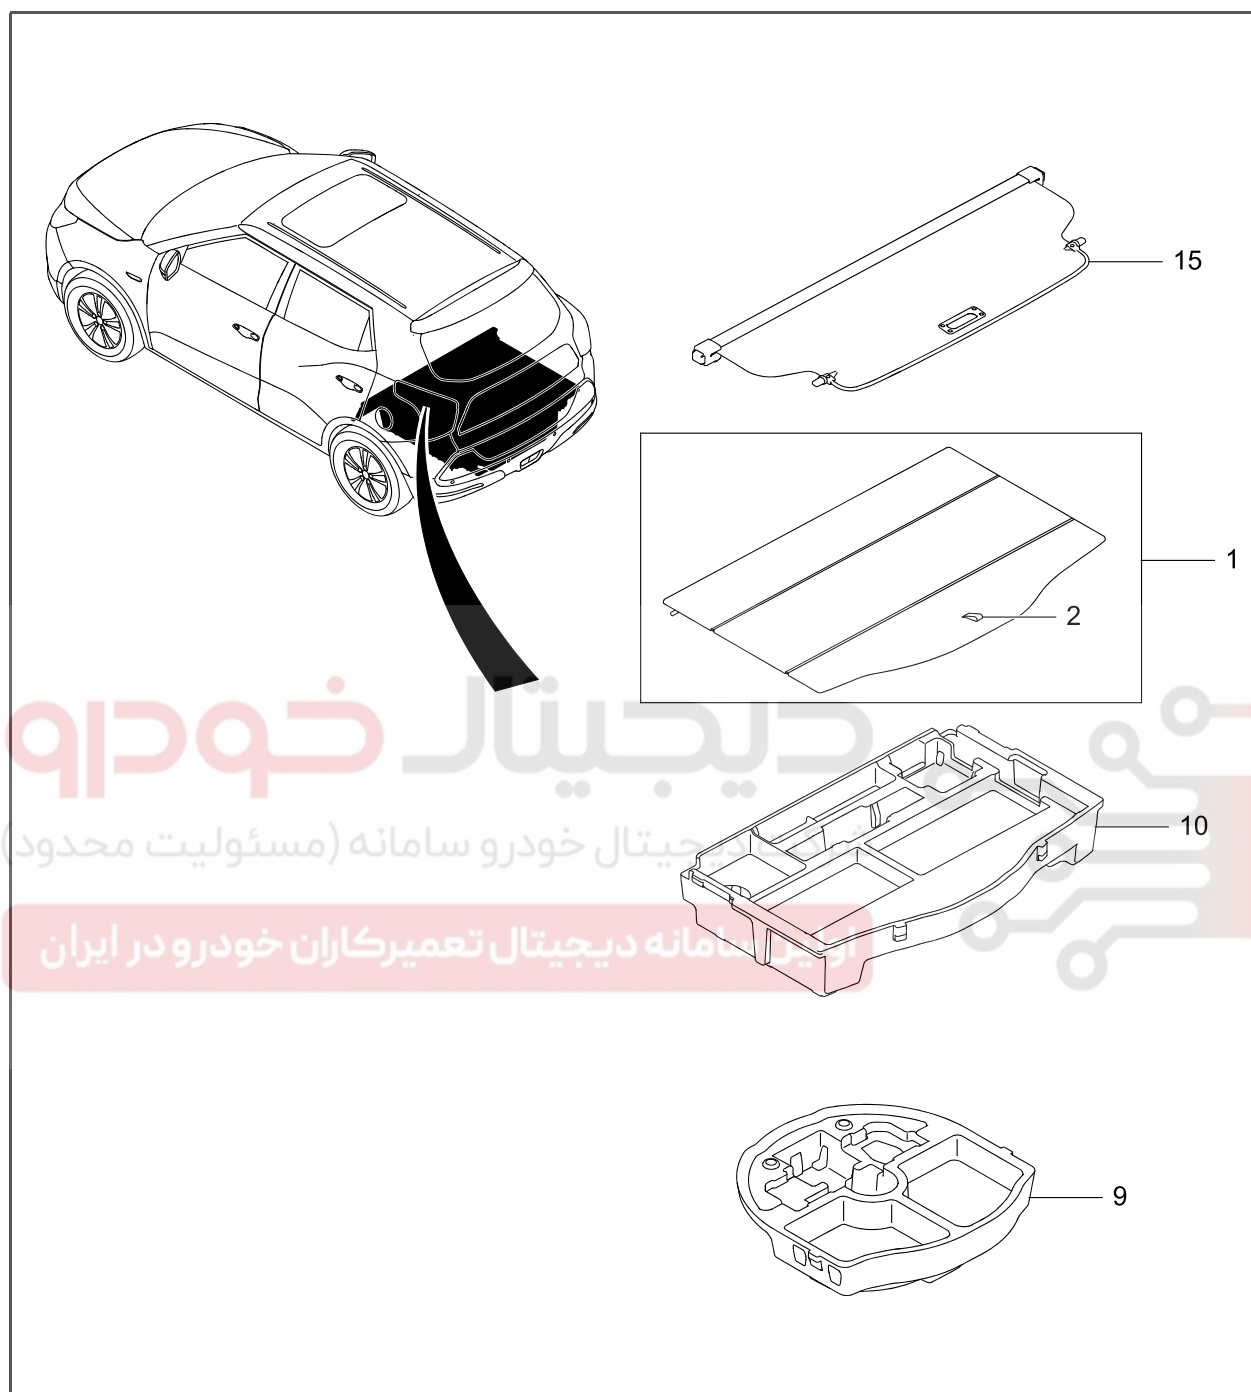
**7752-00 LUGGAGE PARTS**

1. Luggage lid assembly

2. Luggage strap

9. Luggage tray

10. Luggage tray

15. Luggage compartment cover assembly

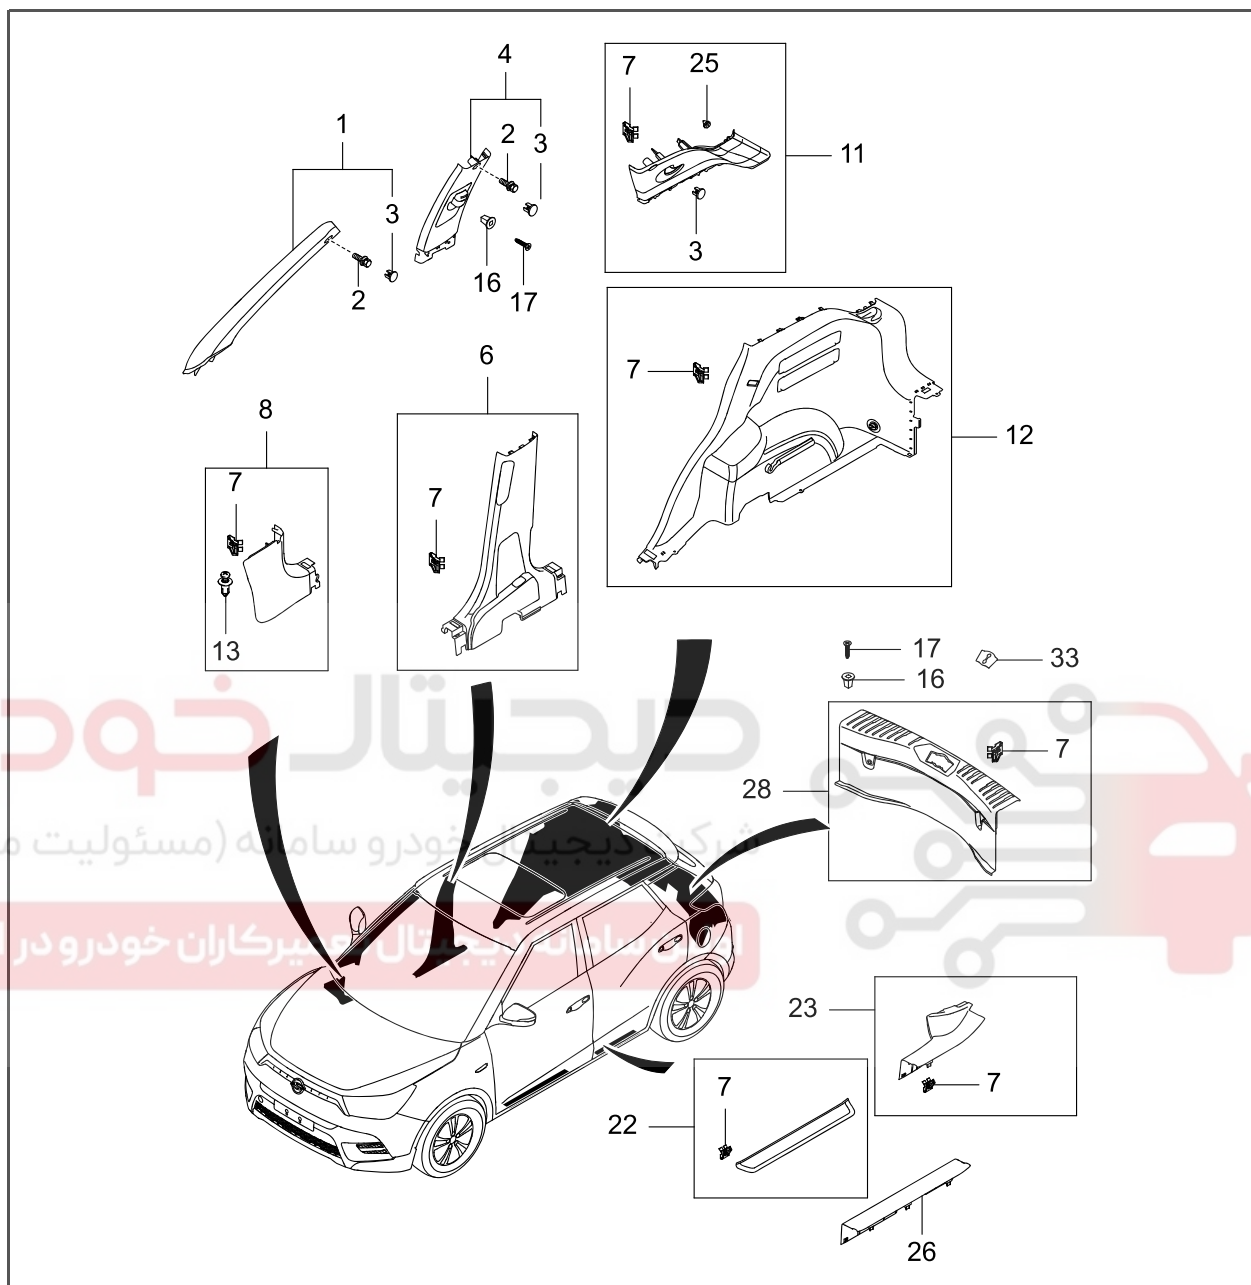
## 7730-00 PILLAR TRIM

| 1. A-pillar trim assembly | 13. Screw rivet |
| 2. Bolt | 16. Screw grommet |
| 3. A-pillar cap | 17. Screw |
| 4. B-pillar upper trim assembly | 22. Front door scuff trim assembly |
| 6. B-pillar lower trim assembly | 23. Rear door scuff trim assembly |
| 7. Trim mounting clip | 25. Clip |
| 8. Side cowl trim assembly | 26. Front door scuff outer trim |
| 11. Quarter upper trim assembly | 28. Rear transverse trim assembly |
| 12. Quarter lower trim assembly | 33. Rear transverse blanking cover |

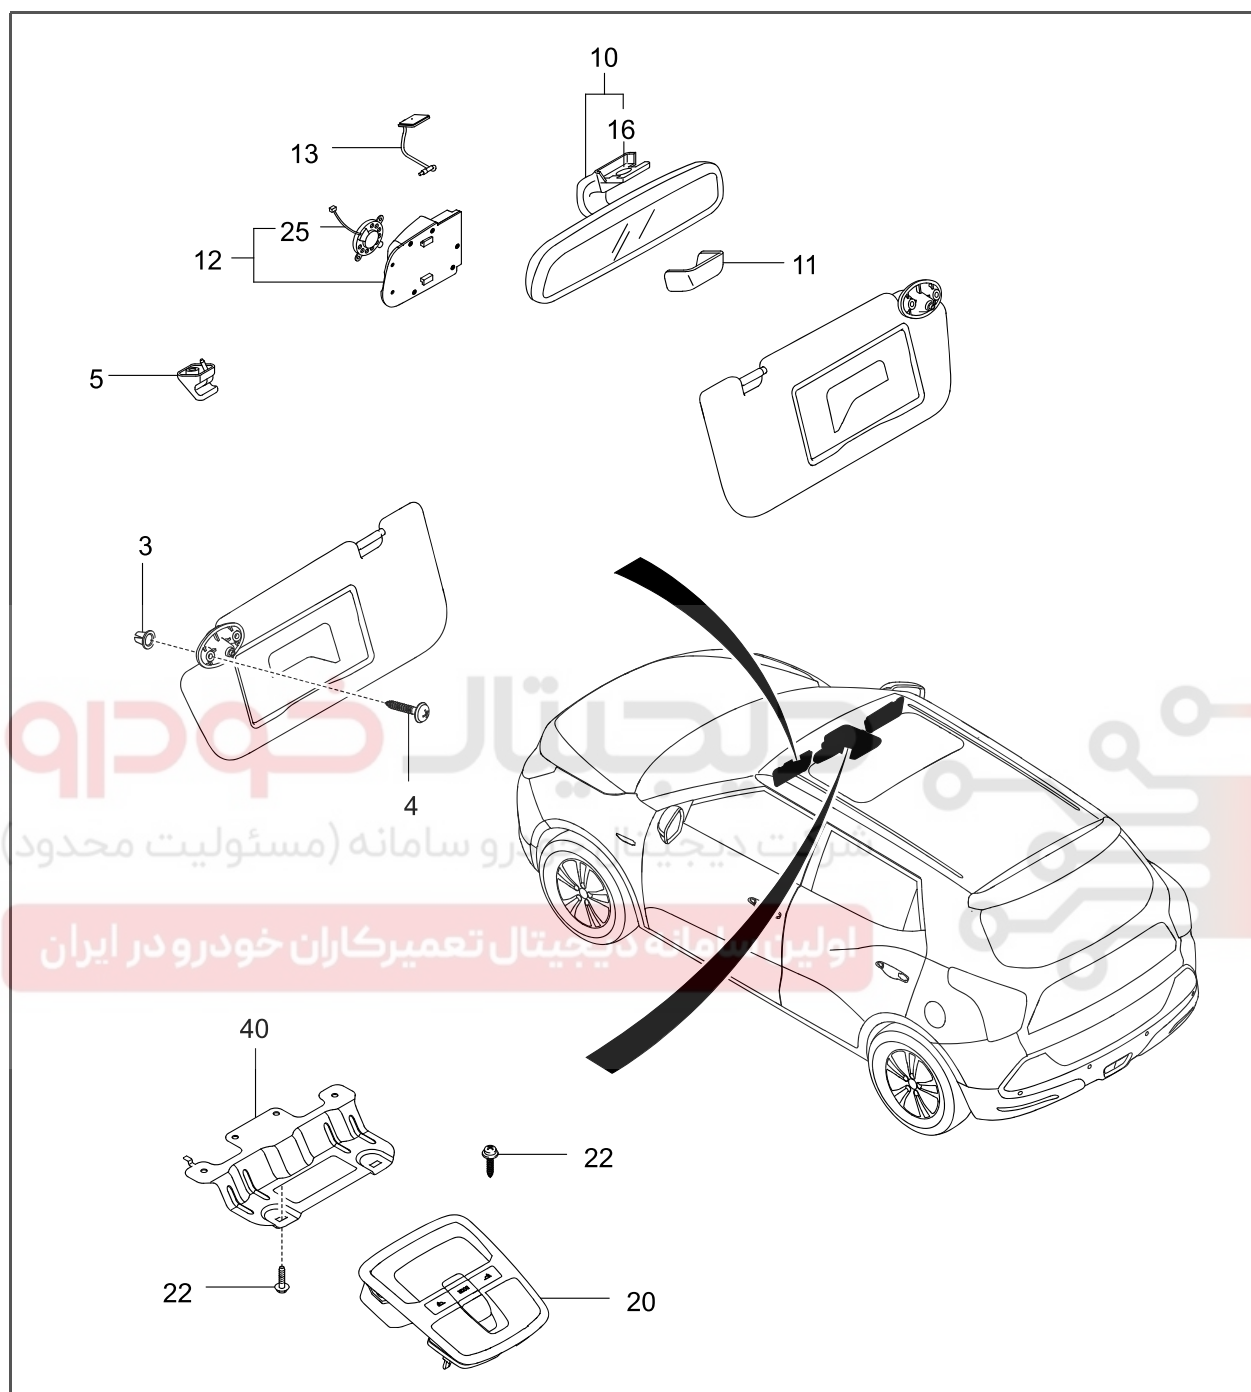
**7770-00 SUN SHADE AND INSIDE MIRROR**

3. Screw grommet

4. Screw

5. Sun visor retainer assembly

10. Rear view inside mirror assembly

11. Inside rear view mirror cover

12. ETCS unit assembly

13. ETCS antenna assembly

16. Inside rear view mirror bracket kit

20. Overhead console assembly

22. Screw

25. ETCS unit speaker assembly

40. Overhead console bracket

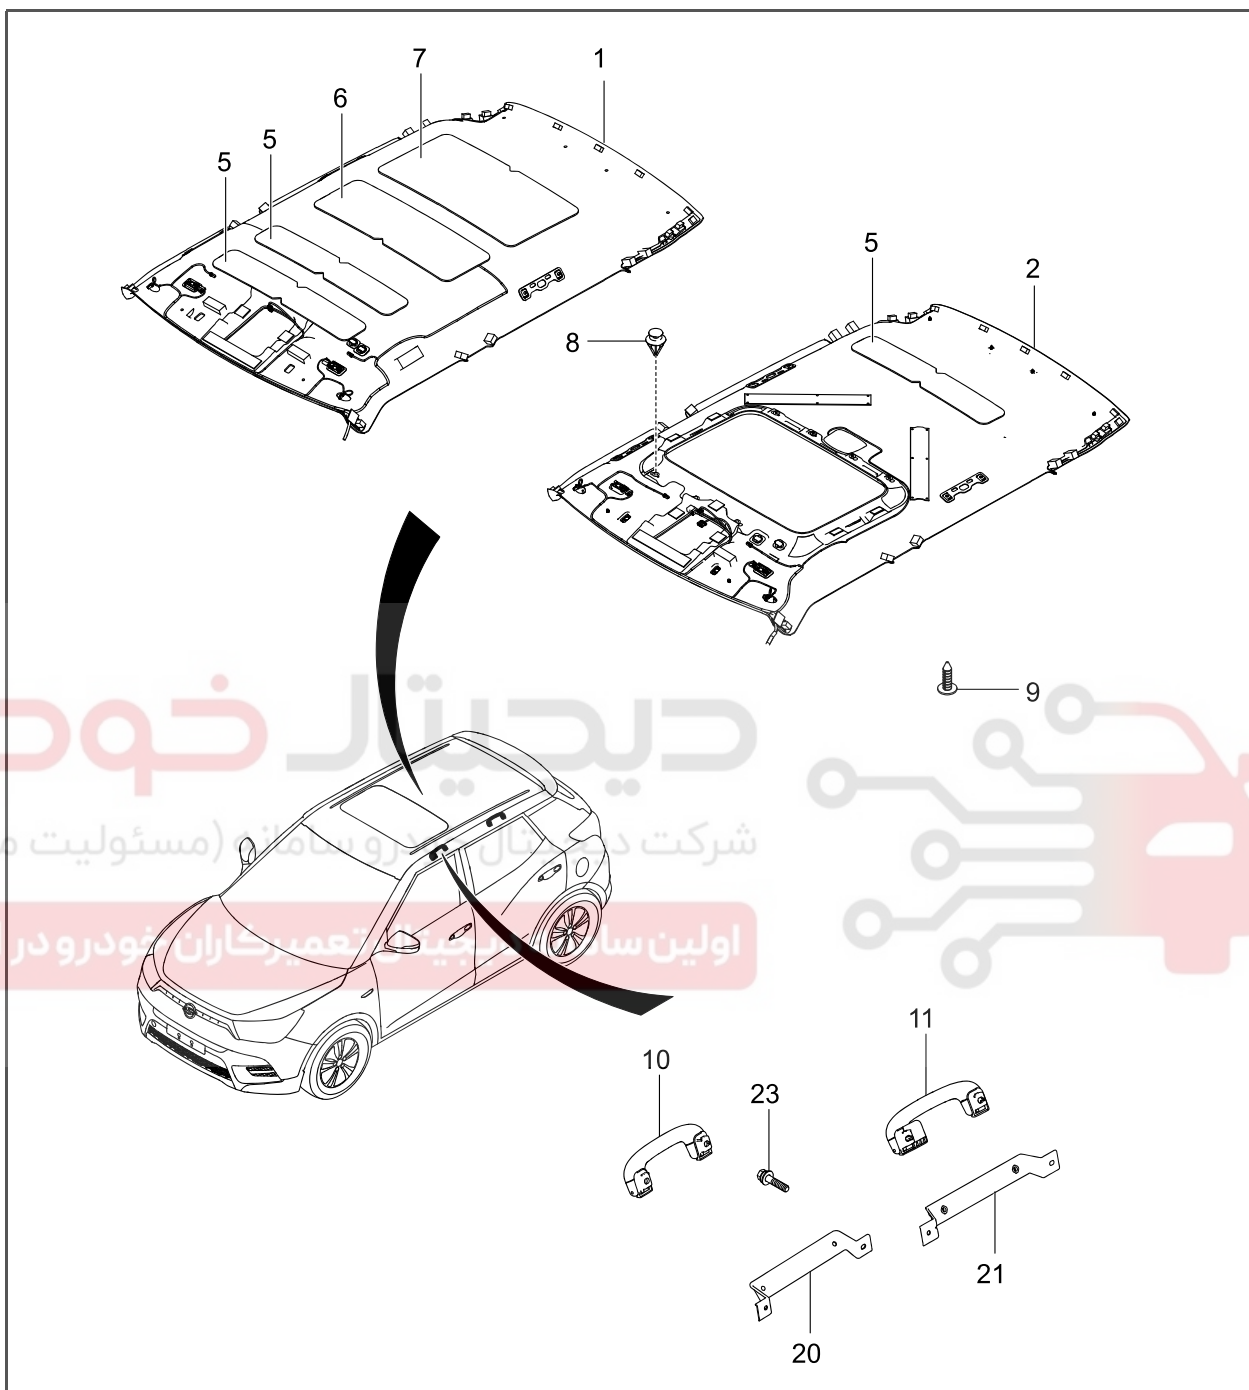
## 7330-00 HEADLINING

1. Headlining

2. Sunroof headlining

5. Roof No. 1 insulation

6. Roof No. 2 insulation

7. Roof No. 3 insulation

8. Fastener

9. Tree type fastener

10. Front grip assembly

11. Rear grip assembly

20. Front grip mounting bracket assembly

21. Rear grip mounting bracket assembly

23. Screw

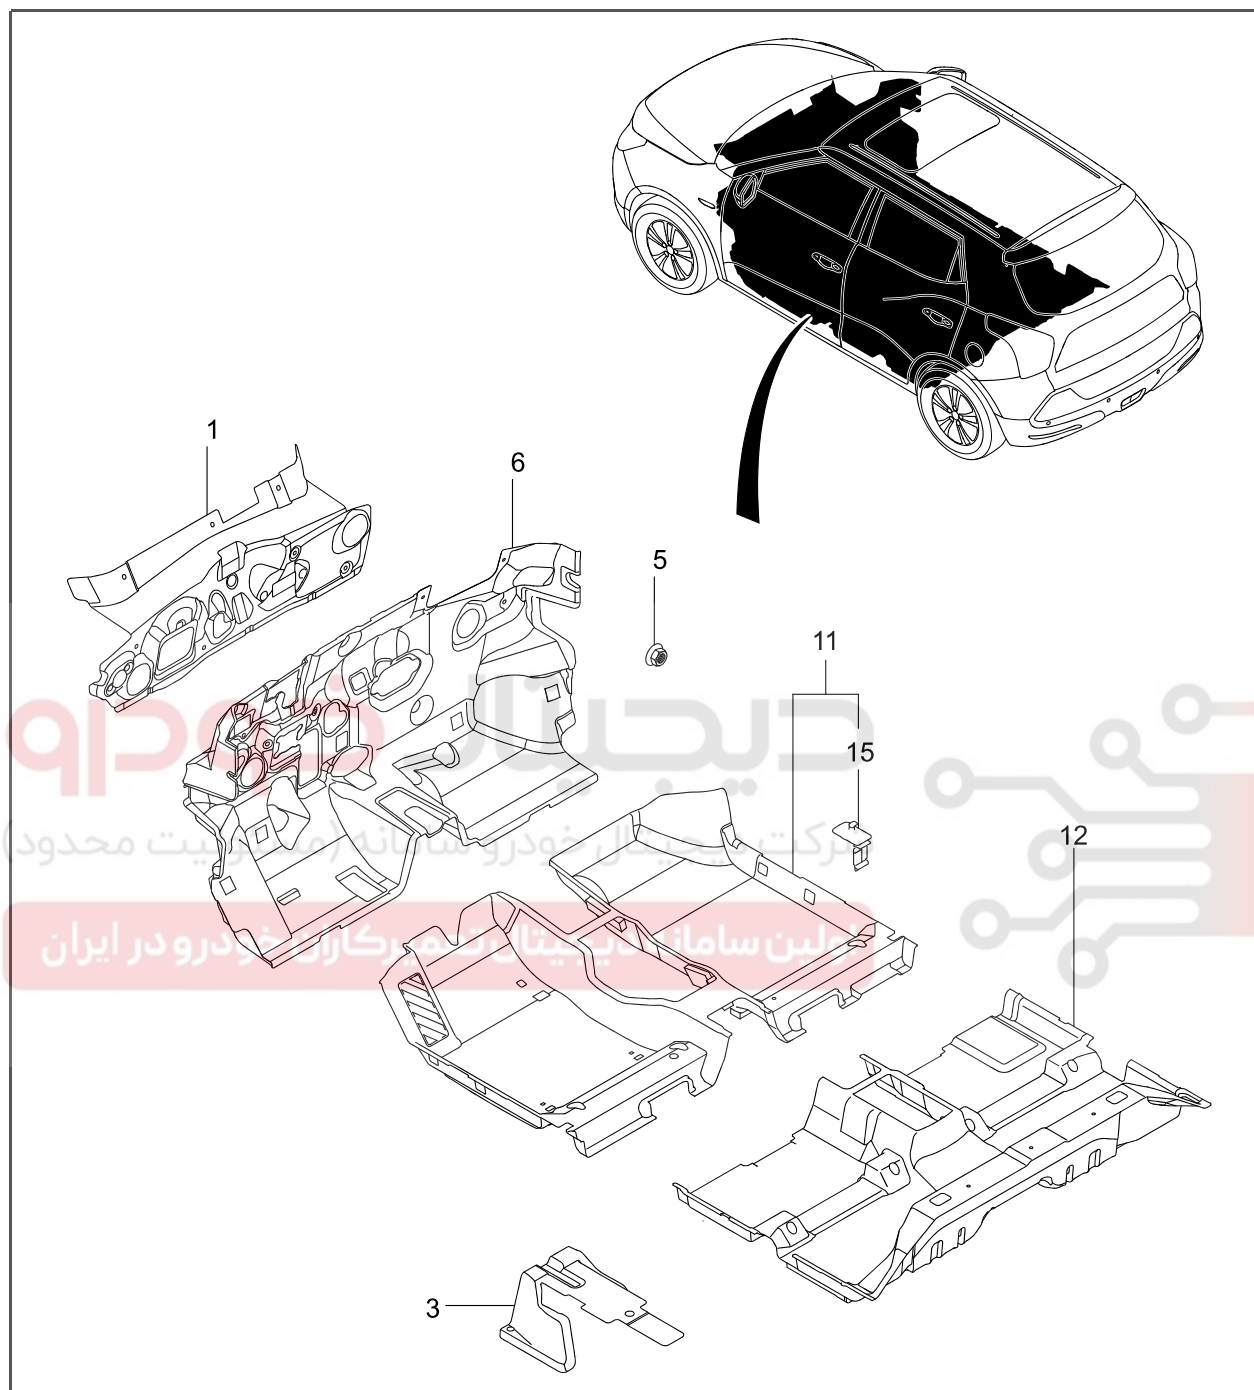
**7710-00 FLOOR CARPET**

- 1. Engine compartment insulator
- 3. Tunnel inner insulator
- 5. Nut
- 6. Dash inner insulator
- 11. Floor front mat assembly
- 12. Floor rear mat assembly
- 15. Car mat hook

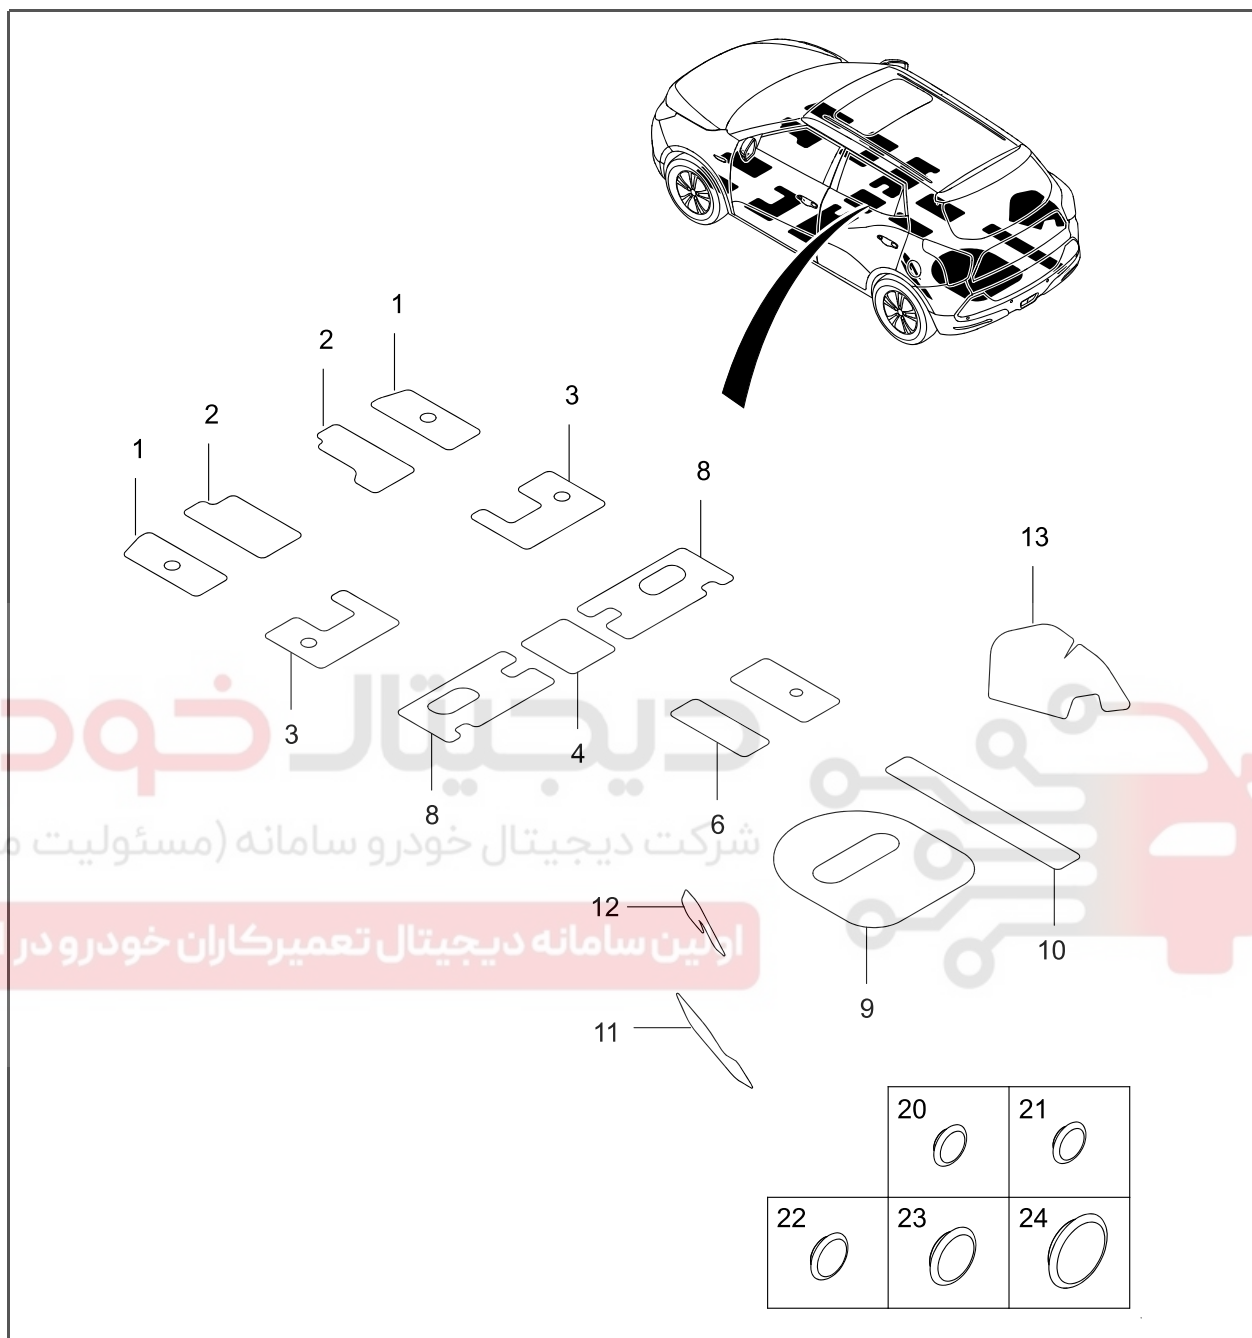
## 7792-00 ANTI-VIBRATION PAD

1. Front floor front outer anti-pad
2. Front floor front inner anti-pad
3. Front floor center anti-pad
4. Front floor rear inner anti-pad
6. Intermediate floor center anti-pad
8. Front floor rear outer anti-pad
9. Spare tire anti-pad
10. Rear floor rear outer anti-pad

11. Rear wheel house inner lower anti-pad
12. Rear wheel house inner upper anti-pad
13. Rear wheel house inner anti-pad
20. Blind plug
21. Blind plug
22. Blind plug
23. Blind plug
24. Blind plug

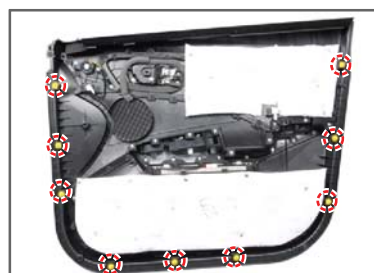
5. Disconnect the front door trim assembly from the bottom while paying attention not to damage the clips (9 off).

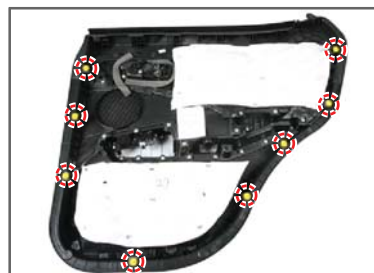
5. Disconnect the rear door trim assembly from the bottom while paying attention not to damage the clips (8 off).

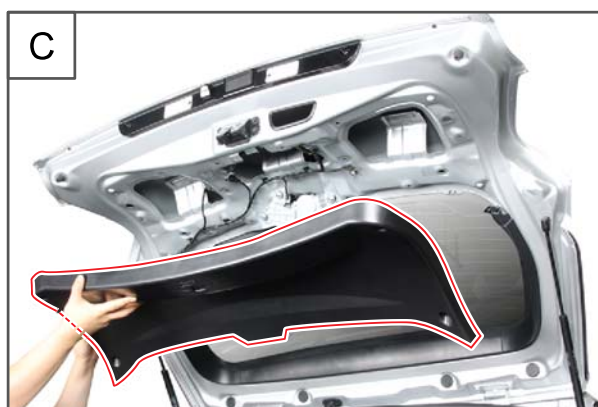
B. Detach the tailgate lower trim assembly at the connection with the tailgate side trim assembly using a hand remover.

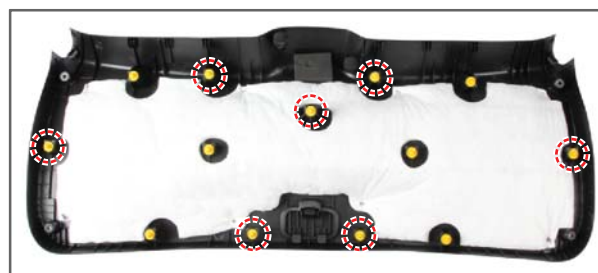
C. Remove the tailgate lower trim assembly while paying attention not to damage the clips (7 off).

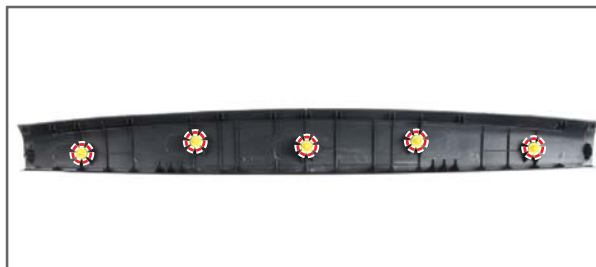
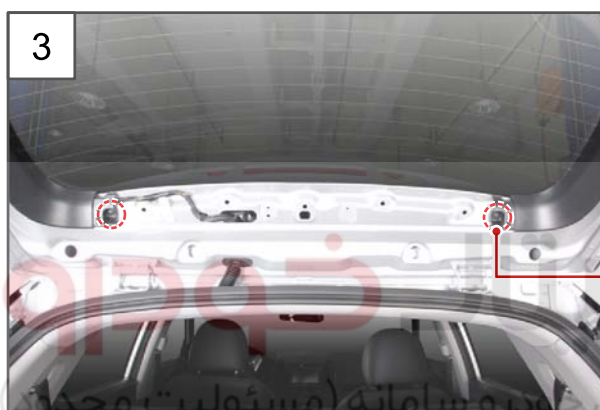
2. Remove the tailgate upper trim assembly while paying attention not to damage the clips (5 off).

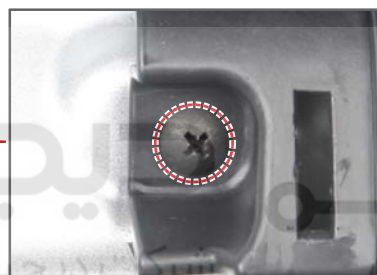
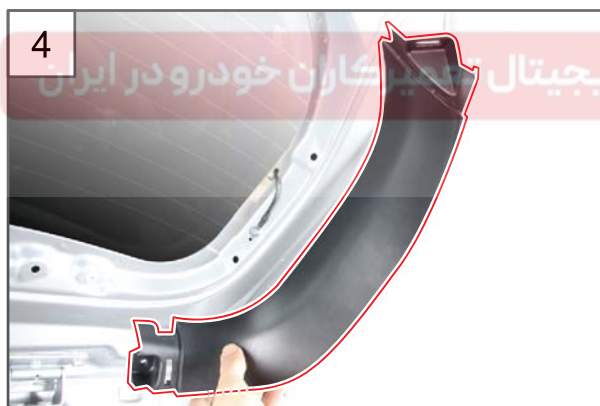
3. Unscrew the one mounting screw for each LH/RH tailgate side trim assembly.

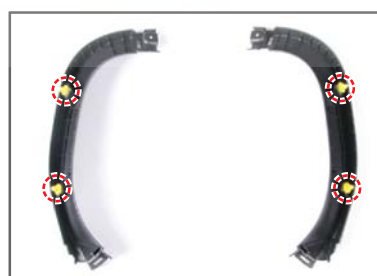
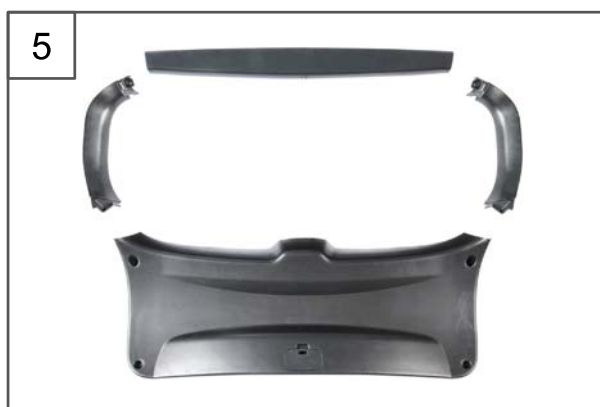
4. Remove the tailgate side trim assembly while paying attention not to damage the clips (2 off).

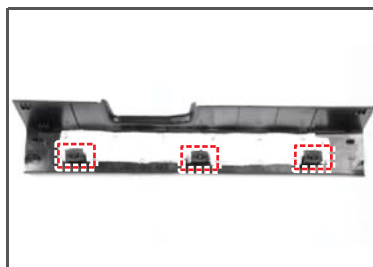
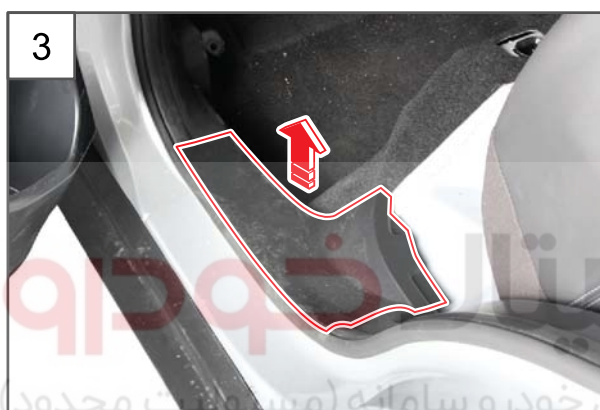
2. Remove the door scuff front trim assembly to the arrow direction while paying attention not to damage the fixing clips (3 off).

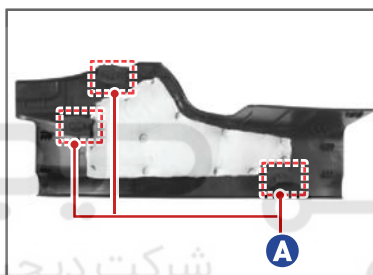
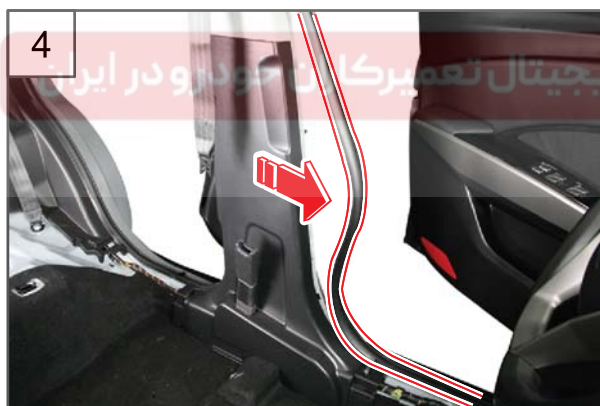
3. Remove the door scuff rear trim assembly to the arrow direction while paying attention not to damage the fixing clips (A, 3 off).

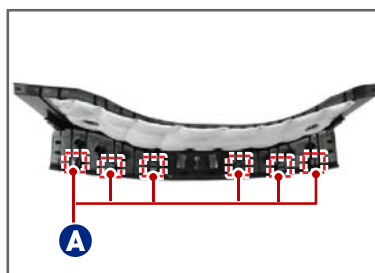
6. Remove the rear transverse trim assembly to the arrow direction while paying attention not to damage the fixing clips (A, 6 off).

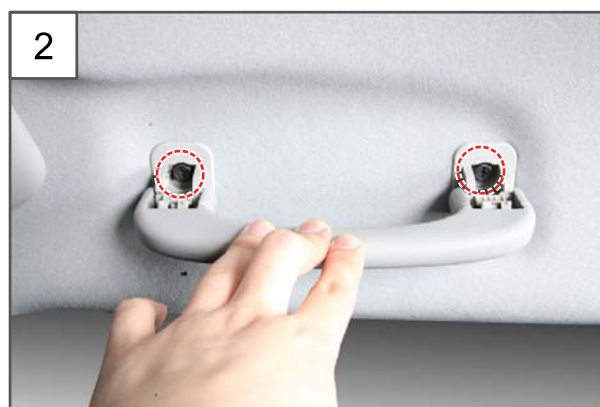
2. Unscrew the 2 mounting screw bolts (10 mm) for the grip assembly.

It is recommended that a phillips screwdriver is used to unscrew the mounting screw bolts since the space is narrow.

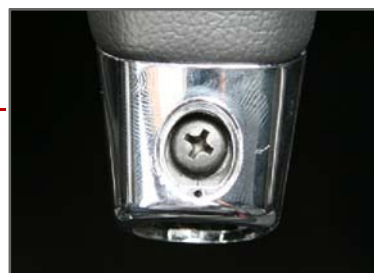
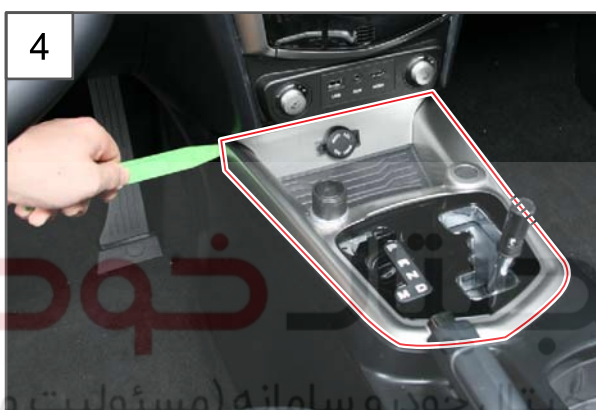
3. Remove the mounting screw cover for the TGS lever knob, unscrew the one mounting screw and remove the TGS lever knob to the arrow direction.

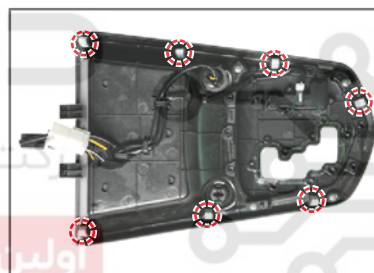
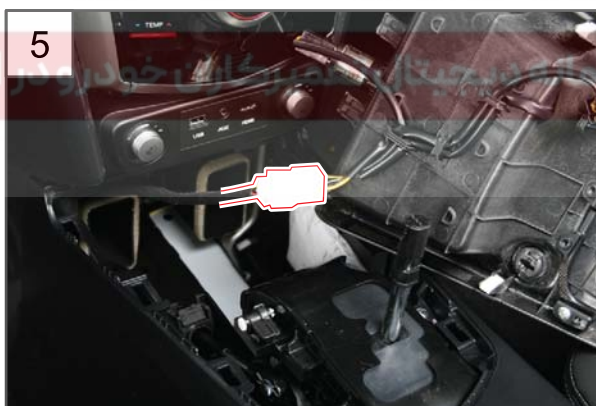
4. Detach the front console A/T upper fascia assembly from the front console assembly using a hand remover while paying attention not to damage the clips (7 off).

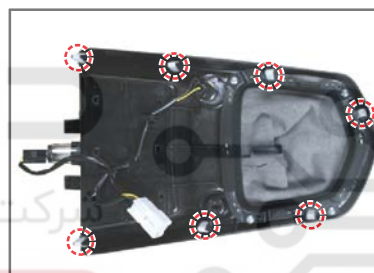
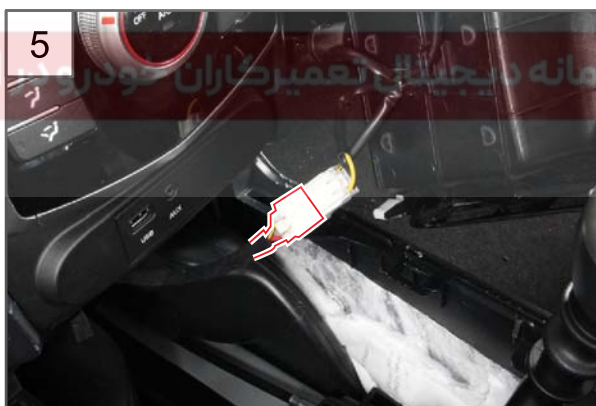
4. Detach the front console M/T upper fascia assembly from the front console assembly using a hand remover while paying attention not to damage the clips (7 off).

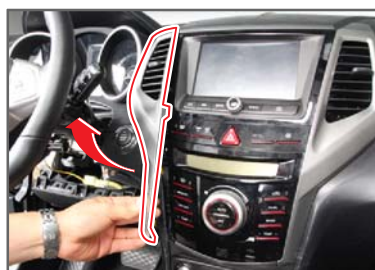
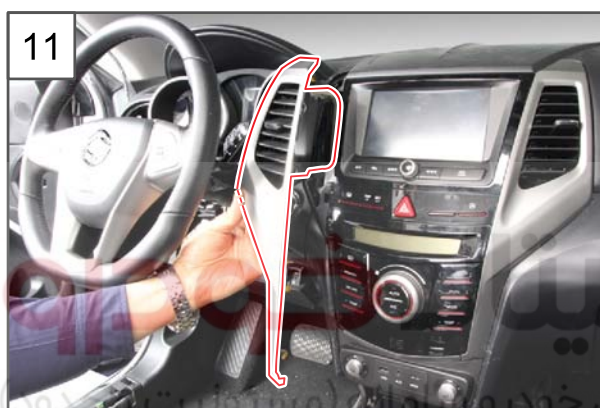
10.Remove the center fascia LH panel from the bottom using a hand remover.

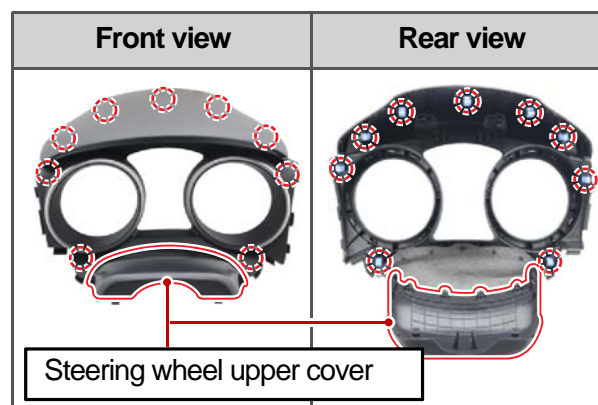
14. Remove the instrument panel cover while paying attention not to damage the fixing clips (9 off).

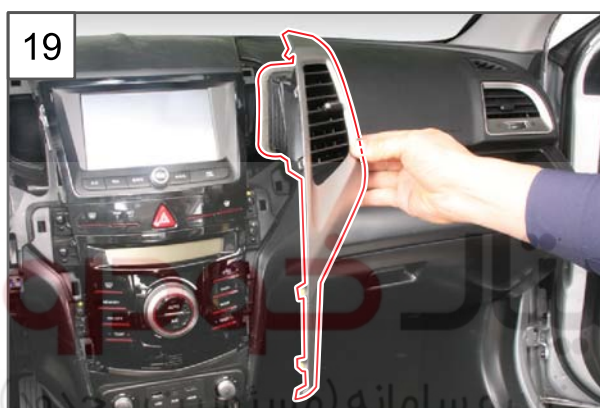
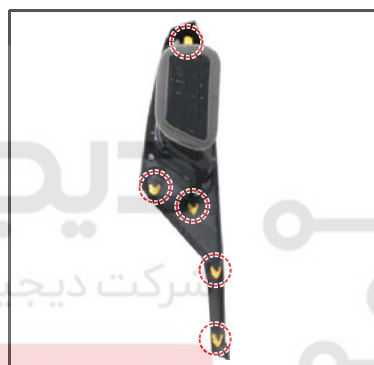
19.Remove the center fascia RH panel while paying attention not to damage the fixing clips (5 off).

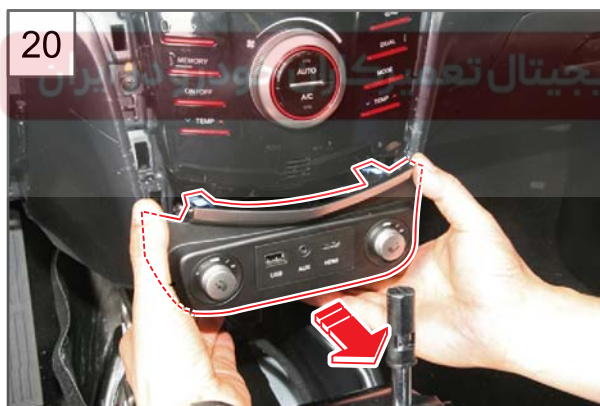
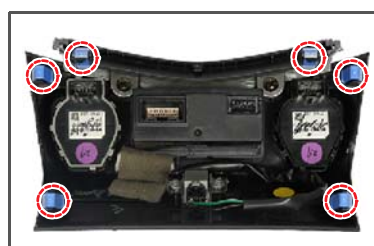
20.Remove the lower section of the center fascia lower panel while paying attention not to damage the fixing clips (6 off).

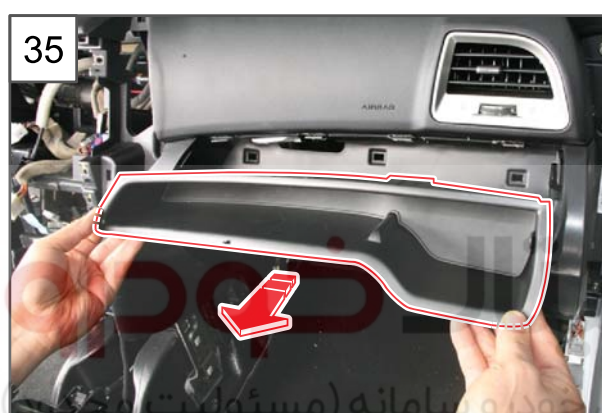
34.Remove the RH side tray by pushing the screwdriver to the arrow direction.
