BODY EXTERIOR

TIVOLI 2015.03

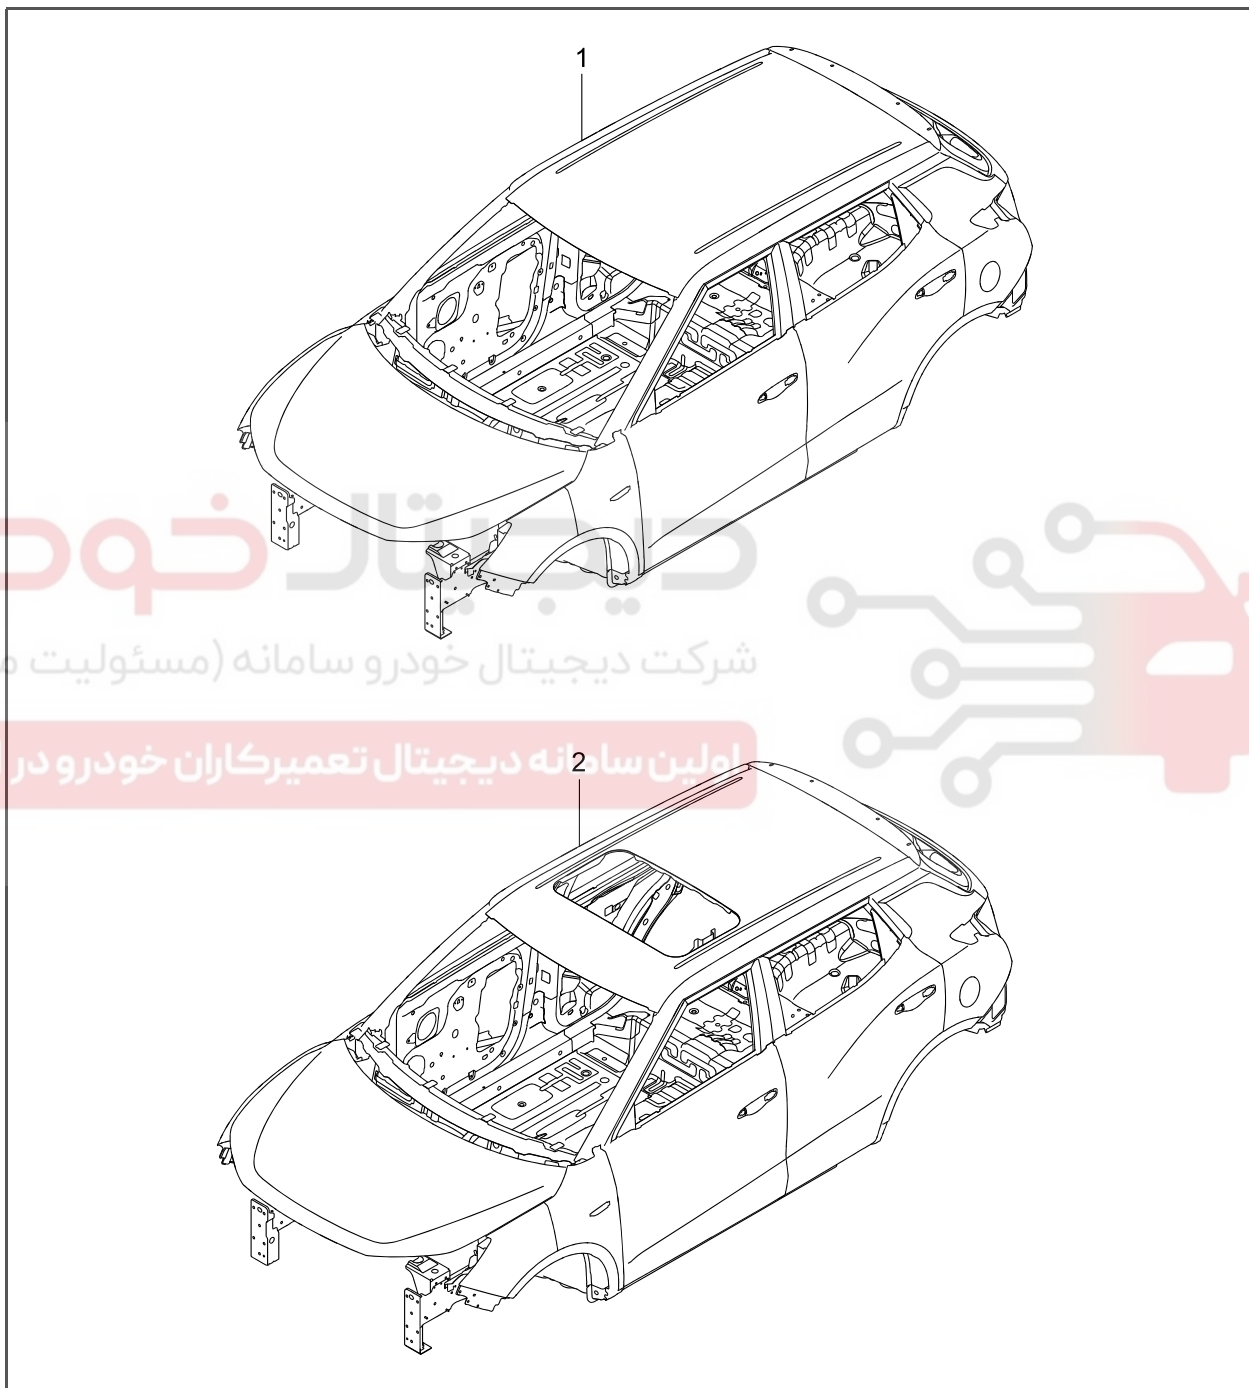
5110-00 WHITE BODY

1. White body
2. White body (for vehicles with sunroof)

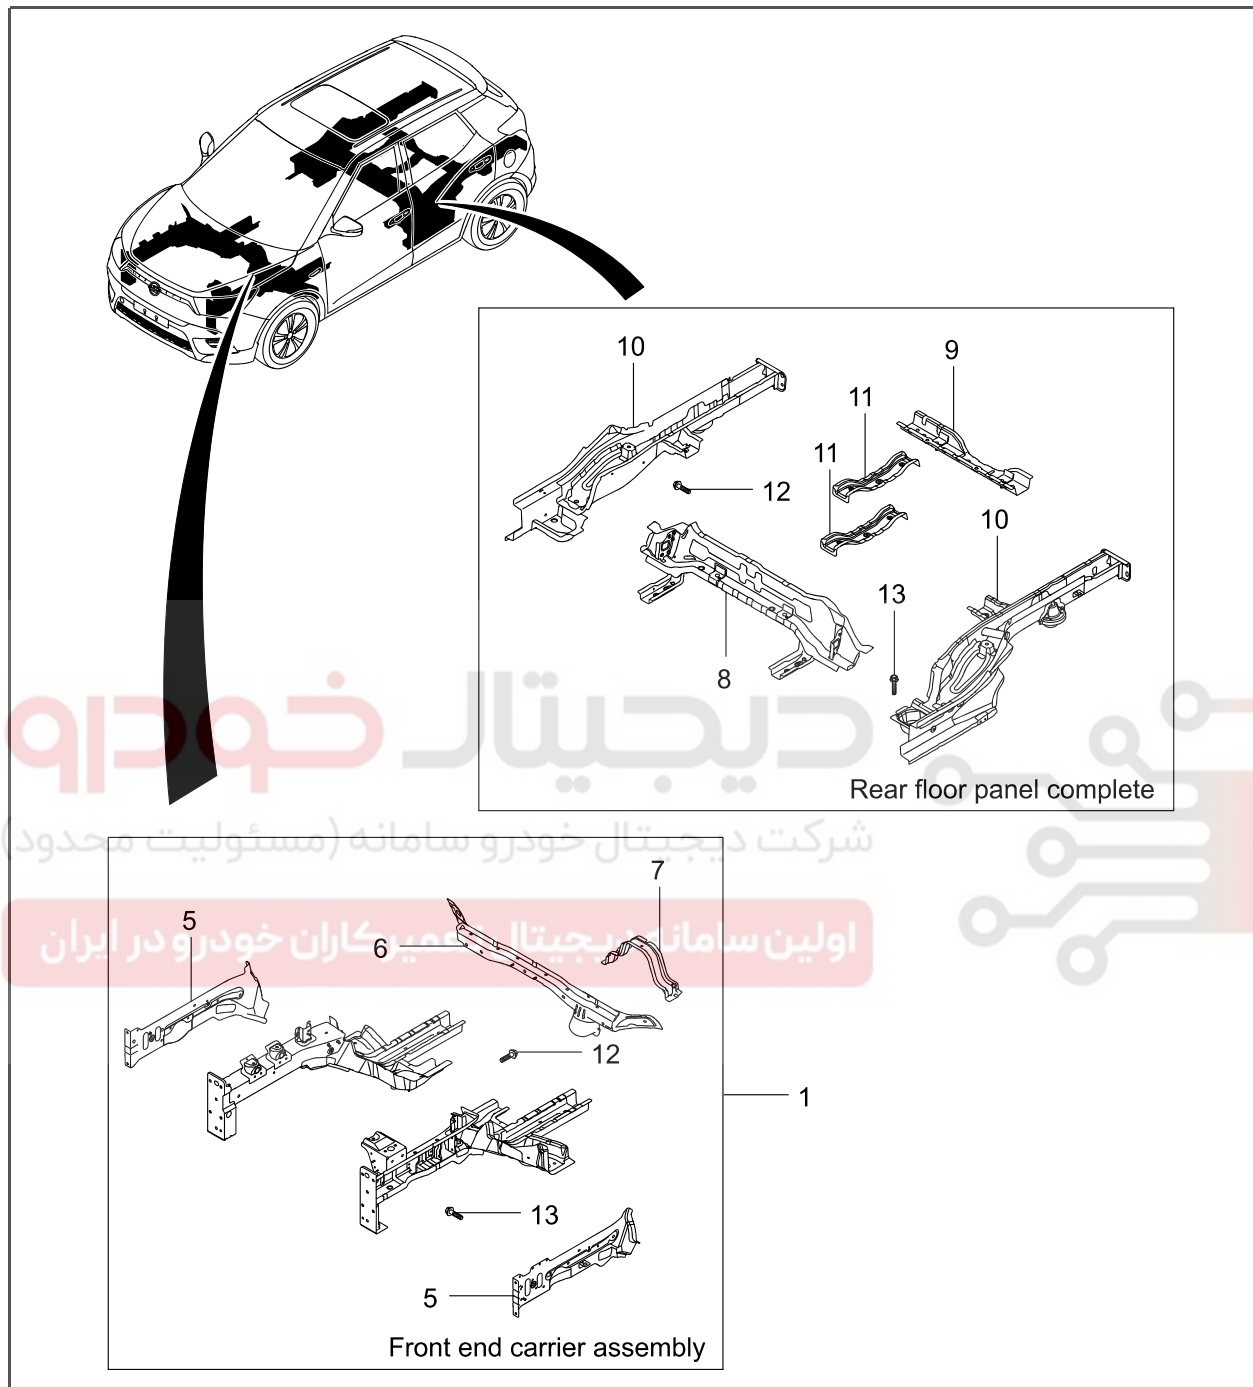
5125-00 BODY FRAME

1. Front H-frame member assembly
2. Rear H-frame member assembly
3. Front side LH member assembly
4. Front side RH member assembly
5. Front side outer member assembly
6. Dash lower front member assembly
7. Dash lower center reinforcement

8. Rear floor No. 1 cross member assembly
9. Rear floor No. 2 cross member assembly
10. Rear side LH member assembly
11. Intermediate floor center member
12. Bolt
13. Bolt

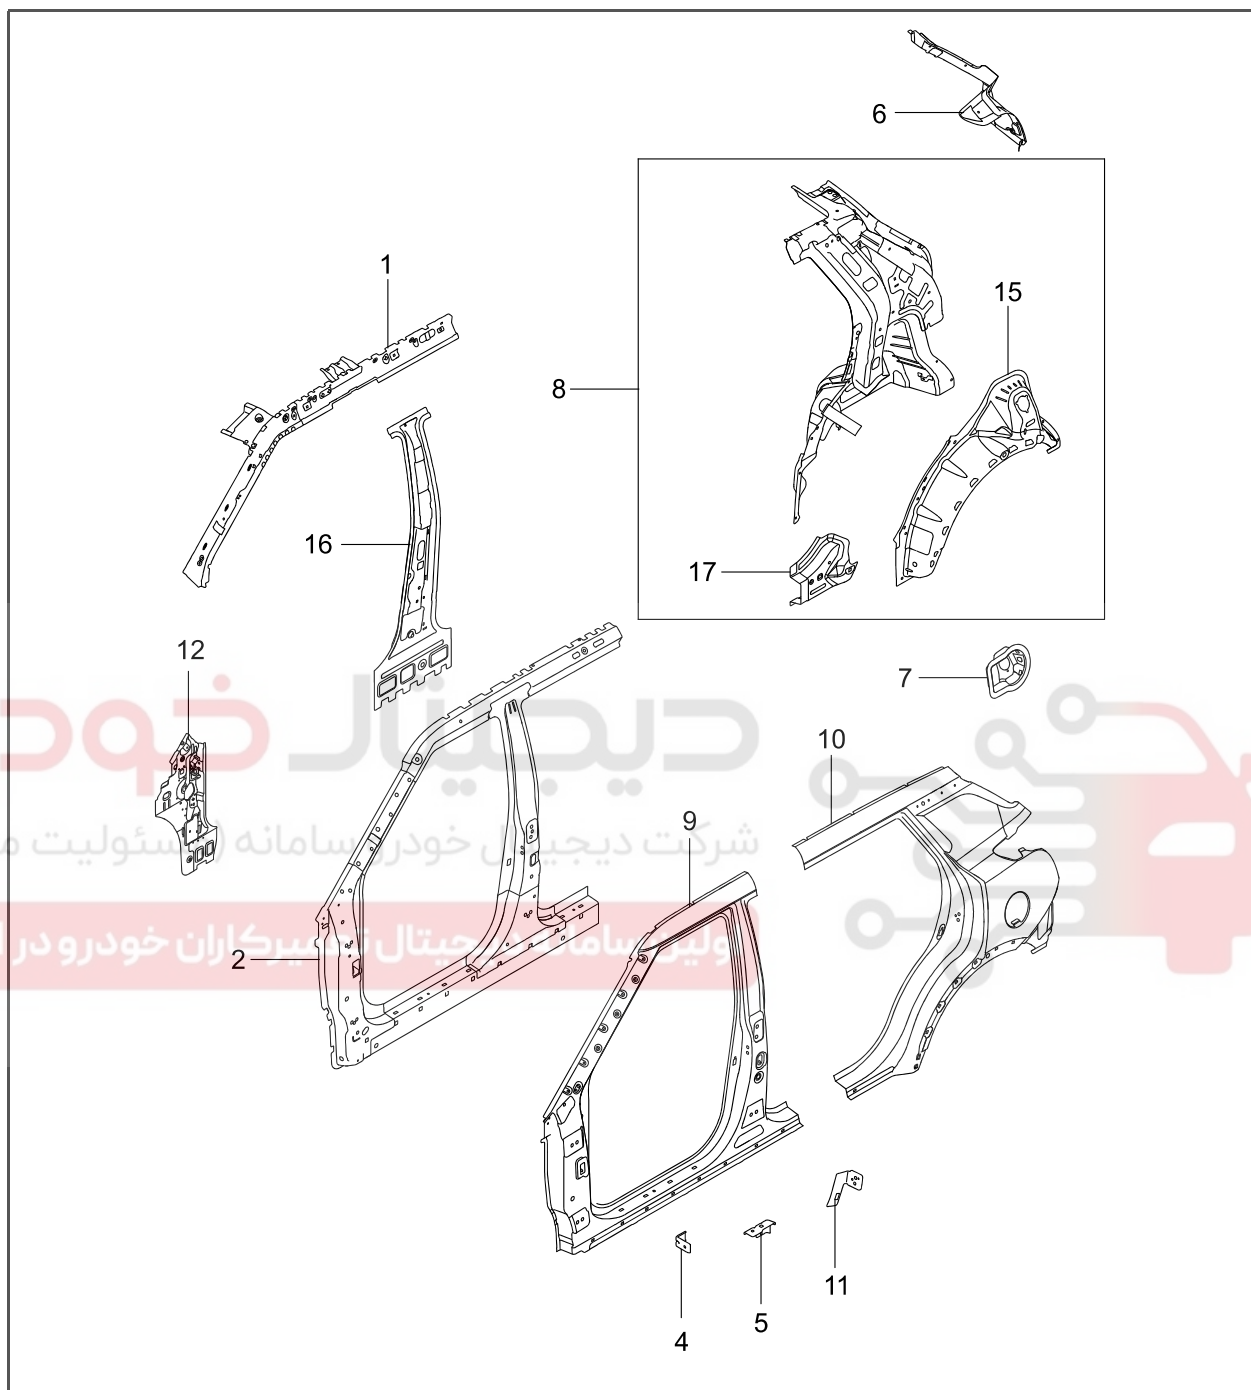
5210-00 SIDE AND REAR BODIES

| 1. A-pillar upper panel assembly | 9. Side outer front panel |
| 2. Side outer reinforcement assembly | 10. Side outer rear panel |
| 4. Fender mounting lower bracket assembly | 11. Rear door striker reinforcement assembly |
| 5. Fender mounting upper bracket assembly | 12. Cowl side inner panel complete |
| 6. D-pillar outer complete | 15. Wheel house rear outer panel assembly |
| 7. Fuel filler housing assembly | 16. B-pillar inner assembly |
| 8. Quarter inner and wheel house panel complete | 17. Side seal rear outer reinforcement |

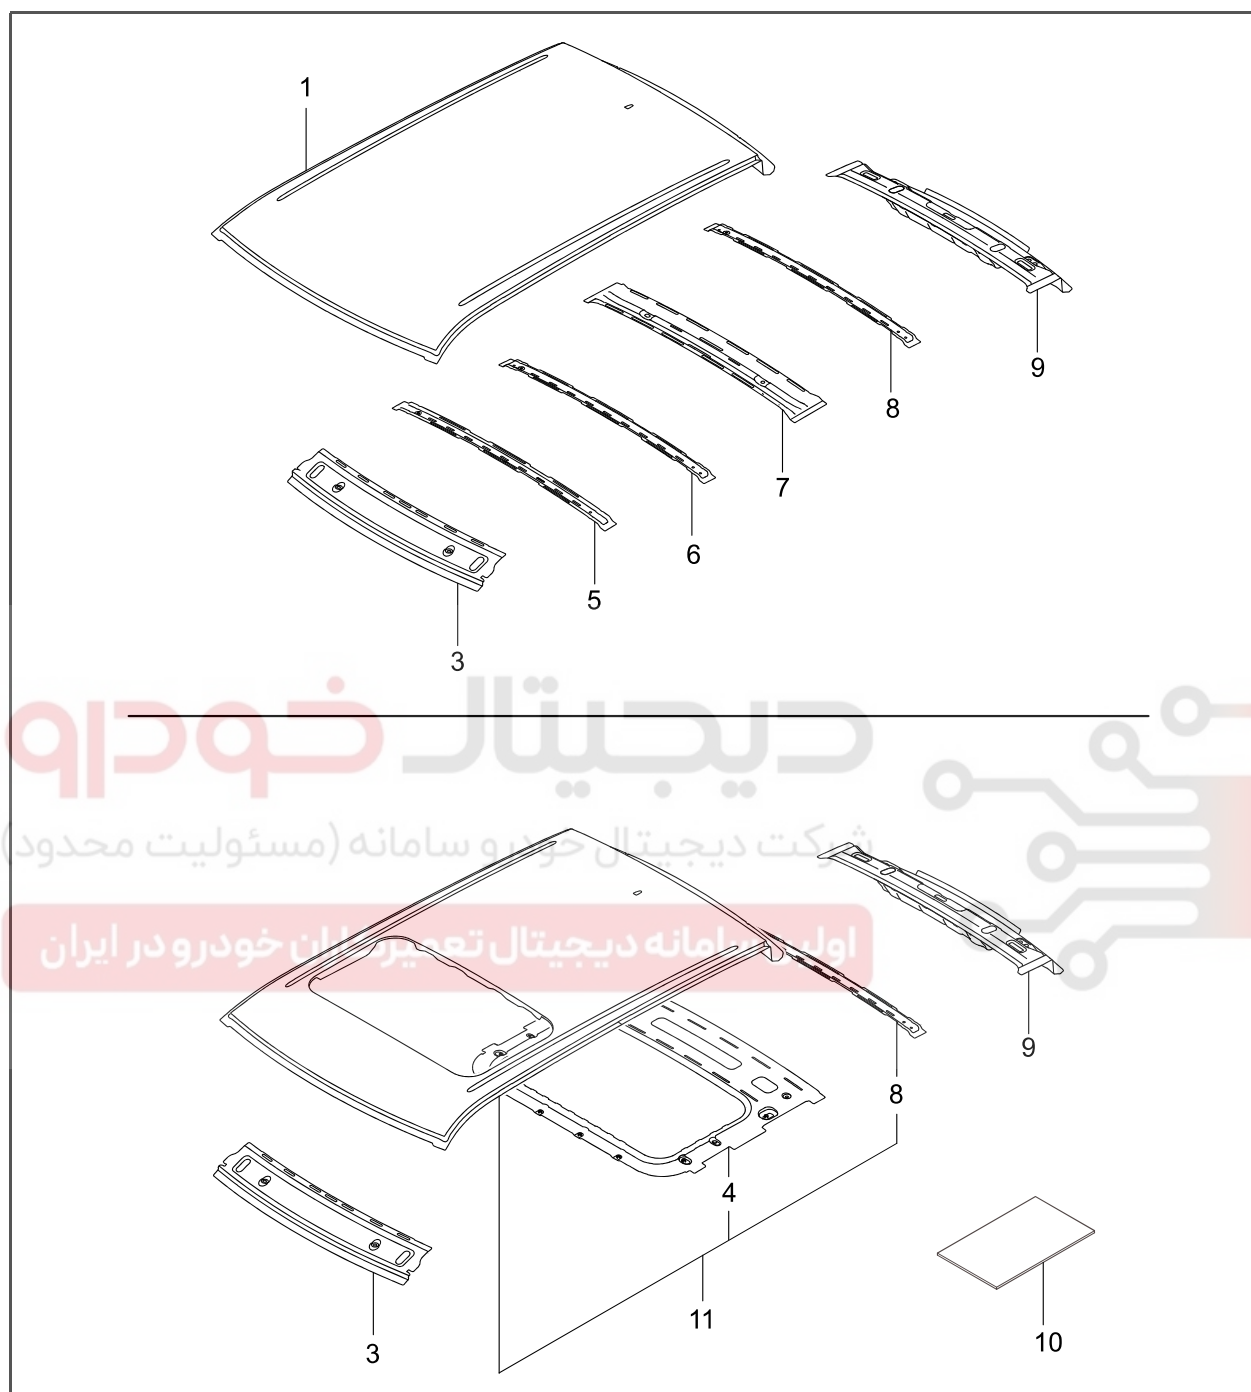
5510-00 ROOF PANEL

- 1. Roof panel
- 3. Front roof rail assembly
- 4. Sunroof reinforcement assembly
- 5. Roof No. 1 center rail
- 6. Roof No. 2 center rail

- 7. Roof No. 3 center rail
- 8. Roof No. 4 center rail
- 9. Roof rear rail assembly
- 10. Anti-vibration pad
- 11. Roof panel assembly

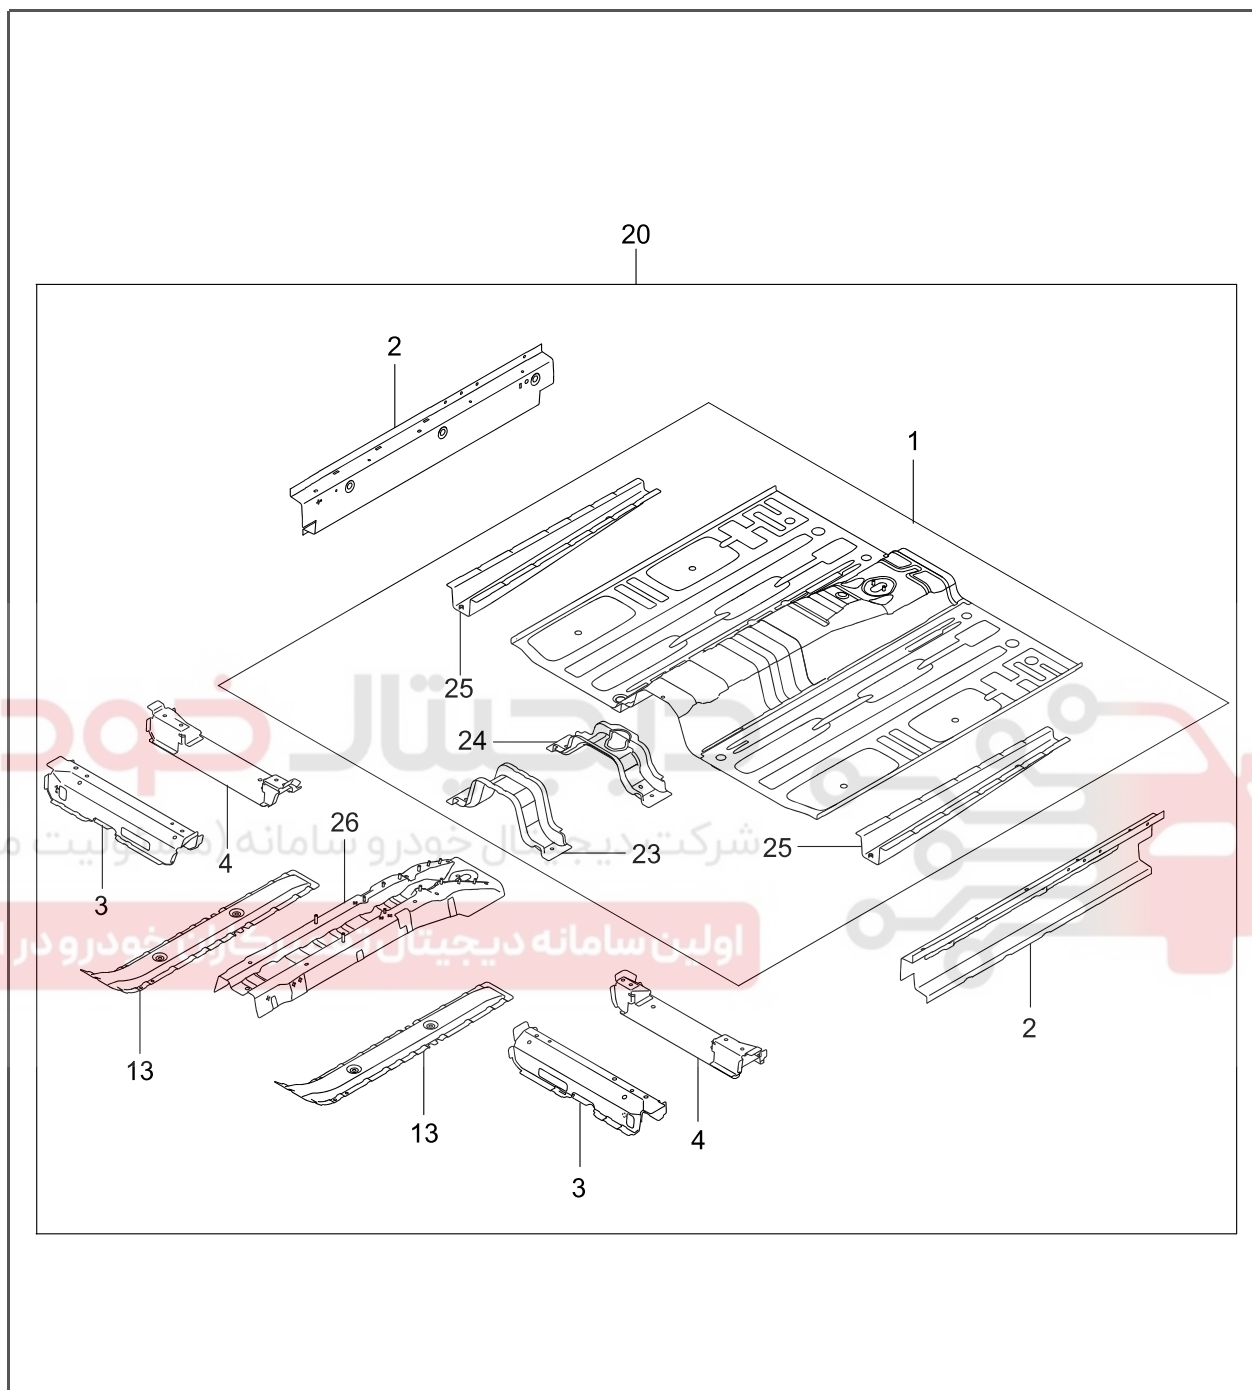
5610-00 FRONT FLOOR PANEL

- 1. Front floor panel assembly
- 2. Side seal inner panel assembly
- 3. Front seat mounting front member assembly
- 4. Front seat mounting rear member assembly
- 13. Front floor upper member

- 20. Front floor panel complete
- 23. Front tunnel front cross member
- 24. Front tunnel rear cross member assembly
- 25. Center side member assembly
- 26. Front tunnel reinforcement assembly

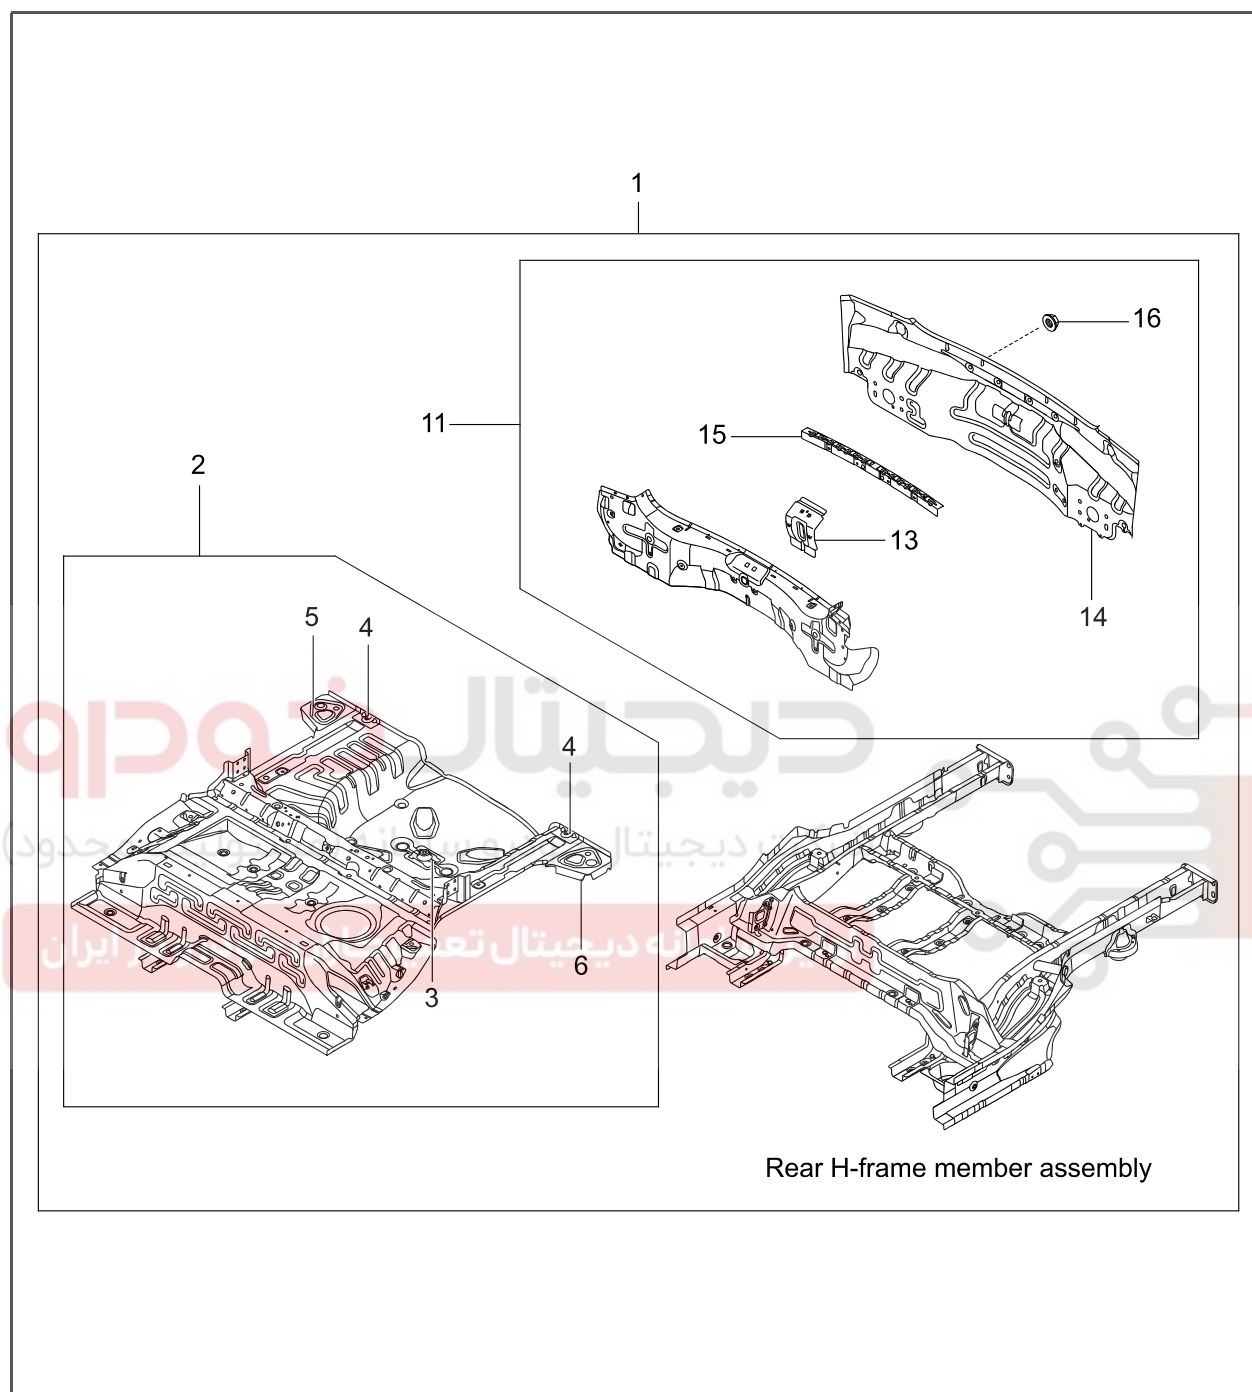
5620-00 REAR FLOOR PANEL

| 1. Rear floor panel complete | 11. Rear end member assembly |
| 2. Rear floor panel assembly | 13. Tailgate striker mounting reinforcement assembly |
| 3. Spare tire mounting bracket assembly | 14. Back outer panel assembly |
| 4. Rear floor rear bracket | 15. Rear bumper mounting upper bracket assembly |
| 5. Rear floor side LH extension | 16. Hexagon flanged nut |
| 6. Rear floor side RH extension | |

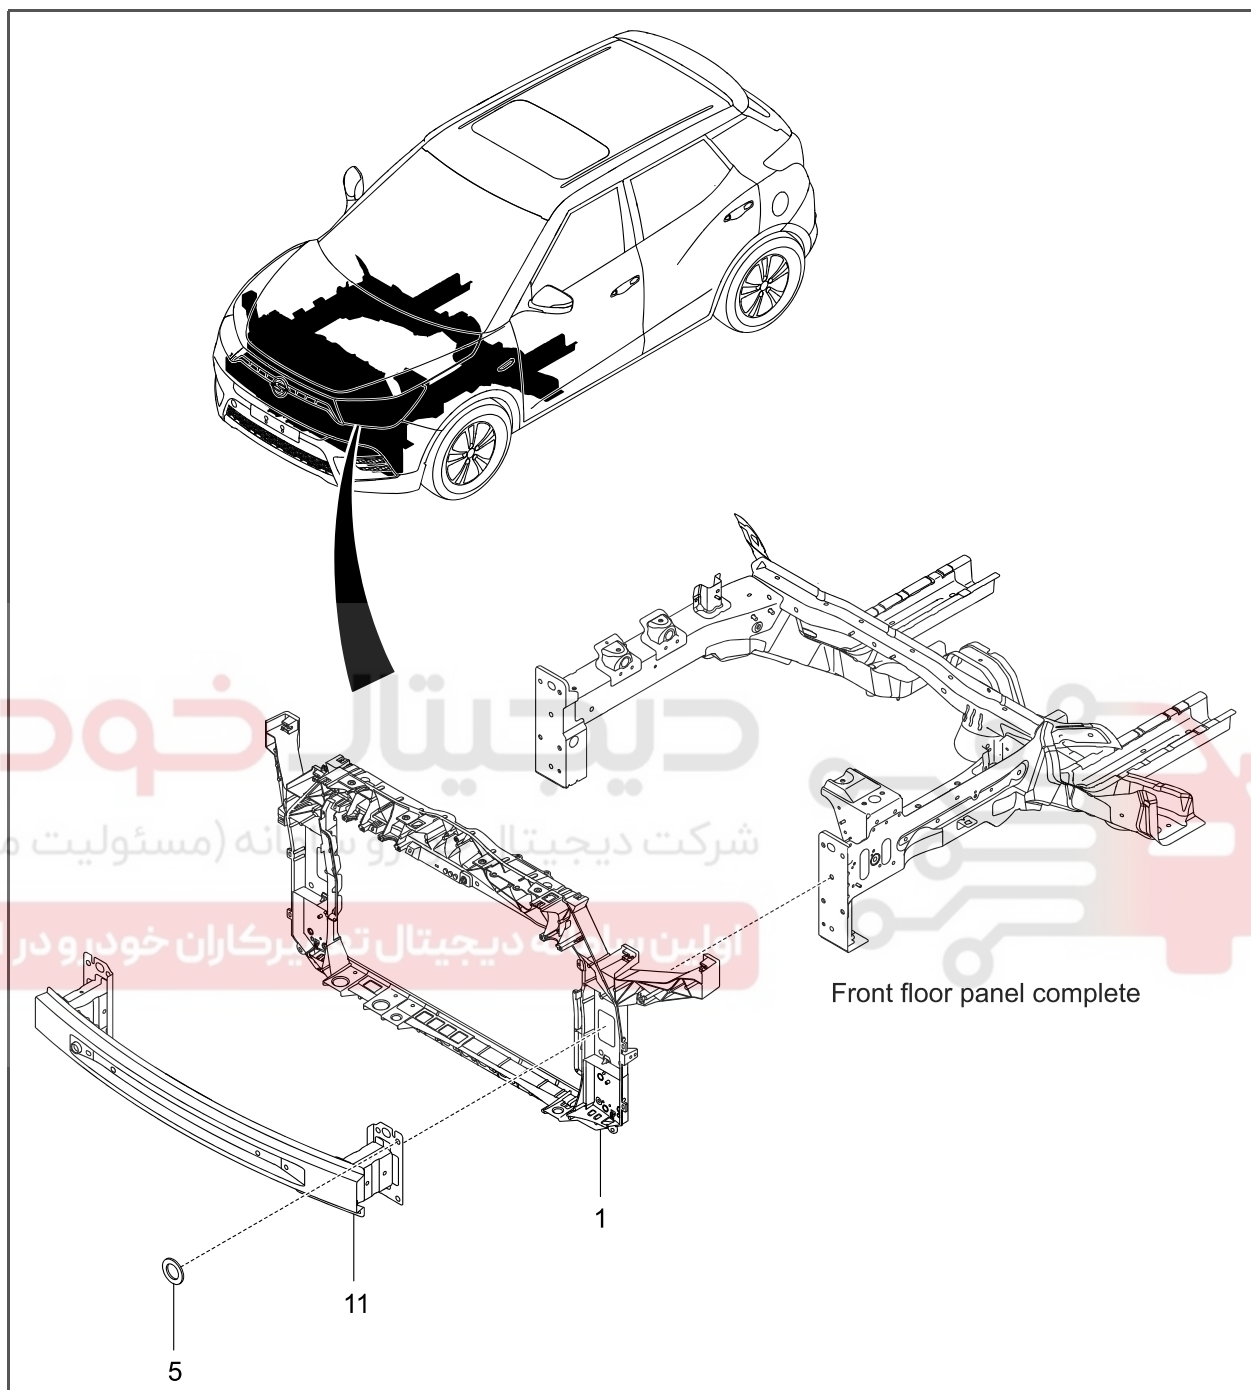
5710-00 FRONT END PANEL

- 1. Front end carrier assembly
- 5. Washer
- 11. Front bumper impact beam assembly

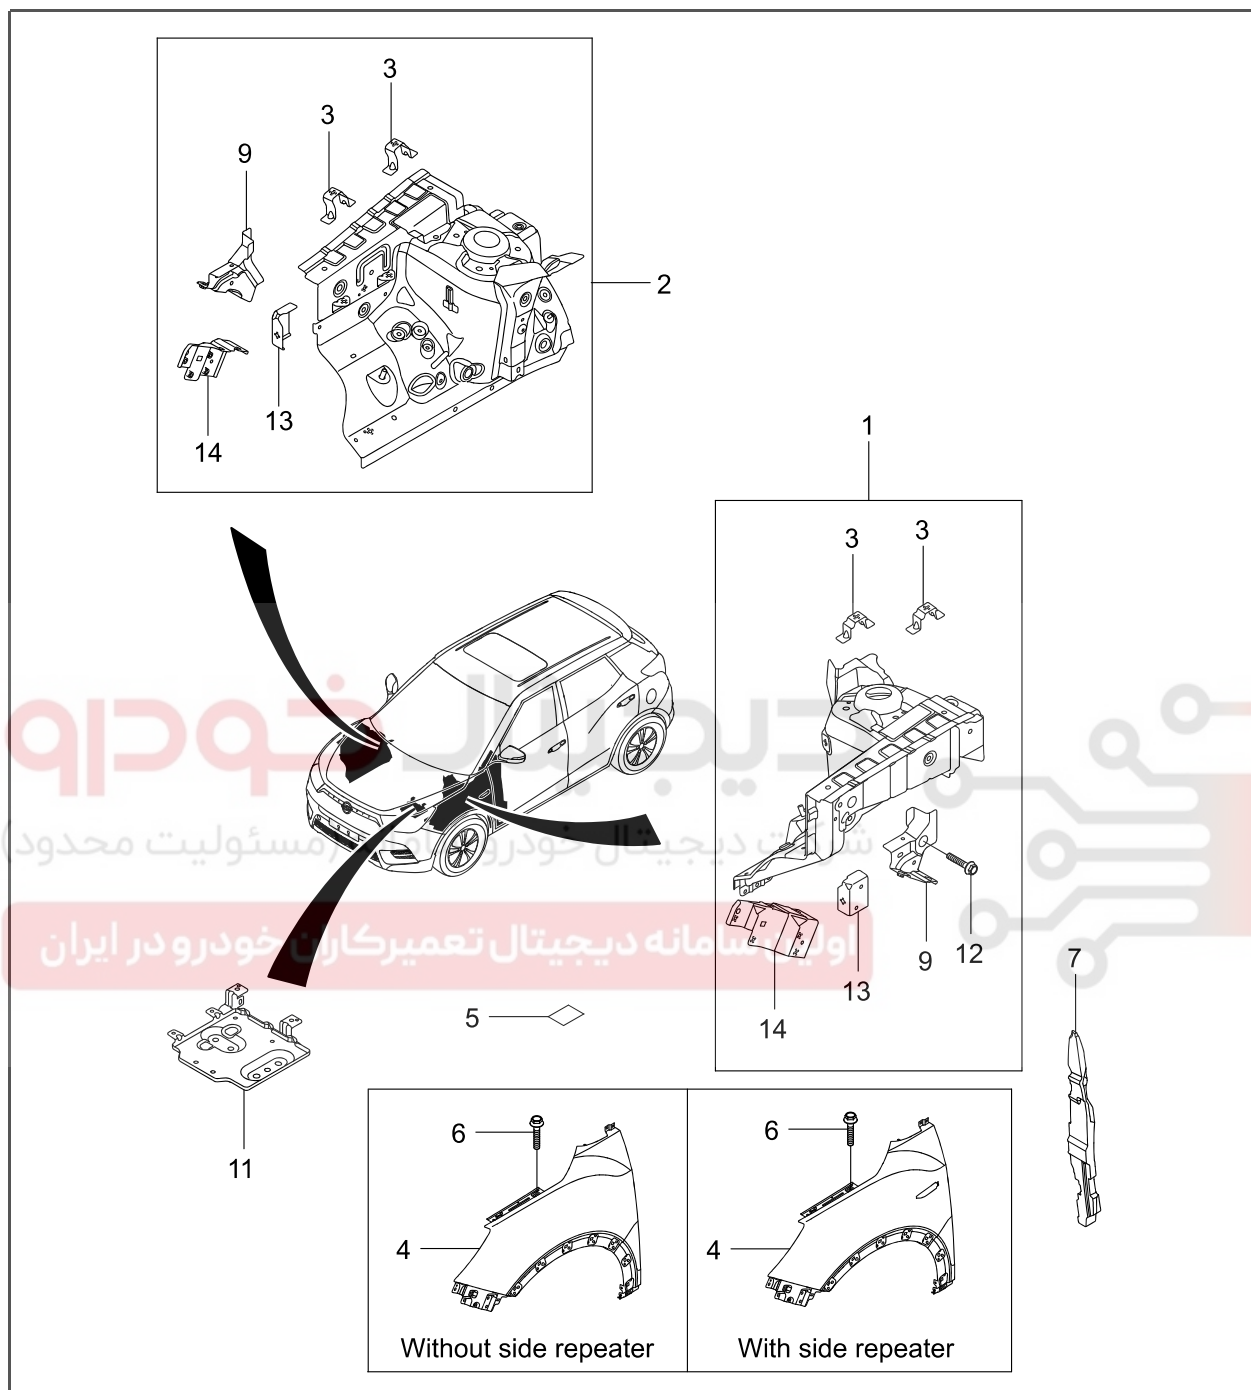
FENDER AND APRON PANEL

1. Fender apron LH panel complete
2. Fender apron RH panel complete
3. Fender mounting front bracket assembly
4. Fender panel
5. Fender mounting sealing pad
6. Flange bolt

7. Fender seal
9. Fender mounting lower support assembly
11. Battery tray plate assembly
12. Flange bolt
13. Cowl side inner panel complete
14. Fender mounting lower bracket assembly

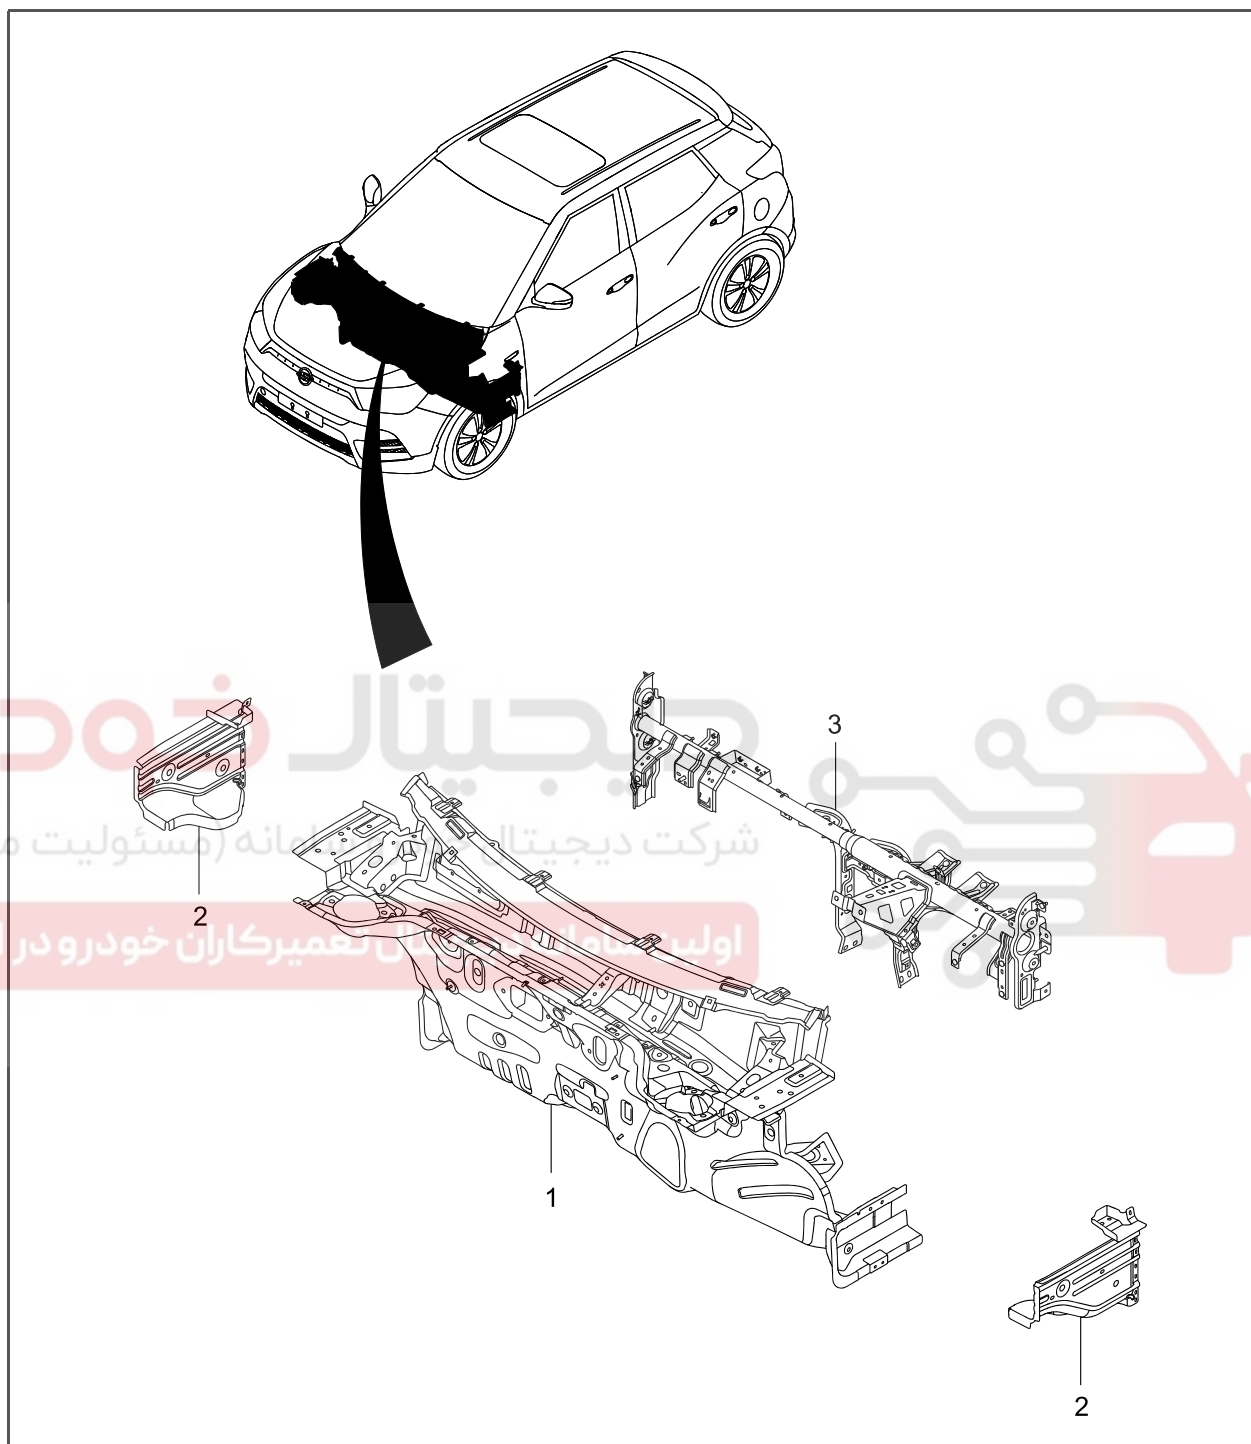
5730-00 DASH PANEL AND COWL

1. Dash and cowl panel complete
2. Cowl side upper member assembly
3. Cross member assembly

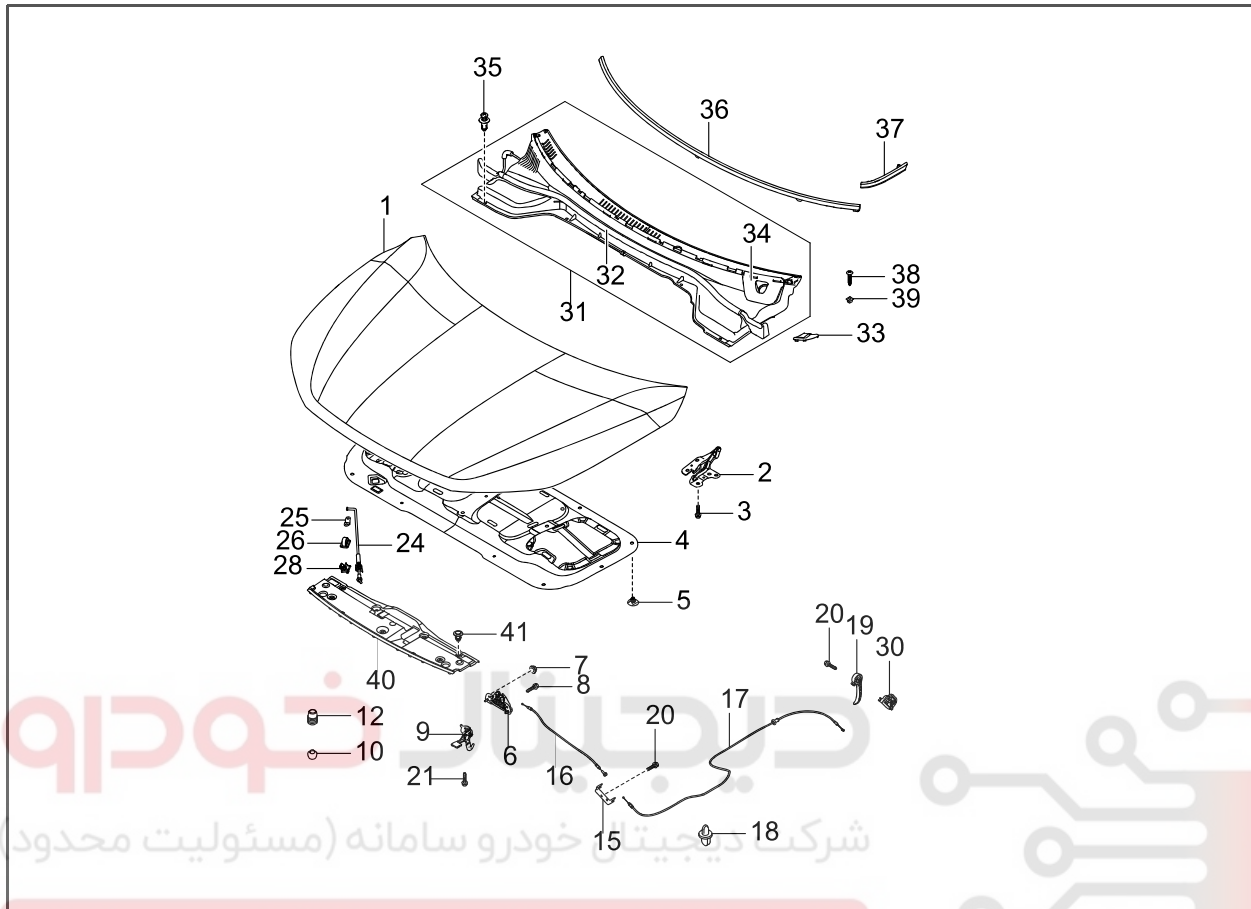
6110-00 HOOD PANEL

| 1. Hood panel assembly | 21. Screw |
| 2. Hood hinge assembly | 24. Hood stay rod assembly |
| 3. Flange bolt | 25. Hood stay rod mounting bracket |
| 4. Hood insulator | 26. Hood stay rod retainer |
| 5. Hood insulator pad fastener | 28. Hood stay rod clip |
| 6. Hood latch assembly | 30. Hood latch release handle mounting base assembly |
| 7. Hood latch mounting nut | 31. Cowl grille assembly |
| 8. Hood latch mounting bolt | 32. Hood rear seal assembly |
| 9. Hood safety hook assembly | 33. Cowl grille extension |
| 10. Hood overslam bumper | 34. Cowl grille support |
| 12. Hood overslam bumper | 35. Screw rivet |
| 15. Hood cable bracket | 36. Cowl grille bright garnish assembly |
| 16. Hood latch release front cable assembly | 37. Fender bright garnish assembly |
| 17. Hood latch release rear cable assembly | 38. Screw |
| 18. Fuel filler door release cable clip | 39. Grommet |
| 19. Hood latch release handle | 40. Front end upper cover |
| 20. Bolt | 41. Screw rivet |

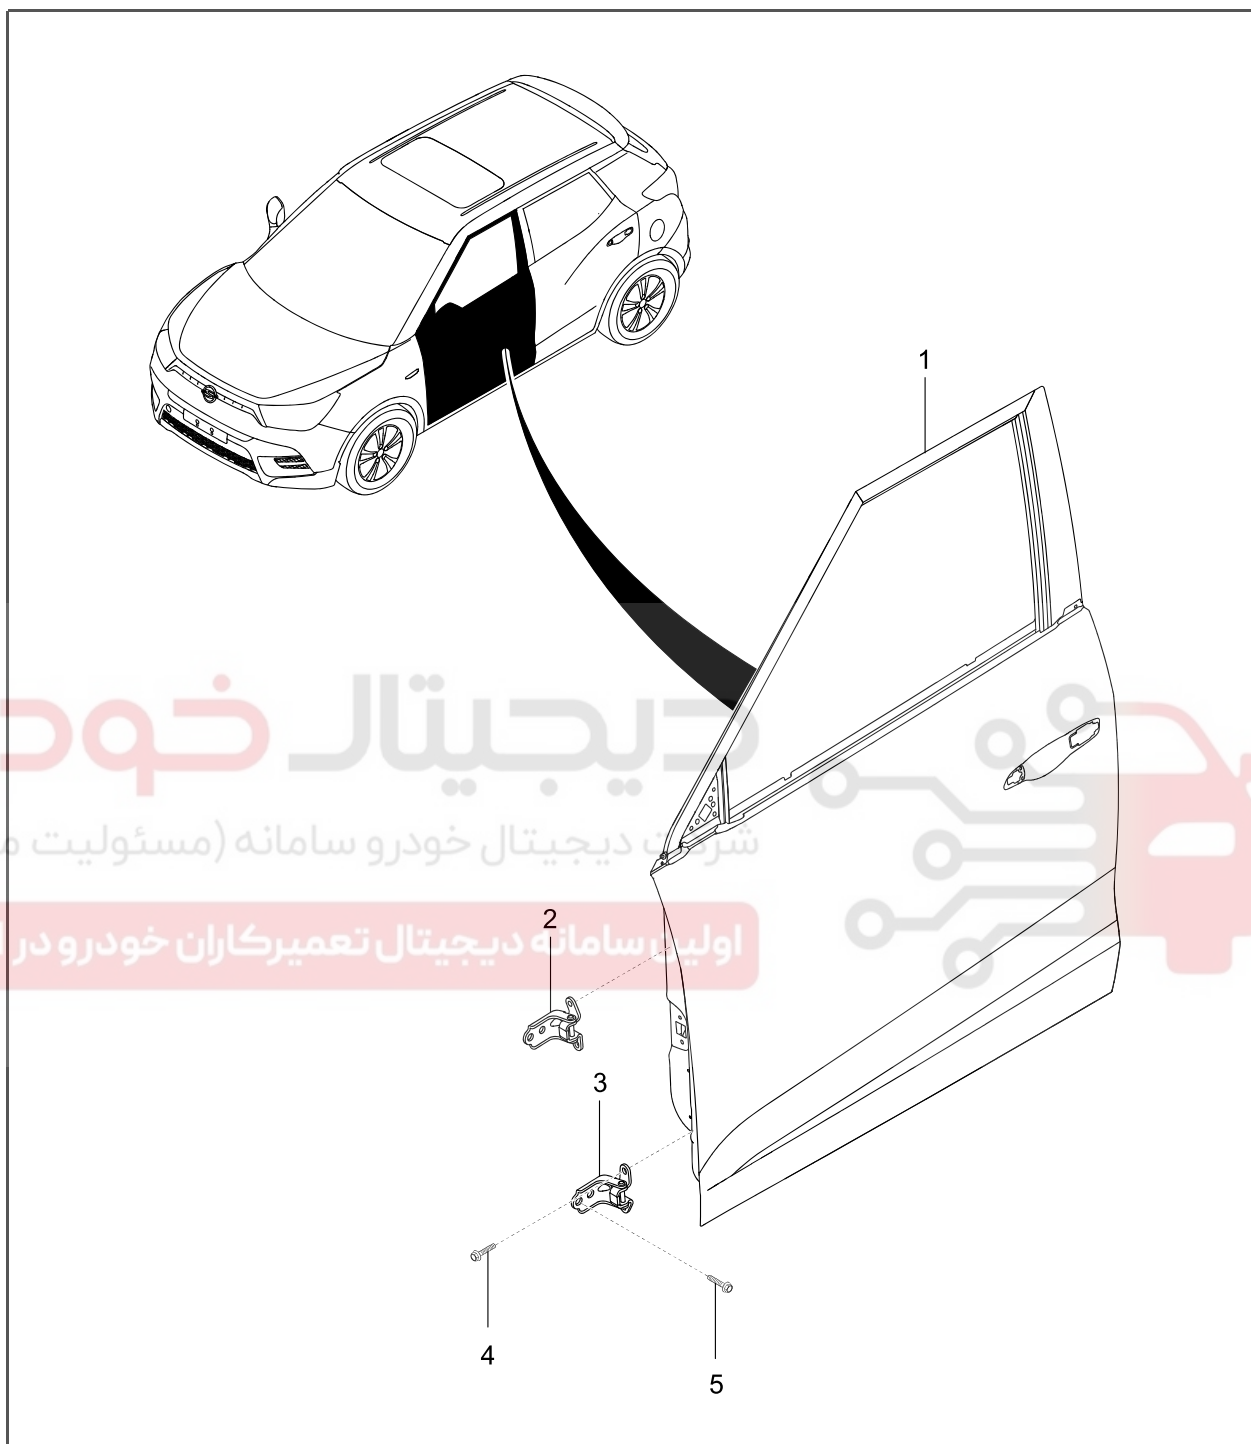
6210-00 FRONT DOOR PANEL

1. Front door panel assembly
2. Front door upper hinge assembly
3. Front door lower hinge assembly
4. Door side hinge bolt
5. Door hinge mounting flange bolt

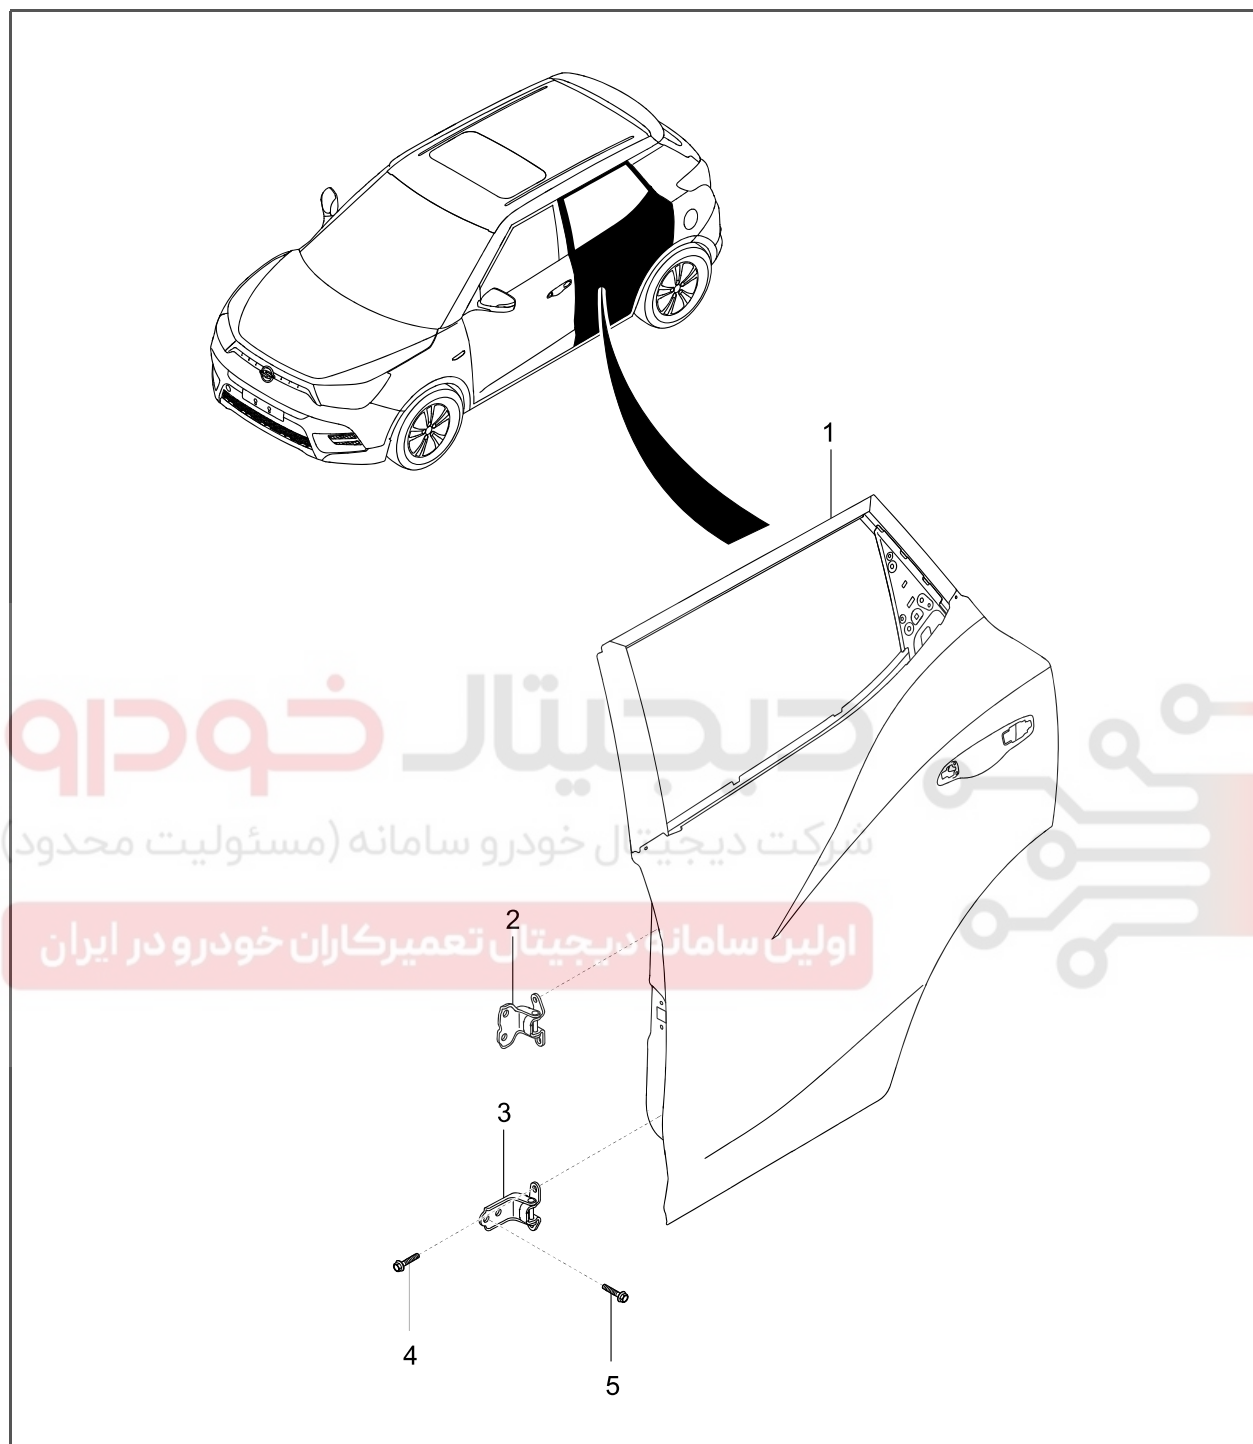
6310-00 REAR DOOR PANEL

1. Rear door panel assembly
2. Rear door upper hinge assembly
3. Rear door lower hinge assembly
4. Door side hinge bolt
5. Door hinge mounting flange bolt
