BODY EXTERIOR

TIVOLI 2015.03

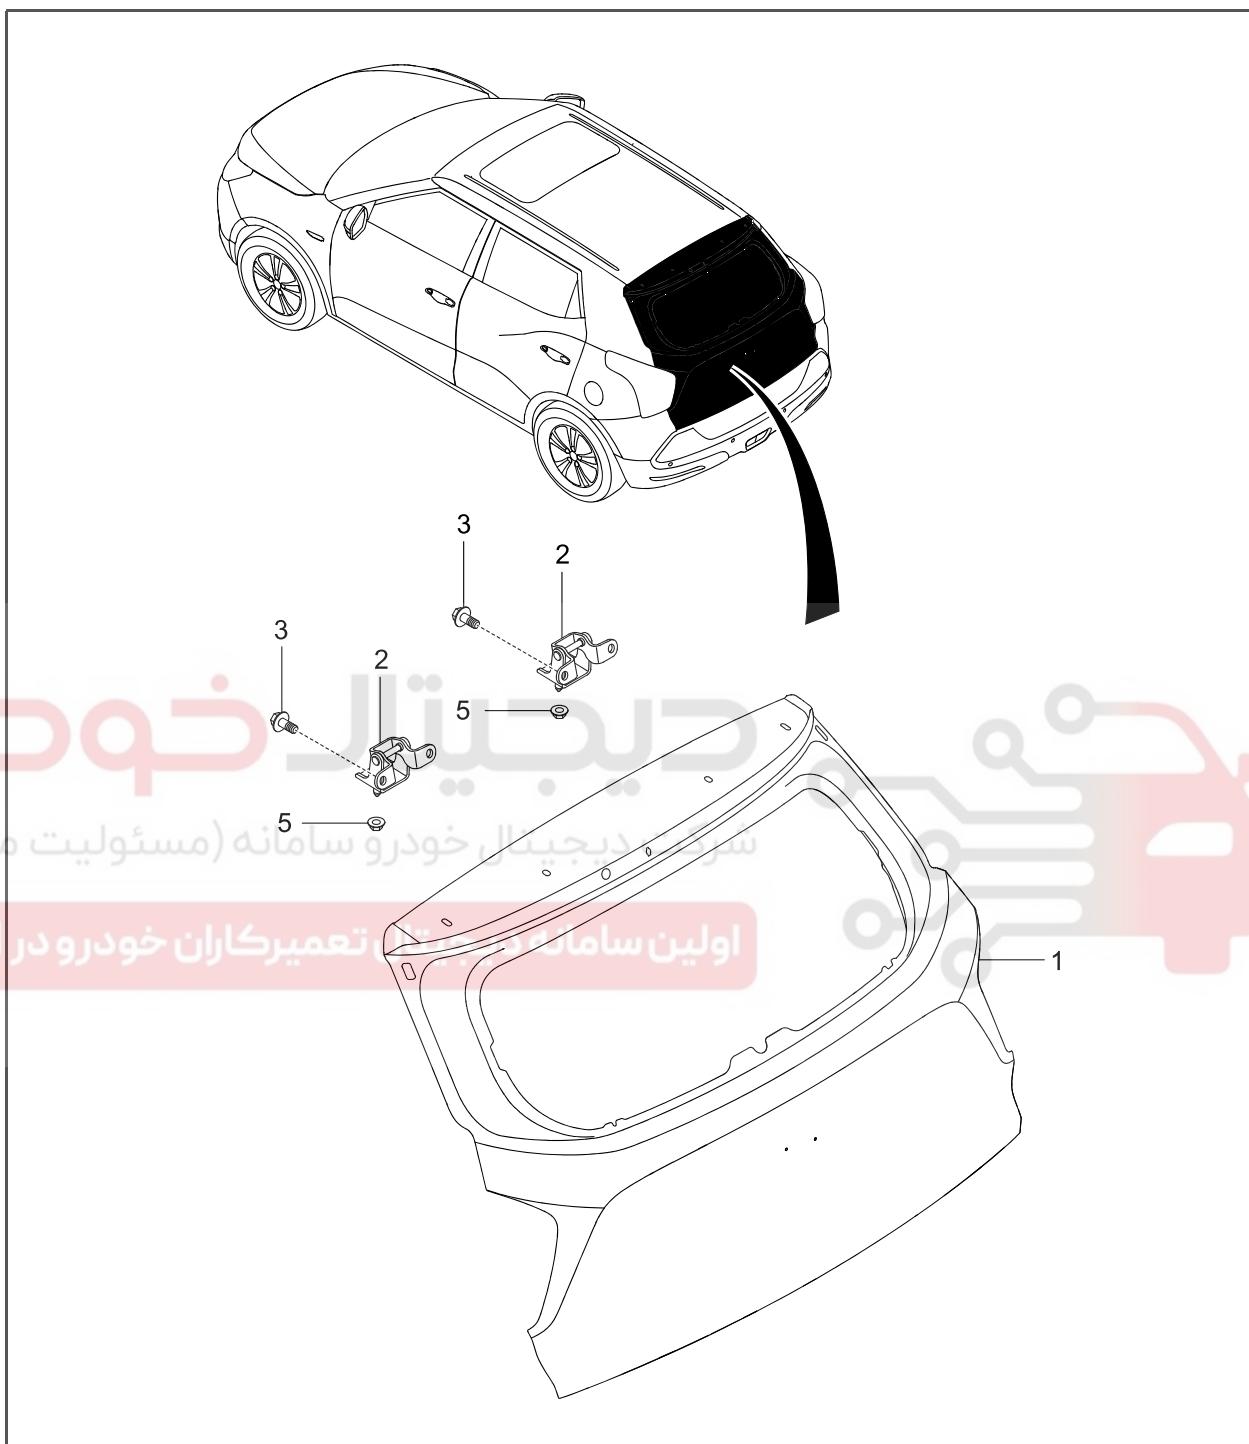
6410-00 T/GATE PNL

1. Tailgate panel assembly
2. Tailgate hinge assembly
3. Flange bolt
5. Tailgate hinge mounting flange bolt

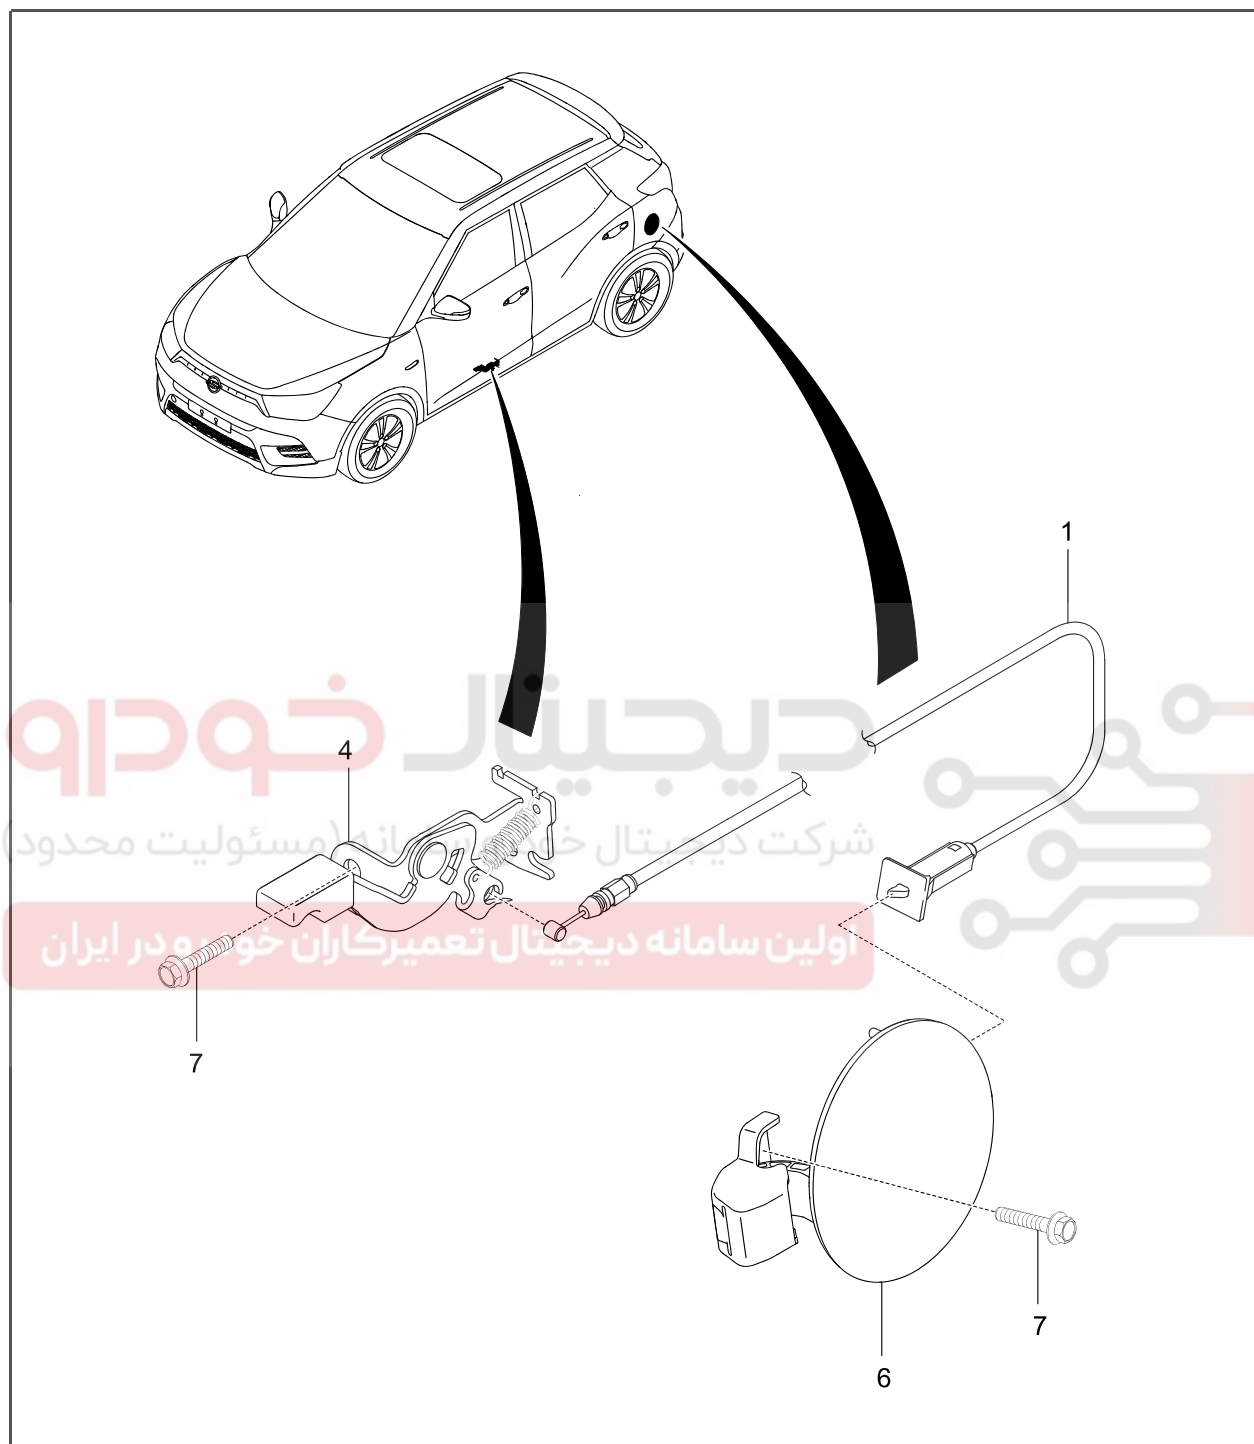
7090-00 FUEL FILLER DOOR

- 1. Fuel filler door release cable assembly
- 4. Fuel filler door release handle assembly
- 6. Fuel filler door assembly
- 7. Bolt

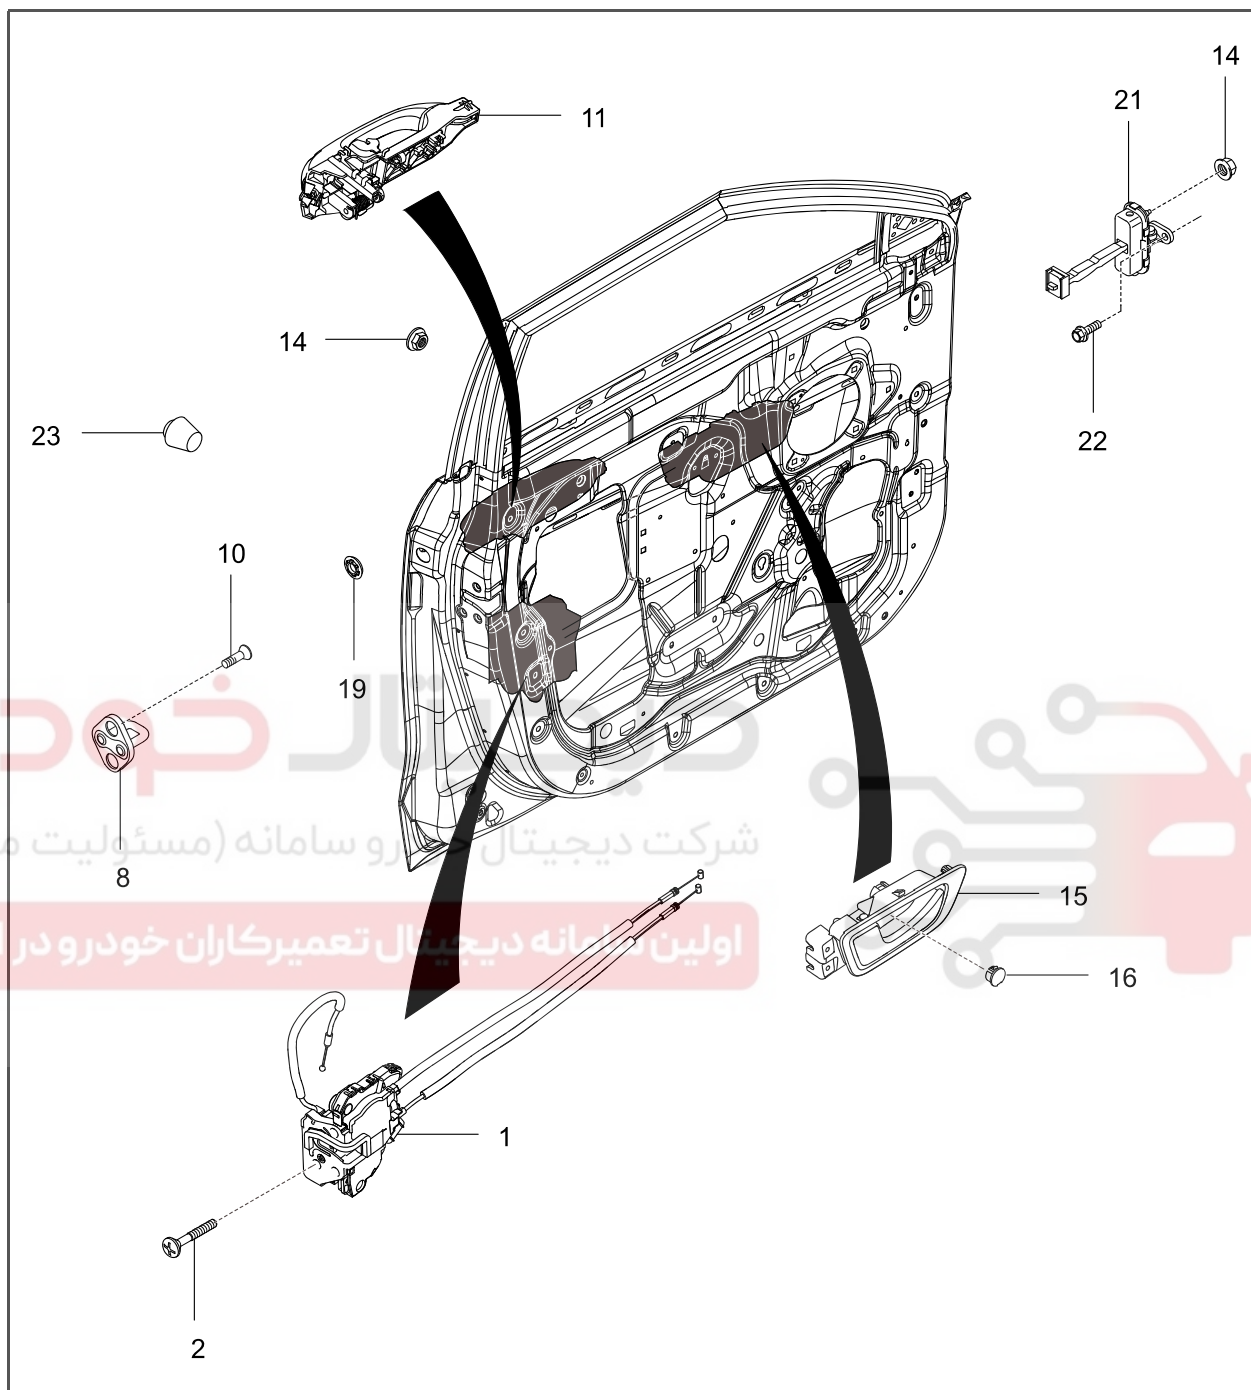
7110-00 FRONT DOOR LATCH CABLE AND HANDLE

- 1. Front door latch & cable assembly
- 2. Door latch mounting bolt
- 8. Door striker assembly
- 10. Door striker mounting screw
- 11. Front door outside handle assembly
- 14. Nut

- 15. Door inside handle assembly
- 16. Door inside handle cap
- 19. Front door tooling hole plug
- 21. Front door checker assembly
- 22. Flange bolt
- 23. Door overslam bumper

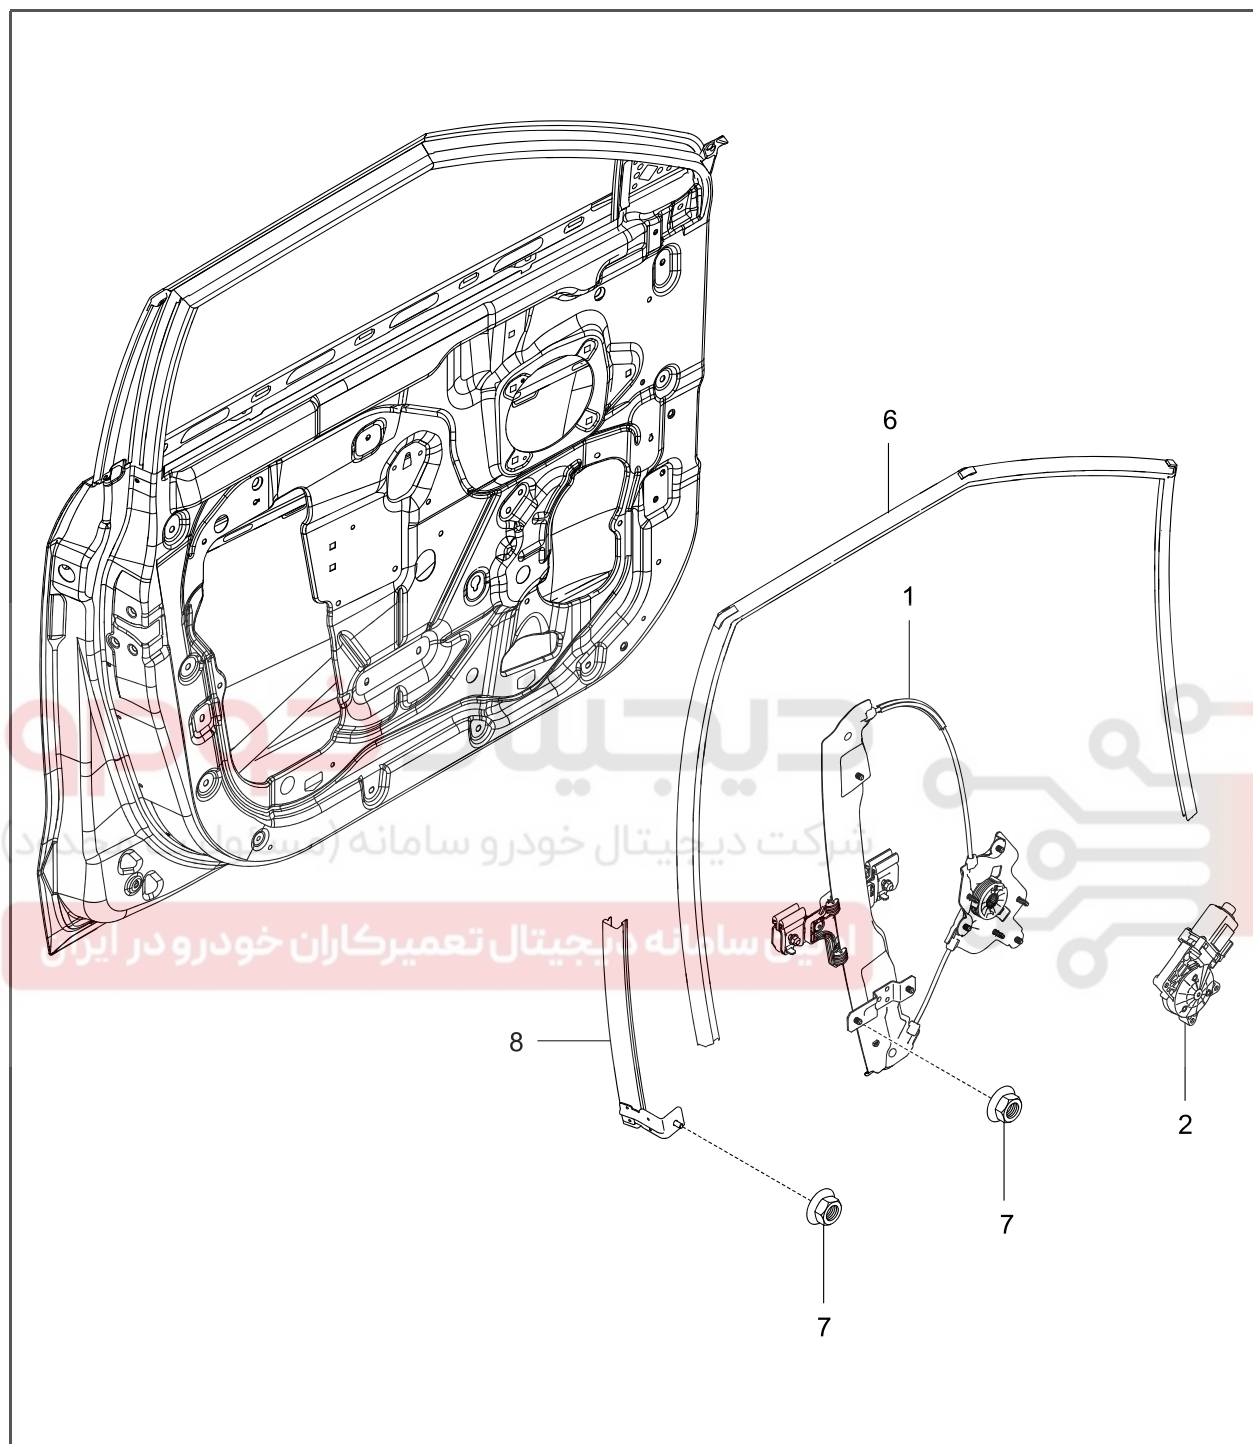
7120-00 FRONT DOOR POWER WINDOW REGULATOR

- 1. Front door power window regulator
- 2. Power window motor assembly
- 6. Front door window glass run
- 7. Nut
- 8. Front door glass guide rail assembly

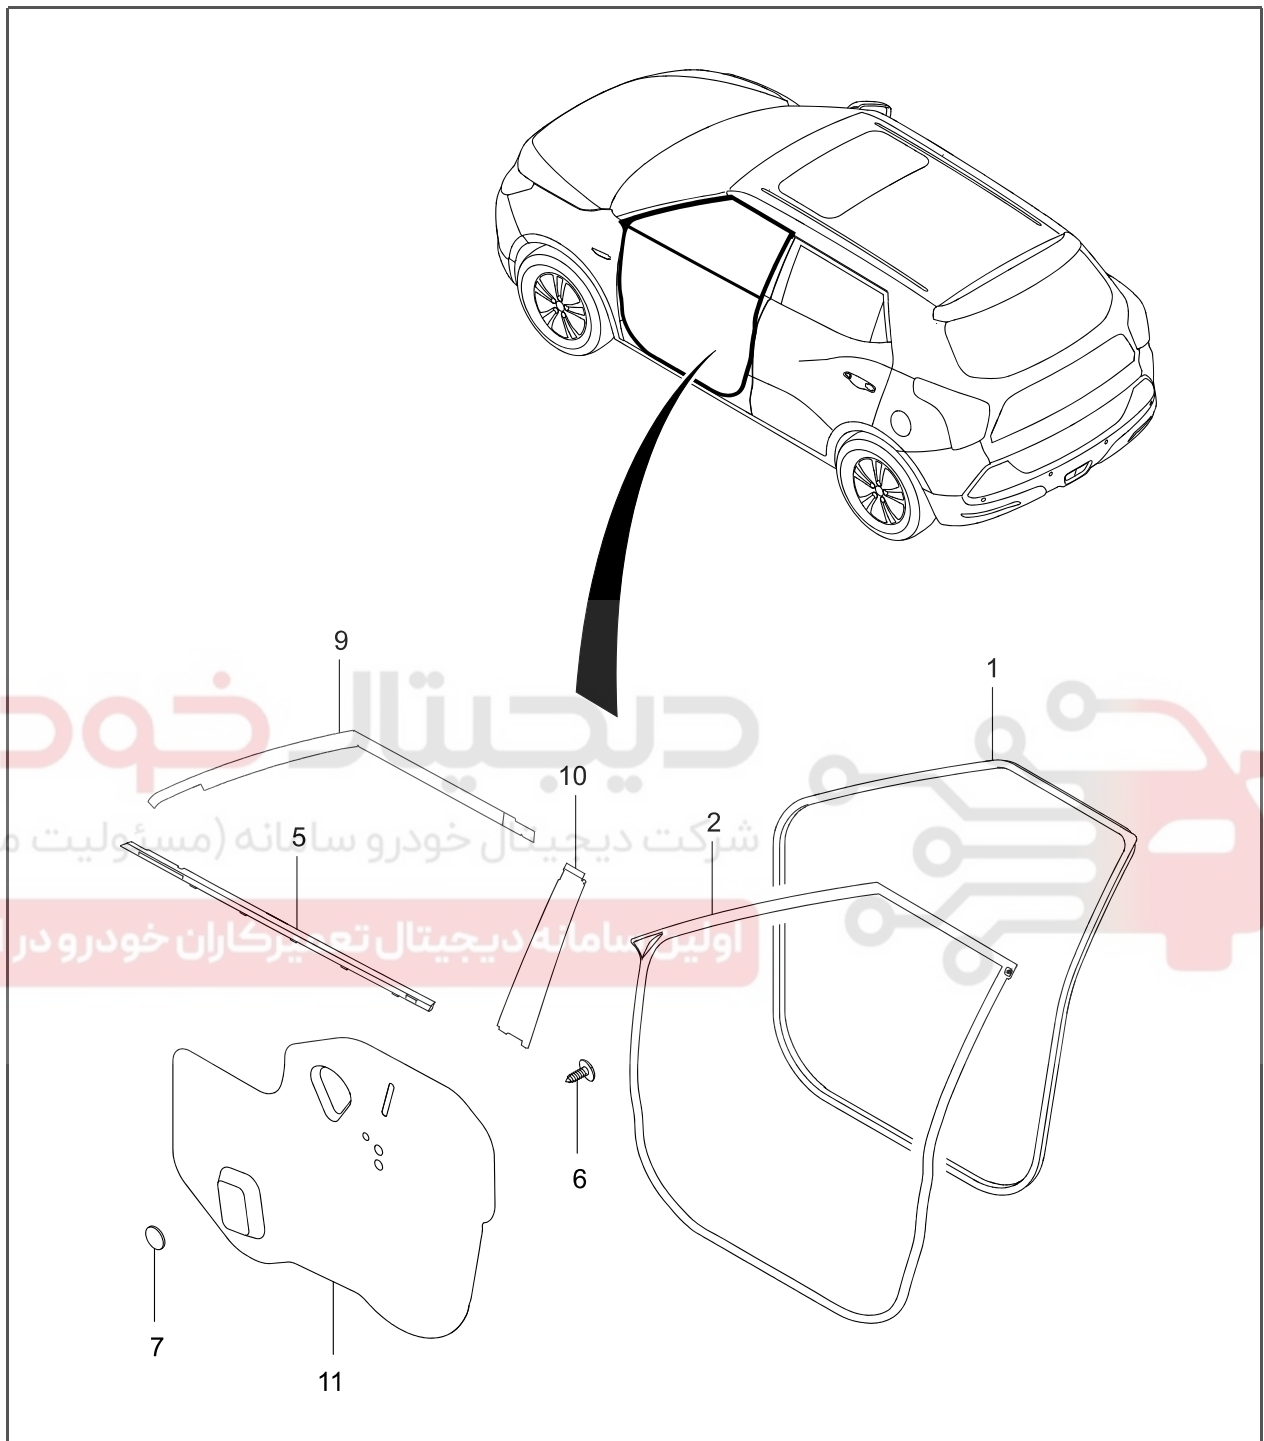
7121-00 FRONT DOOR WEATHERSTRIP

- 1. Front door body side weatherstrip
- 2. Front door opening weatherstrip assembly
- 5. Front door belt outside weatherstrip assembly
- 6. Screw

- 7. Door tooling hole sealing tape
- 9. Front door frame A-tape
- 10. Front door frame B-tape
- 11. Front door trim vinyl - seal

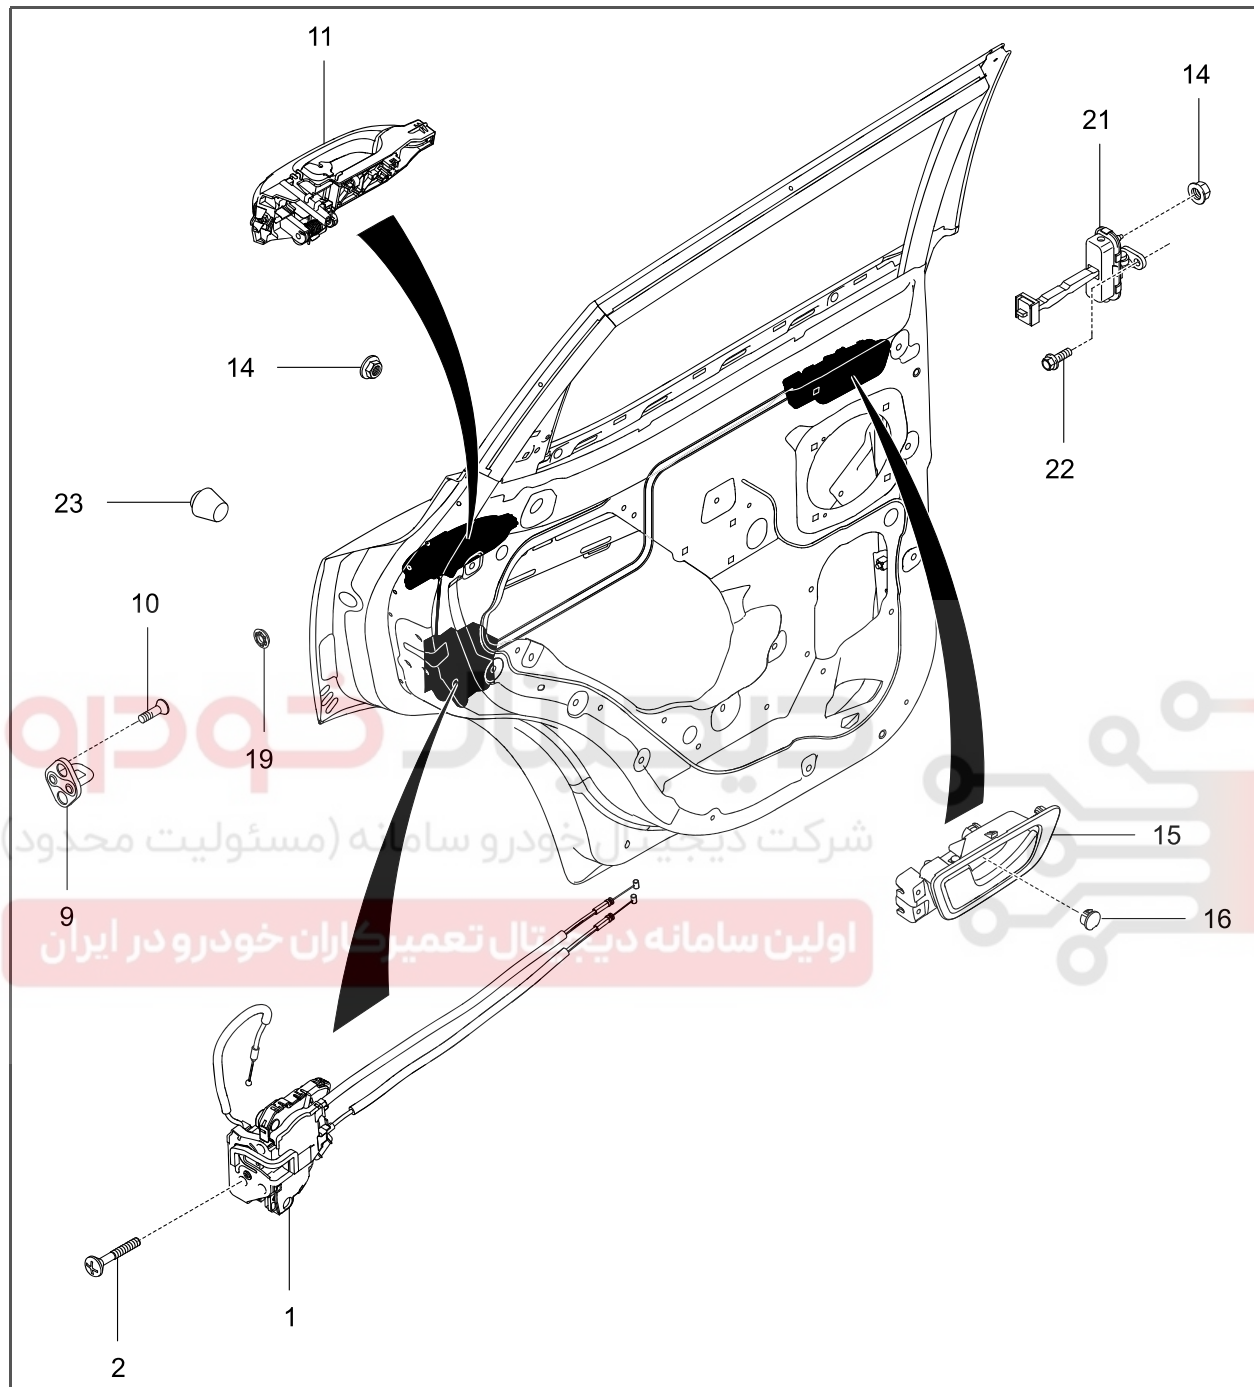
7210-00 REAR DOOR LATCH CABLE AND HANDLE

- 1. Rear door latch & cable assembly
- 2. Door latch mounting bolt
- 9. Door striker assembly
- 10. Door striker mounting screw
- 11. Rear door outside handle assembly
- 14. Nut

- 15. Door inside handle assembly
- 16. Door inside handle cap
- 19. Rear door tooling hole plug
- 21. Rear door checker assembly
- 22. Flange bolt
- 23. Door overslam bumper

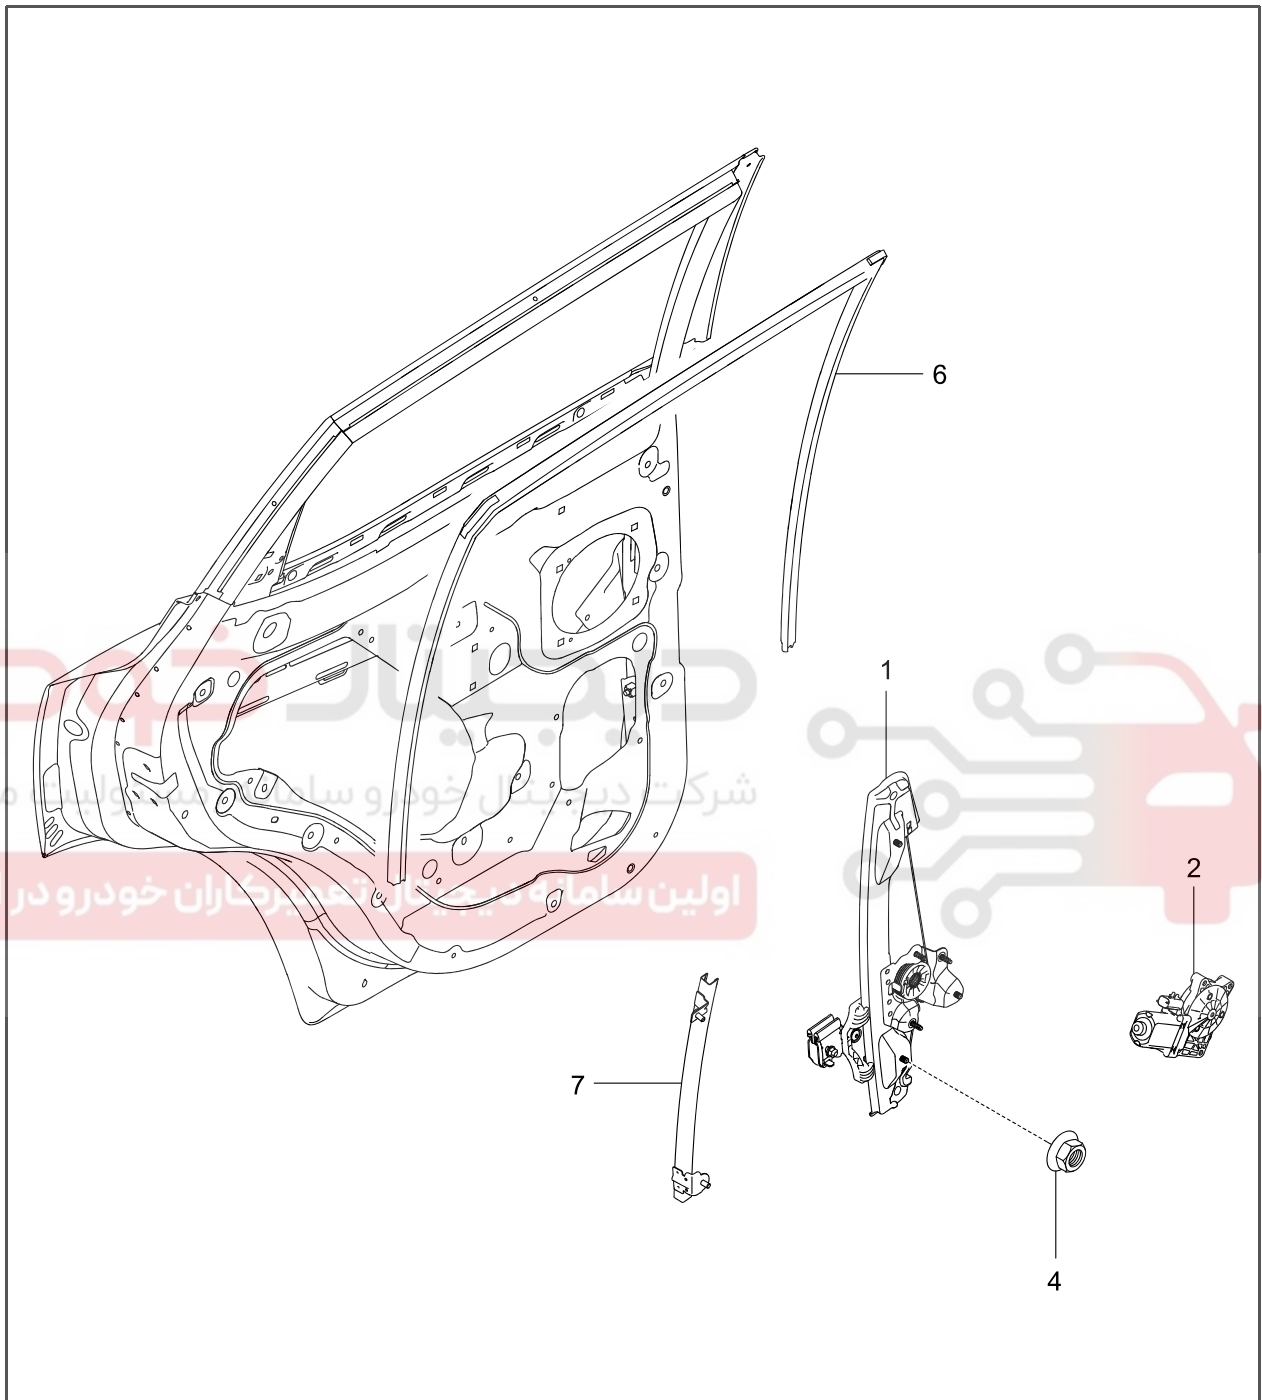
REAR DOOR POWER WINDOW REGULATOR AND MOTOR

1. Rear door power window regulator
2. Power window motor assembly
4. Nut
6. Rear door window glass run
7. Rear door glass guide rail assembly

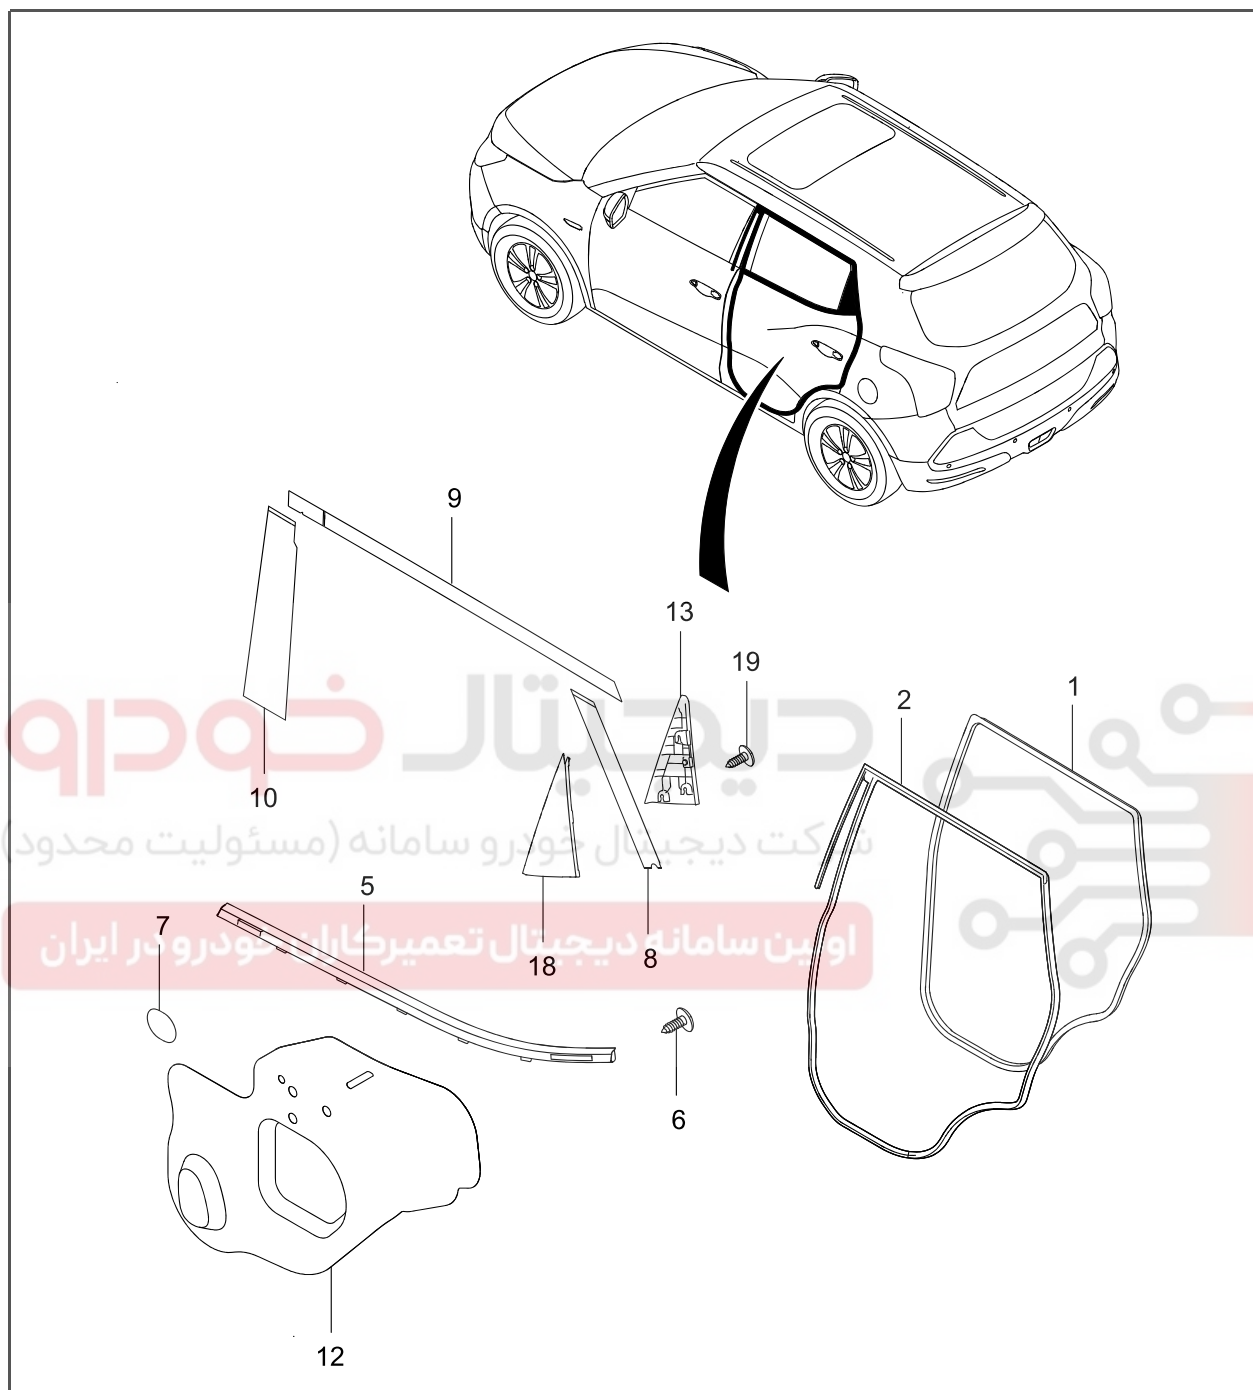
7221-00 REAR DOOR WEATHERSTRIP

- 1. Rear door body side weatherstrip
- 2. Rear door side weatherstrip assembly
- 5. Rear door belt outside weatherstrip assembly
- 6. Screw
- 7. Door tooling hole sealing tape
- 8. Rear door frame C-tape

- 9. Rear door frame B-tape
- 10. Rear door frame A-tape
- 12. Rear door trim vinyl - seal
- 13. Rear door trim upper cover assembly
- 18. Rear door delta molding assembly
- 19. Screw

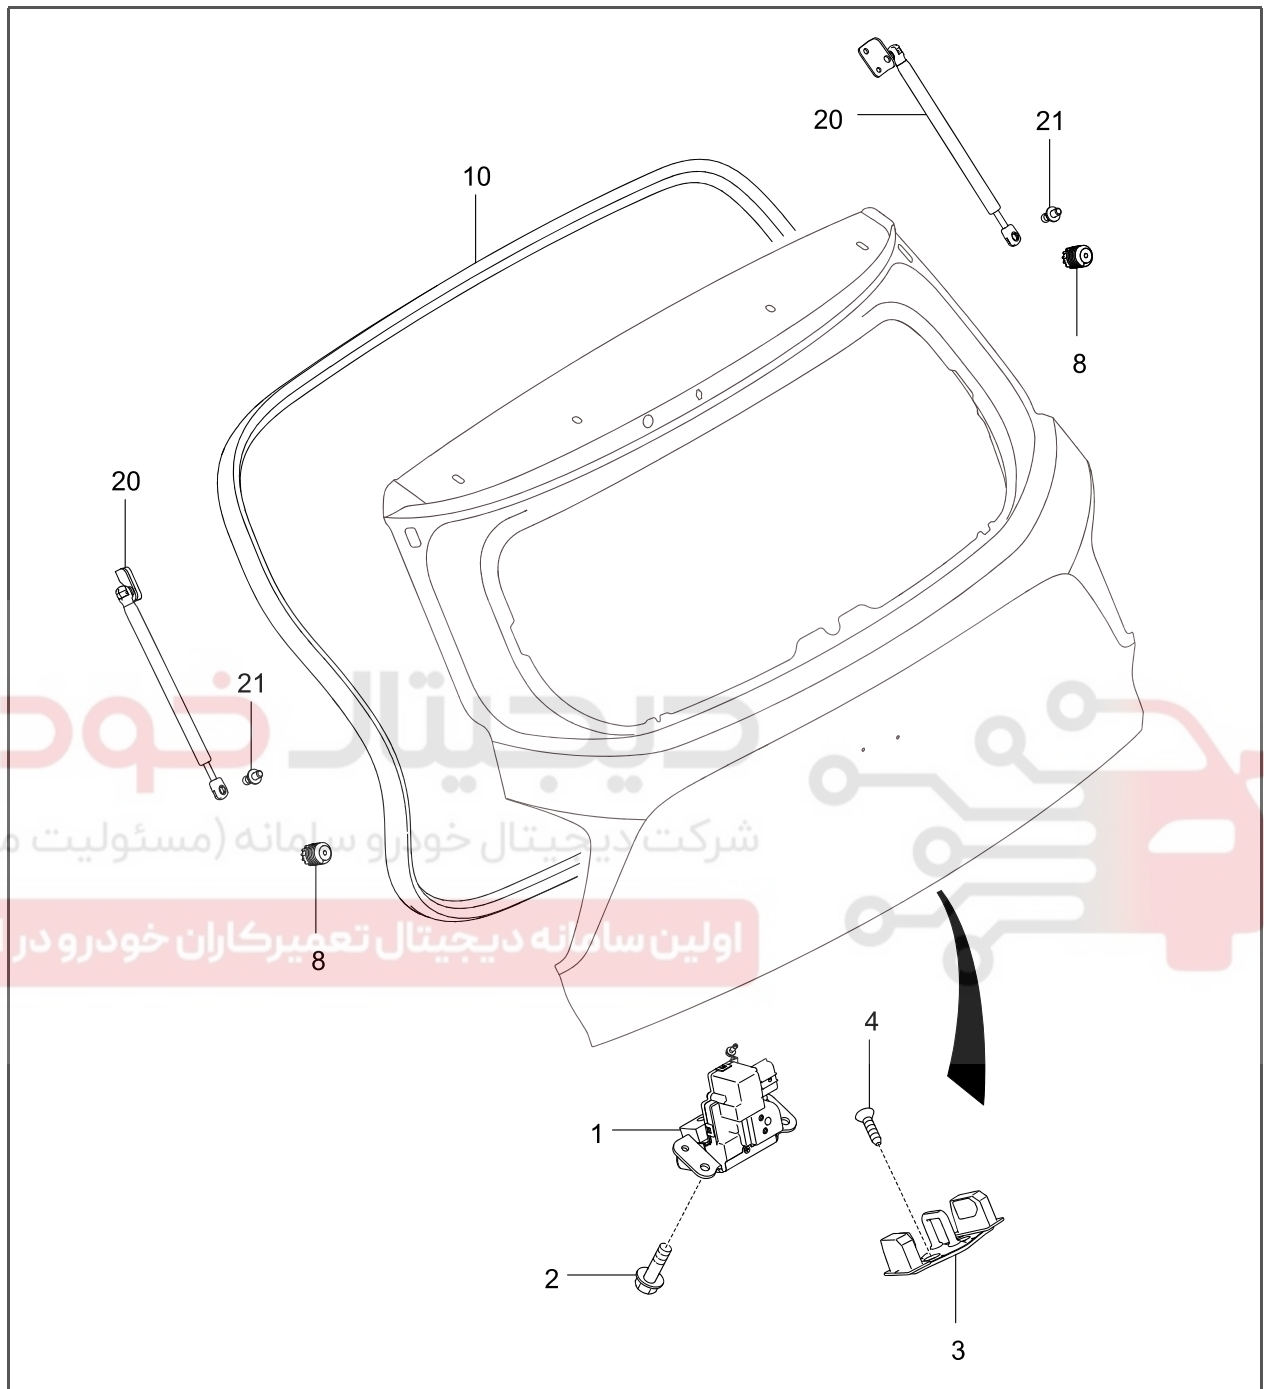
7310-00 TAILGATE OPENING SYSTEM

1. Tailgate latch assembly
2. Bolt
3. Tailgate striker assembly
4. Screw

8. Tailgate overslam bumper assembly
10. Tailgate opening weatherstrip
20. Tailgate lifter assembly
21. Ball stud

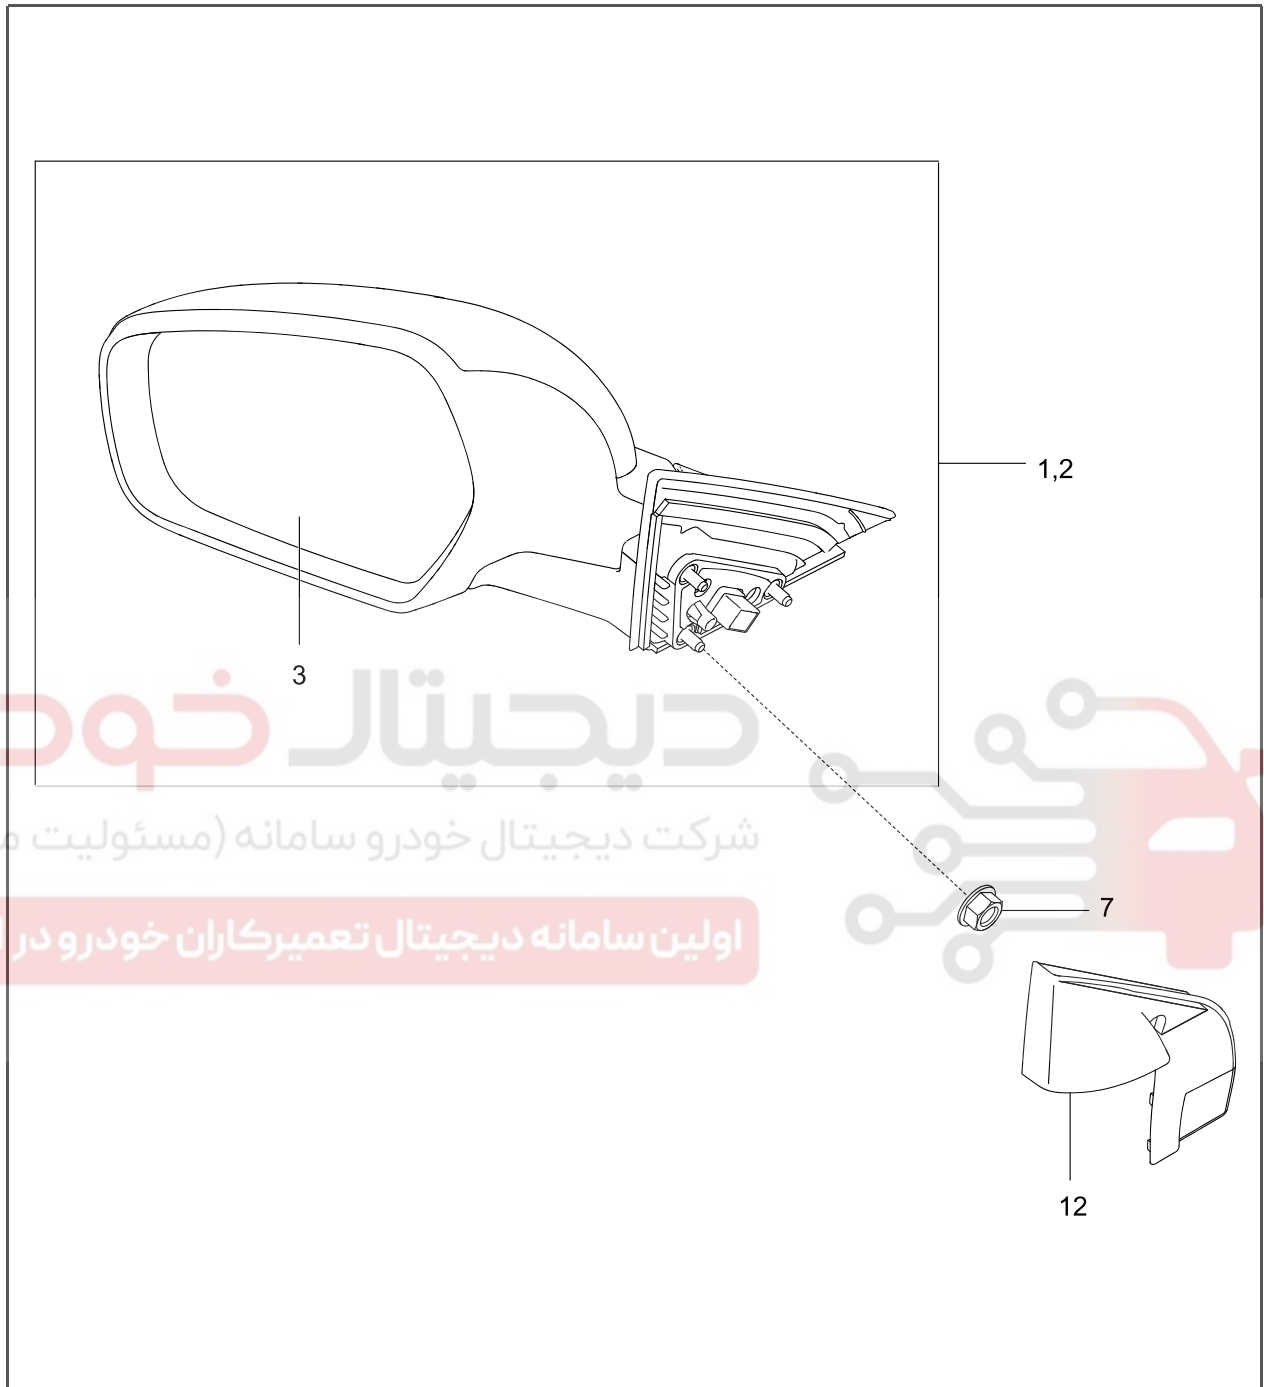
OUTSIDE REAR VIEW MIRROR

1. Outside LH rear view mirror assembly
2. Outside RH rear view mirror assembly
3. Outside rear view mirror glass holder assembly
7. Nut
12. Inner cover assembly

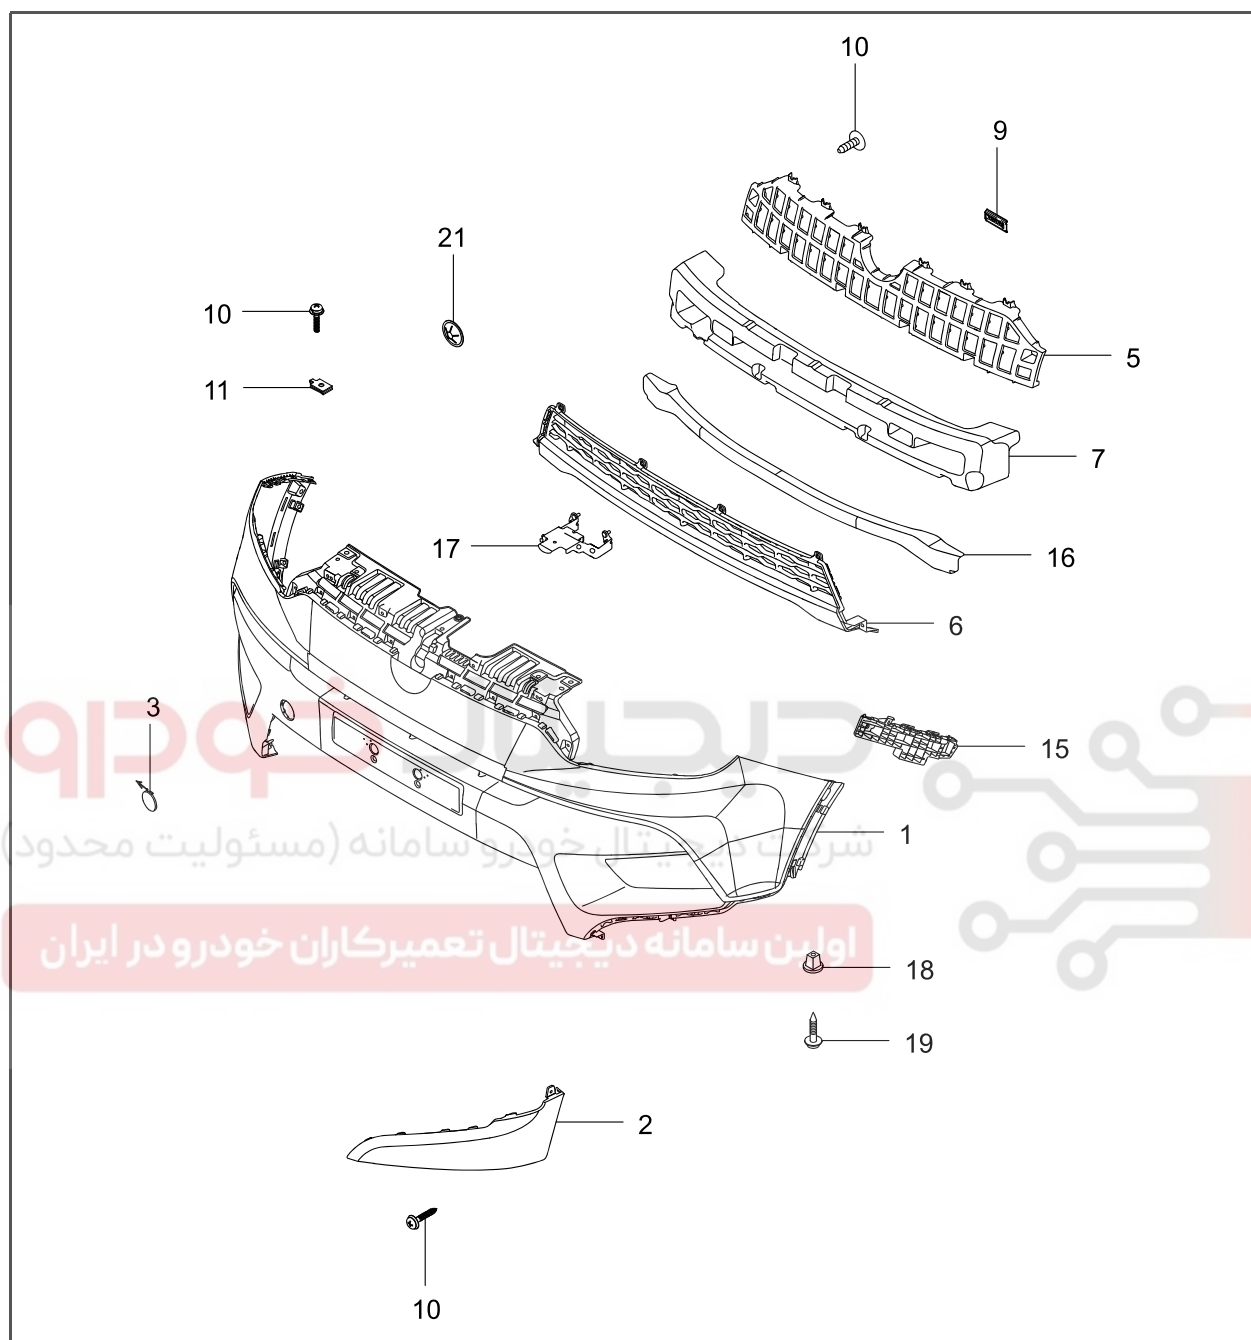
7870-00 FRONT BUMPER

| 1. Front bumper fascia | 11.Spring nut |
| 2. Front bumper lower fascia | 15.Front bumper side bracket |
| 3. Towing front cover | 16.Front bumper lower stiffener assembly |
| 5. Front bumper center reinforcement | 17.Front bumper center bracket assembly |
| 6. Intake grille | 18.Screw grommet |
| 7. Front bumper energy absorber | 19.Bolt |
| 9. Lock clip | 21.Clamping washer |
| 10.Screw | |

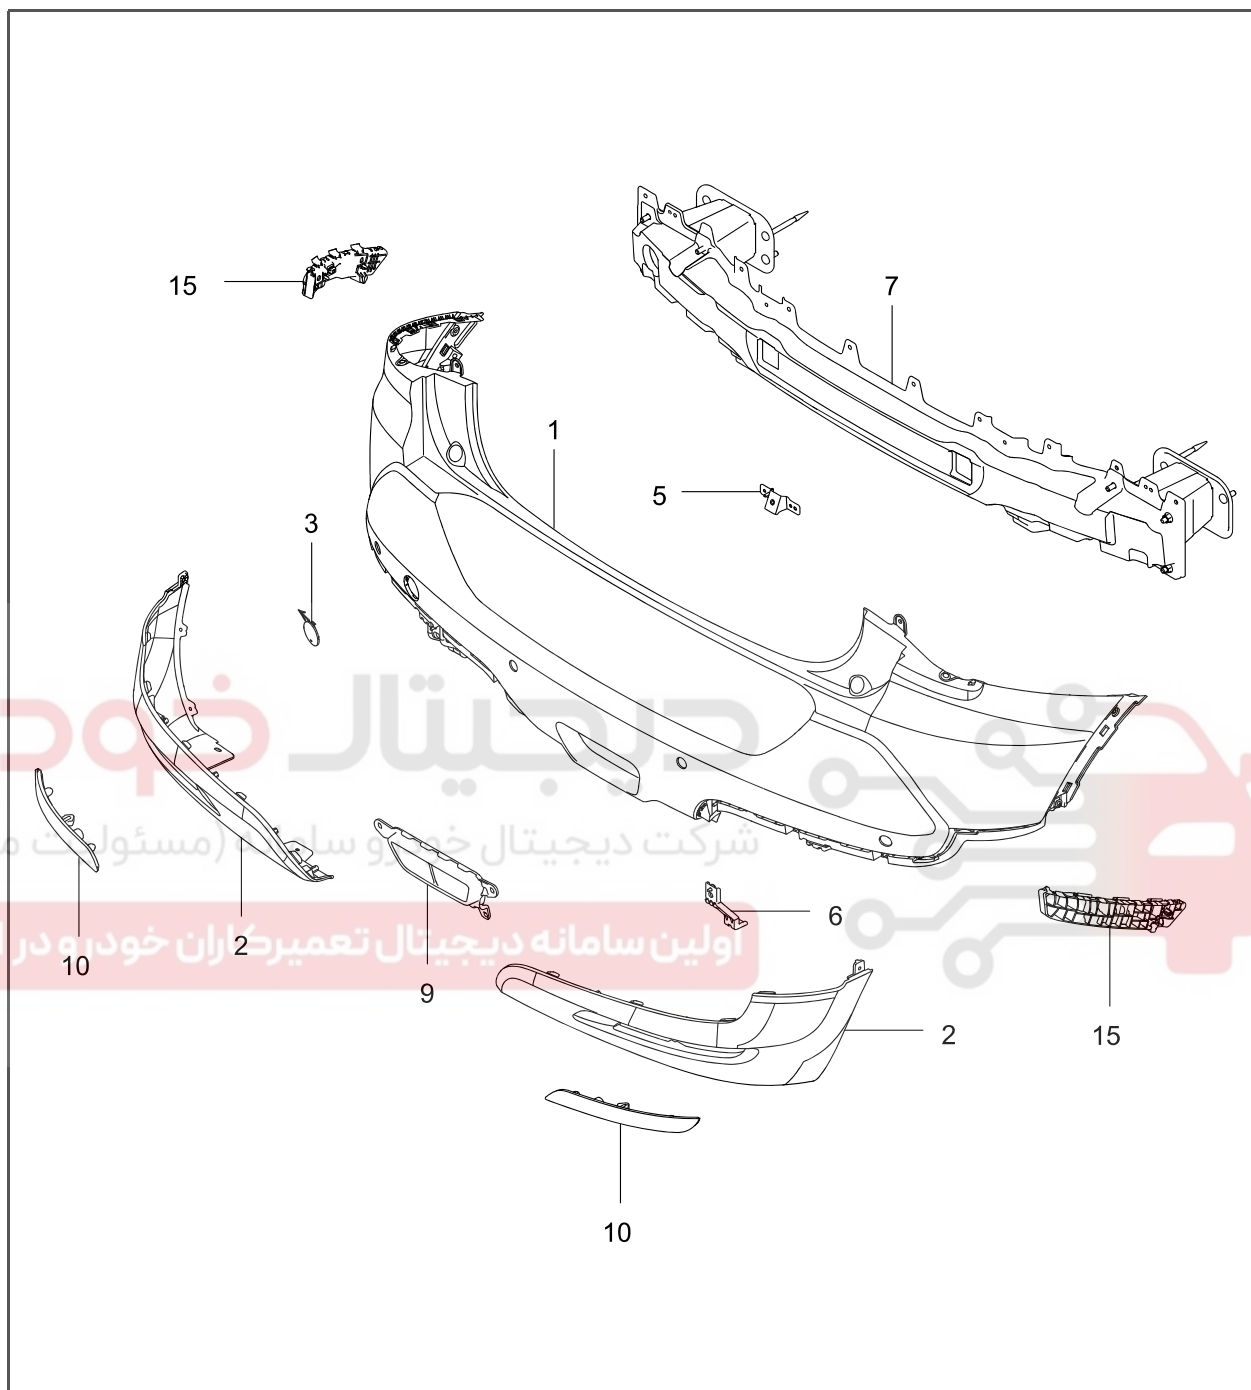
7880-00 REAR BUMPER

1. Rear bumper upper fascia
2. Rear bumper lower fascia
3. Towing rear cover
5. License plate mounting bracket assembly
6. Fascia mounting lower bracket

7. Impact rear bumper beam assembly
9. Rear fog lamp blanking cover
10. Reflex reflector lamp assembly
15. Rear bumper side bracket
