BODY EXTERIOR

TIVOLI 2015.03

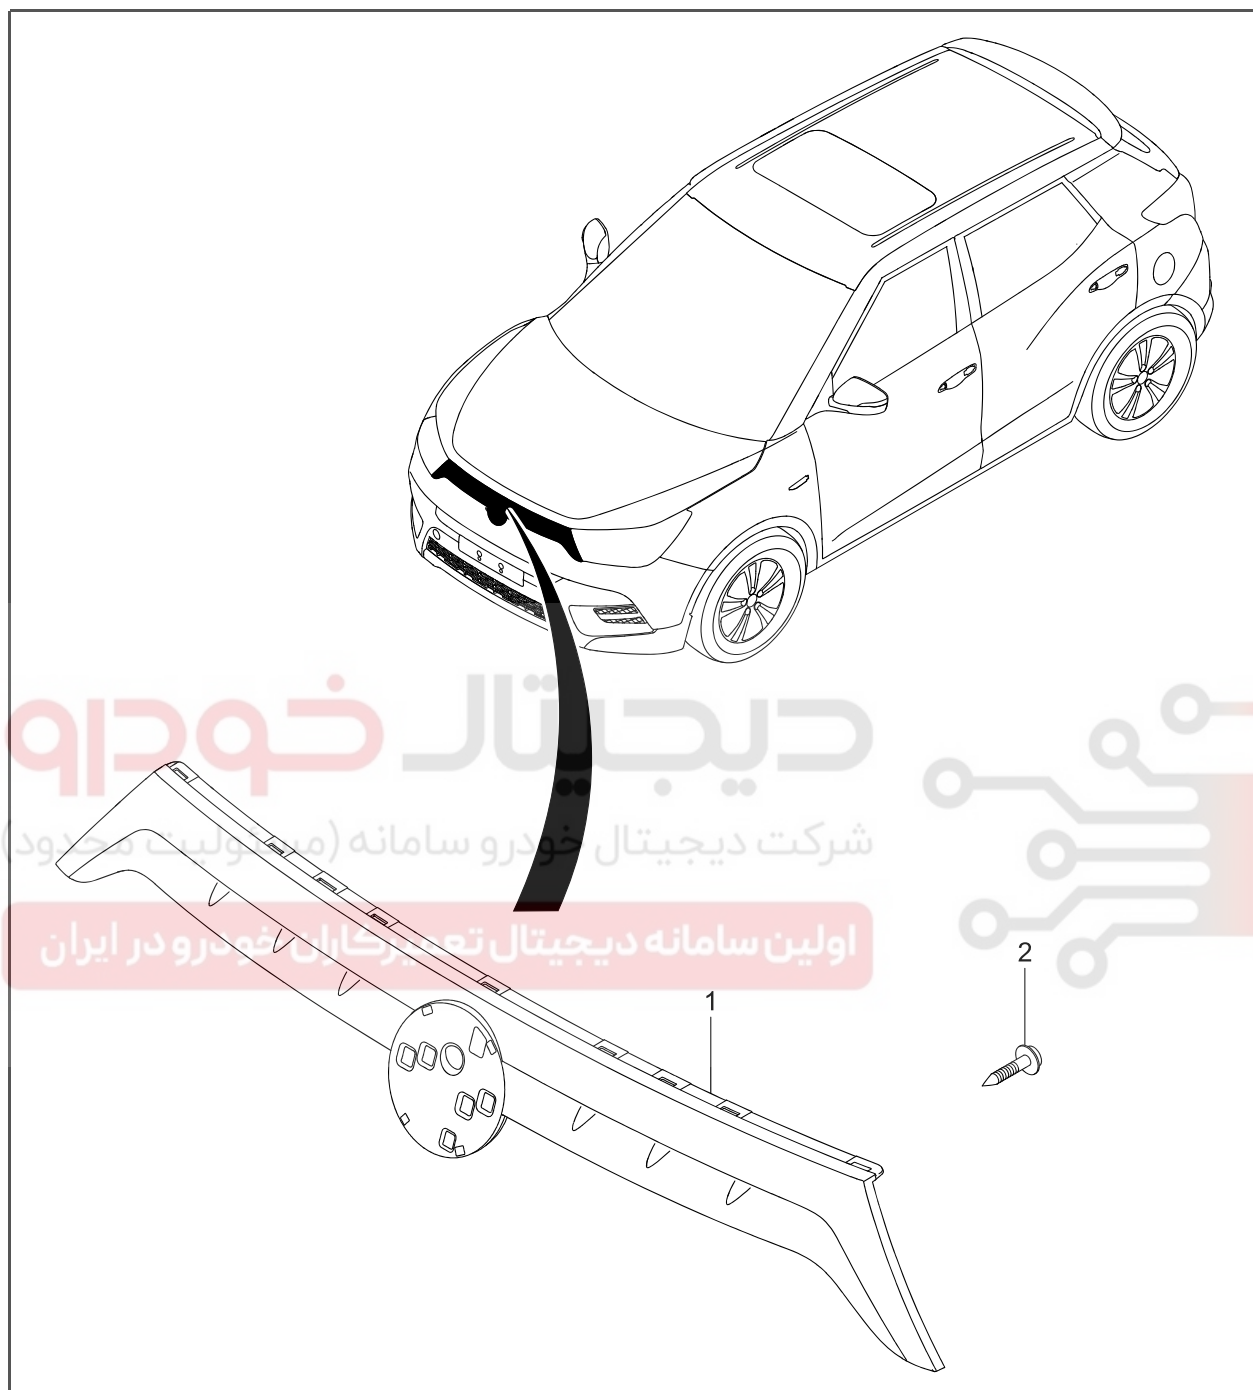
7910-00 Radiator Grille

1. Radiator Grille

2. Screw

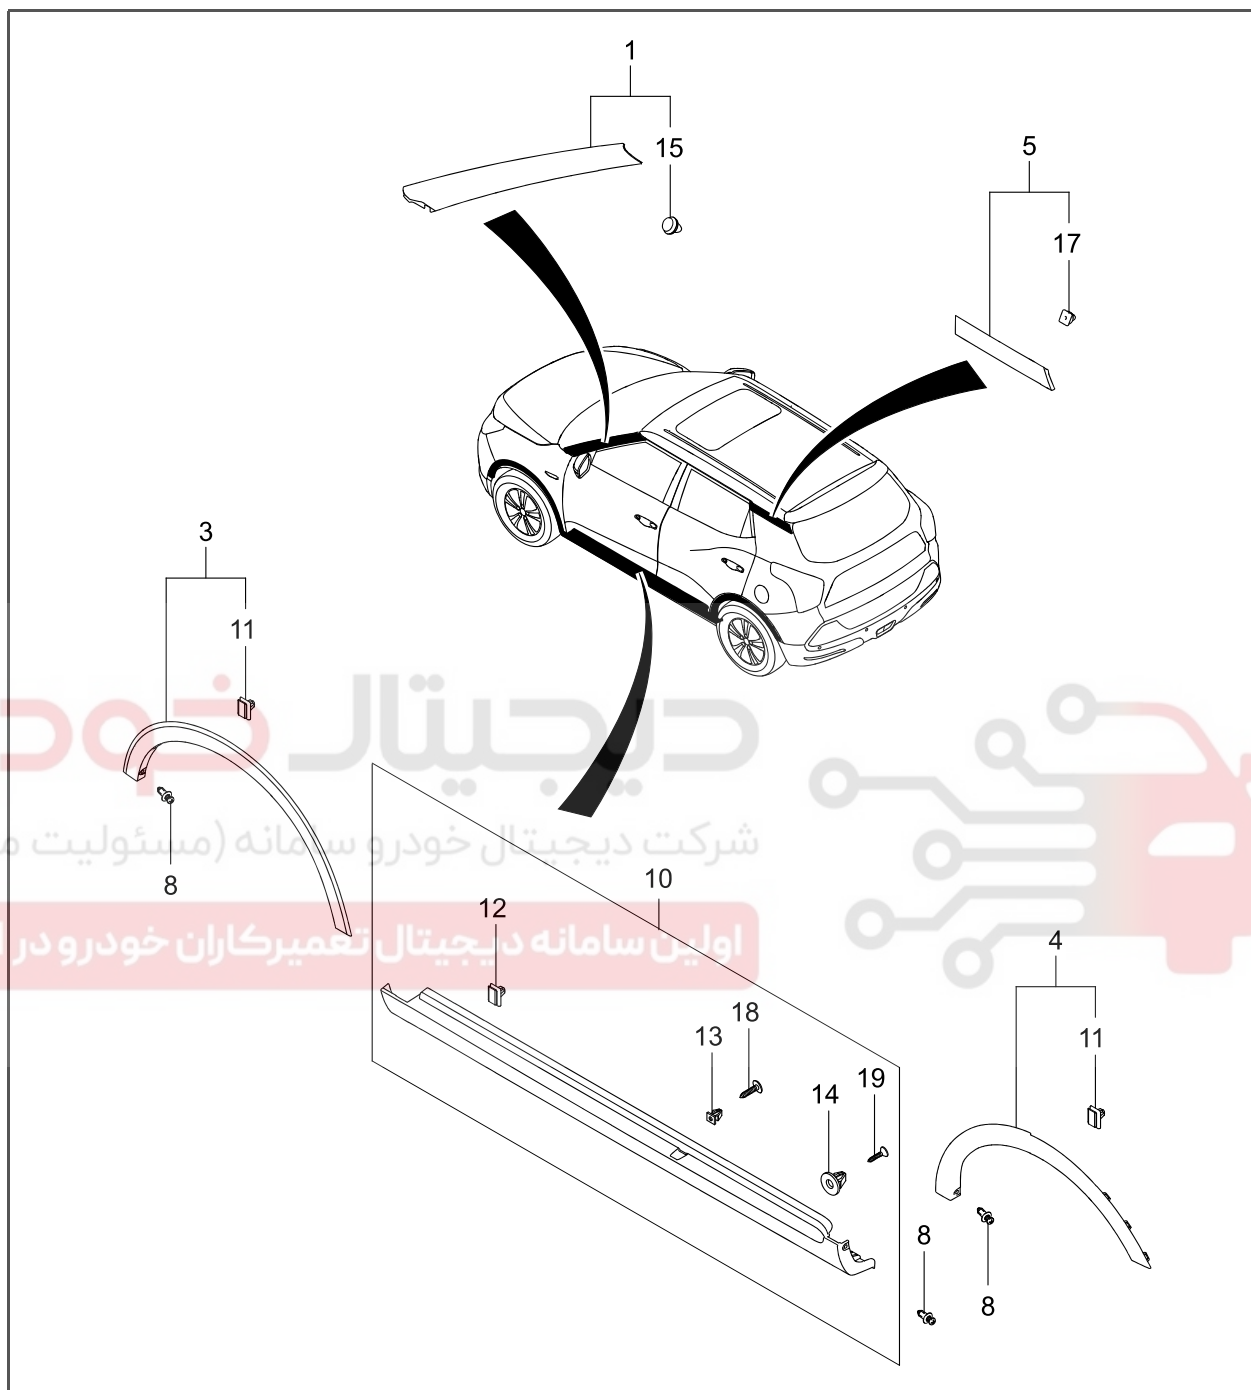
7930-00 SIDE BODY MOLDING

1. A-pillar garnish assembly
3. Front wheel arch garnish assembly
4. Rear wheel arch garnish assembly
5. C-pillar garnish assembly
8. Under cover mounting screw rivet
10. Side seal garnish assembly
11. Wheel arch molding mounting clip

12. Side seal molding mounting clip
13. Side seal molding mounting lower clip
14. Door garnish mounting clip
15. A-pillar clip
17. C-pillar clip
18. Screw
19. Screw

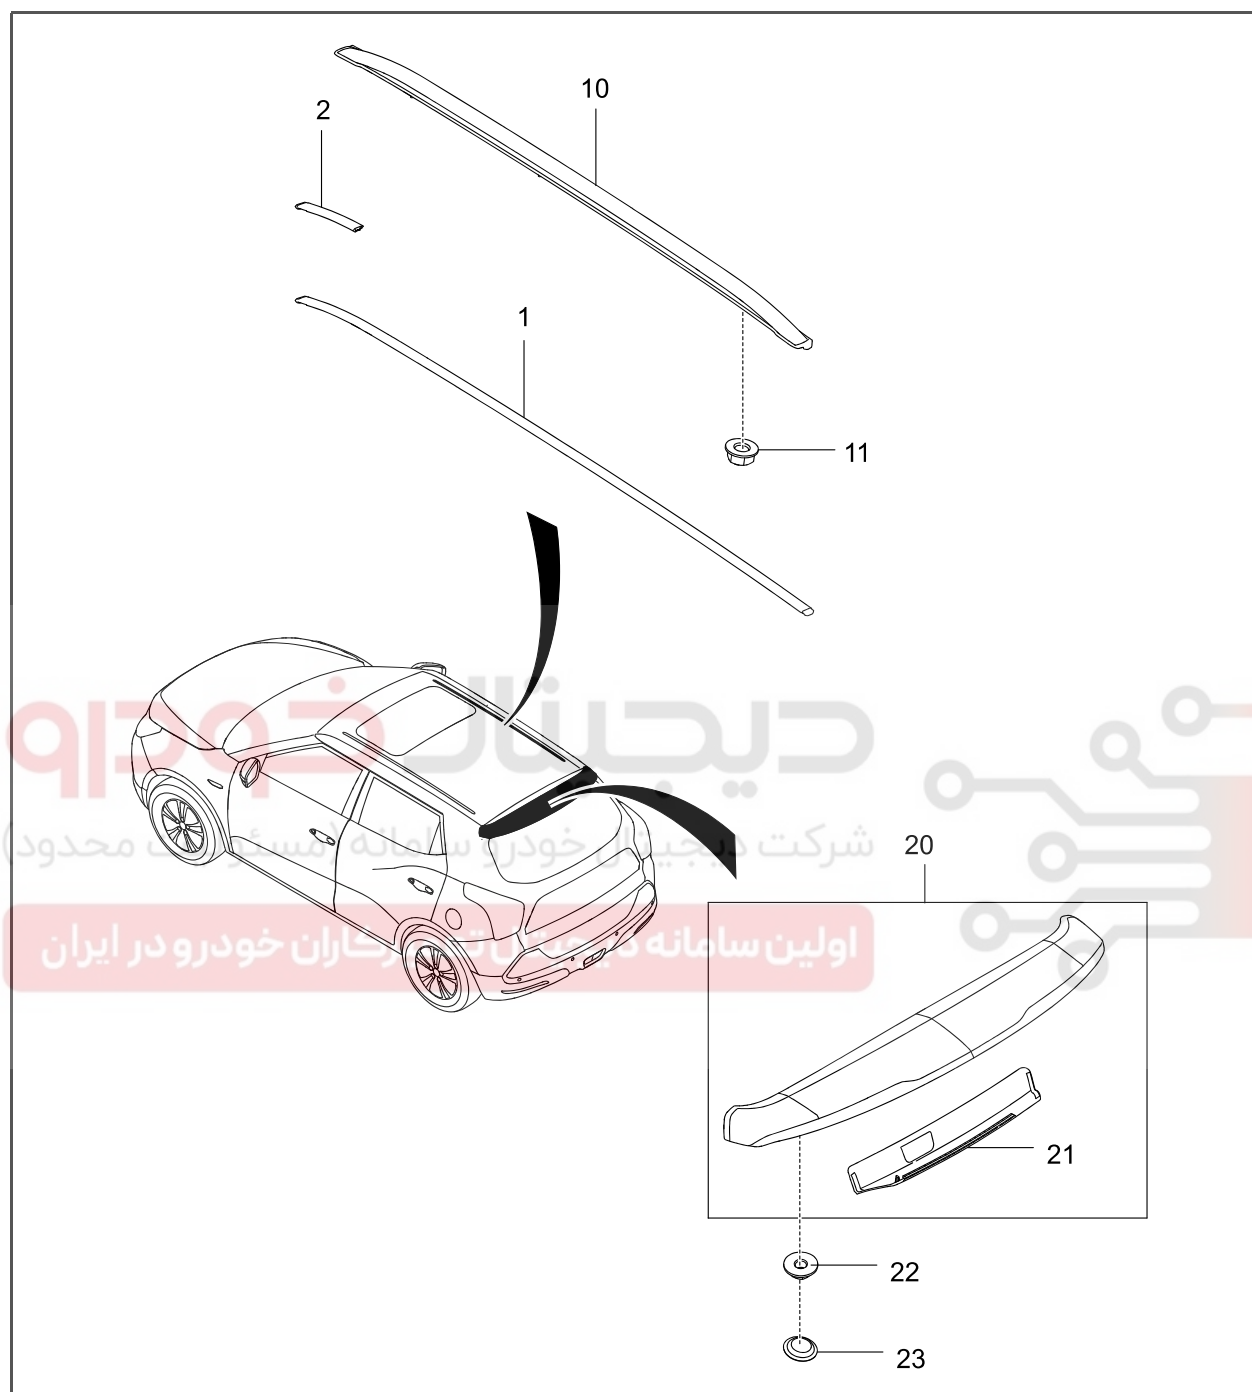
7940-00 ROOF AND REAR BODY

- 1. Roof molding assembly
- 2. Roof No. 1 molding assembly
- 10. Fashion rail assembly
- 11. Nut

- 20. Spoiler assembly
- 21. Spoiler lower cover
- 22. Nut
- 23. Blind plug

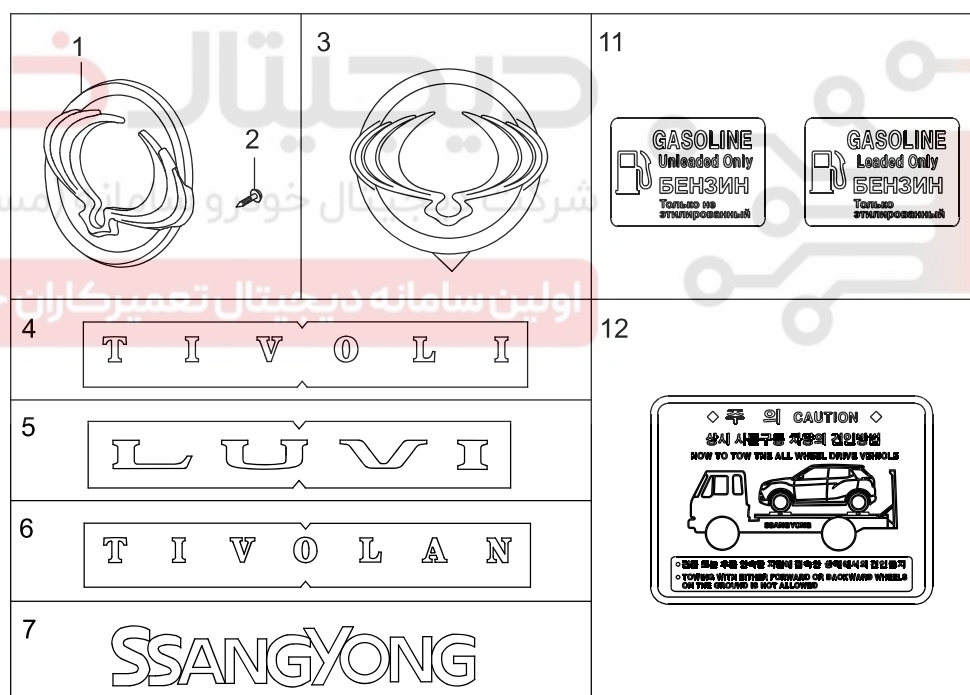
7950-00 EMBLEM

1. Radiator emblem assembly
2. Screw
3. Tailgate emblem assembly
4. TIVOLI emblem
7. Emblem-SSANGYONG
11. GASOLINE label
12. TOWING label

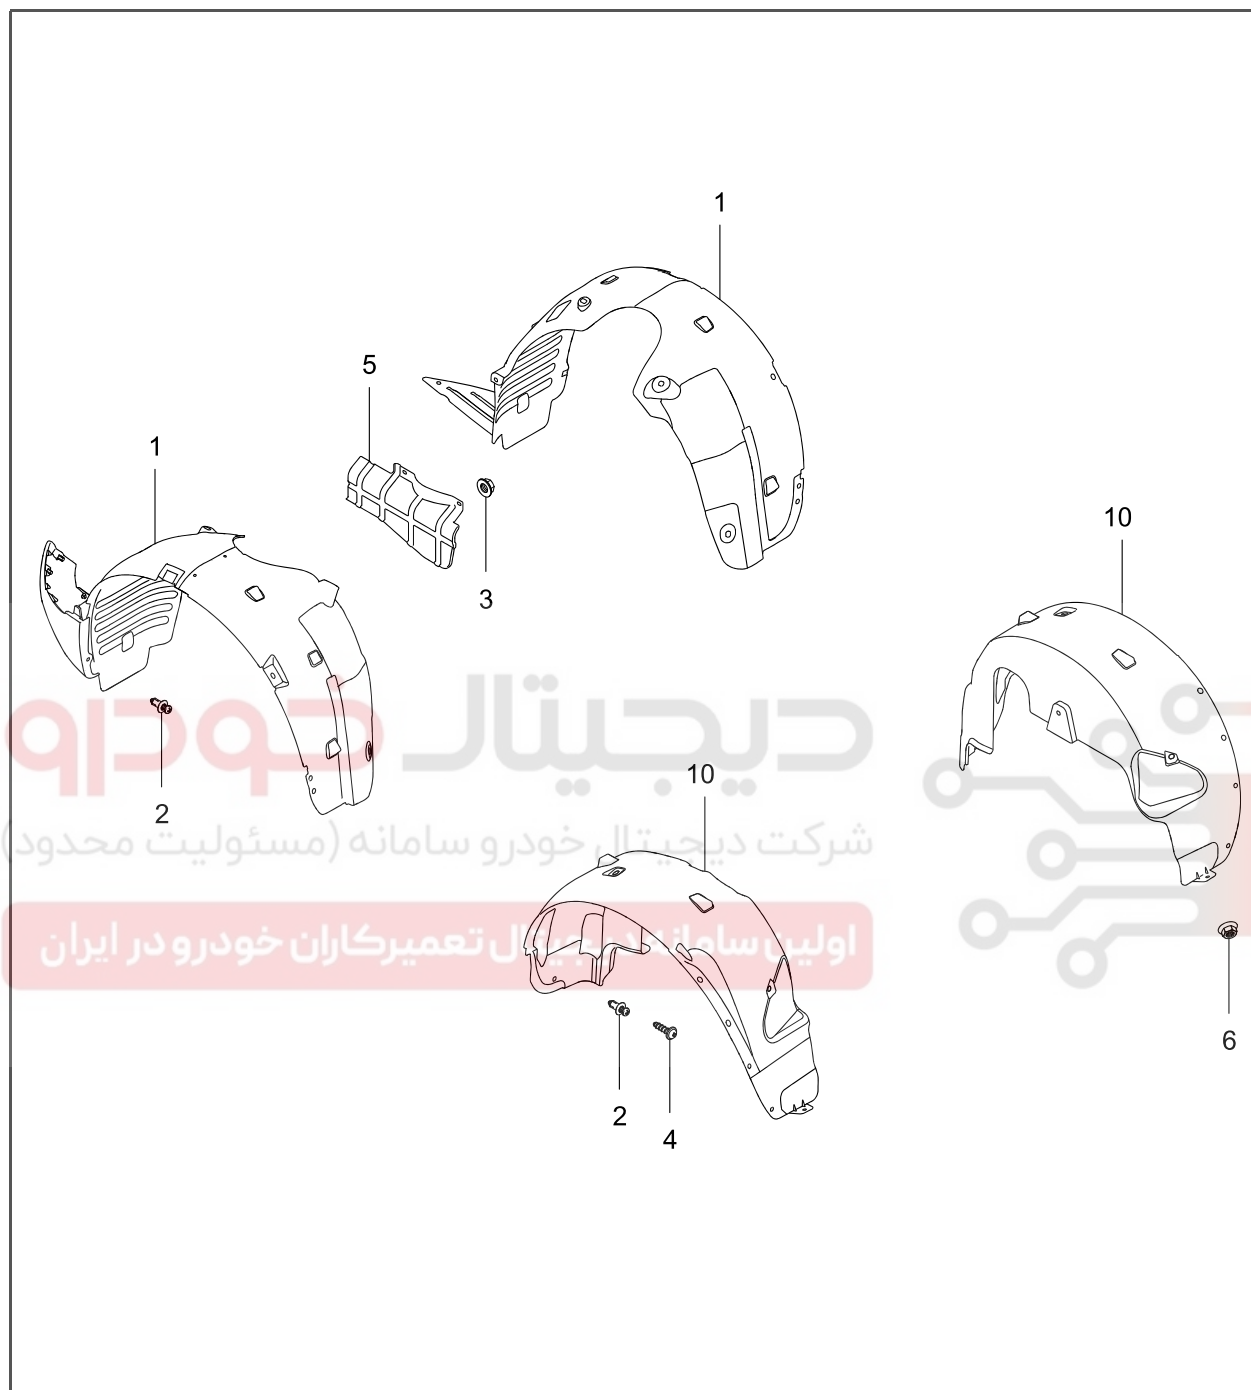
S.G.N.
7970-00 WHEEL HOUSE COVER

1. Front wheel house cover assembly
2. Screw rivet
3. Cap nut
4. Screw
5. Engine compartment side cover
6. Nut
10. Rear wheel house cover

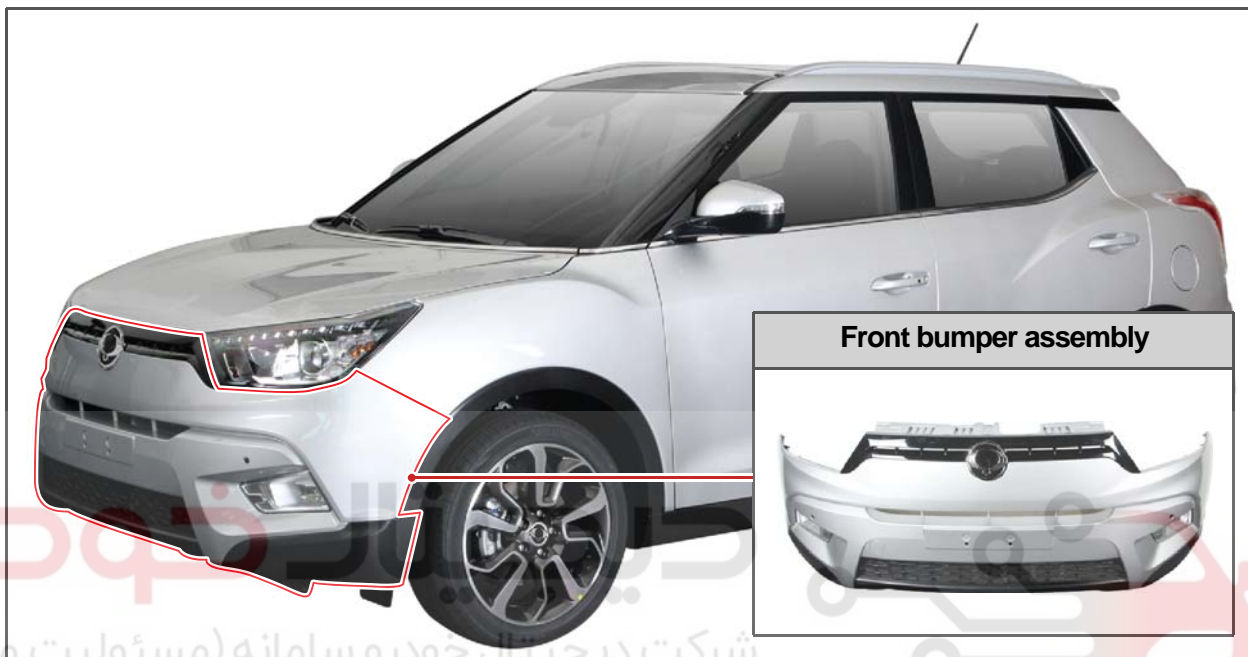
FRONT BUMPER ASSEMBLY

1. Remove the 4 front under cover mounting screw rivets (A) and 4 LH/RH wheel house cover mounting screw rivets (B).

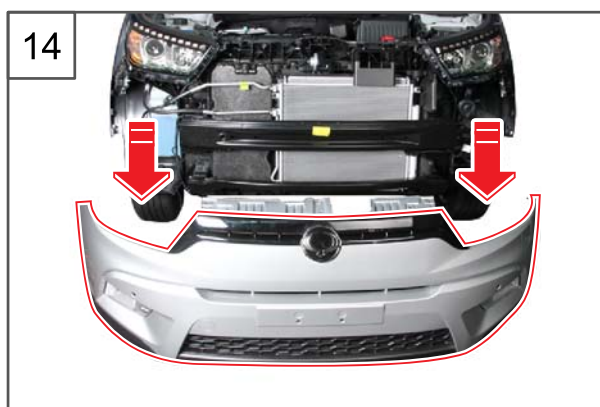
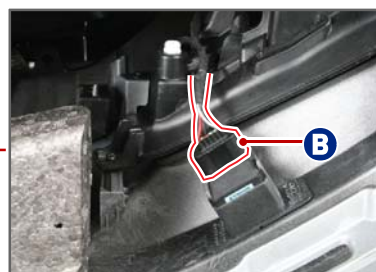
13. Remove the front bumper and disconnect the LH/RH front parking aid sensor connectors (B) from the back side of the bumper.

Do not pull off the front bumper excessively as this may damage the front parking aid sensor bracket.

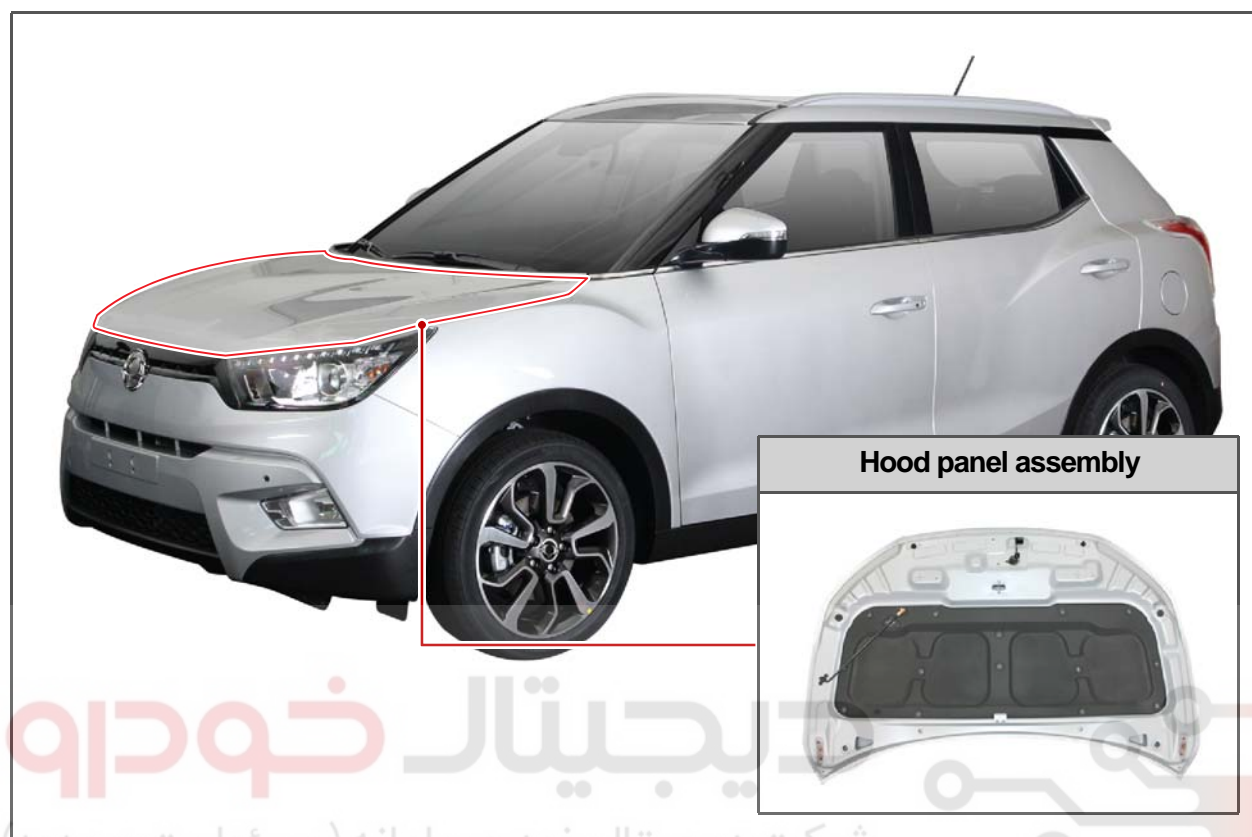
6110-01 HOOD PANEL ASSEMBLY

1. Unscrew the 2 hood panel mounting bolts (12 mm) on both sides and remove the hood panel assembly.

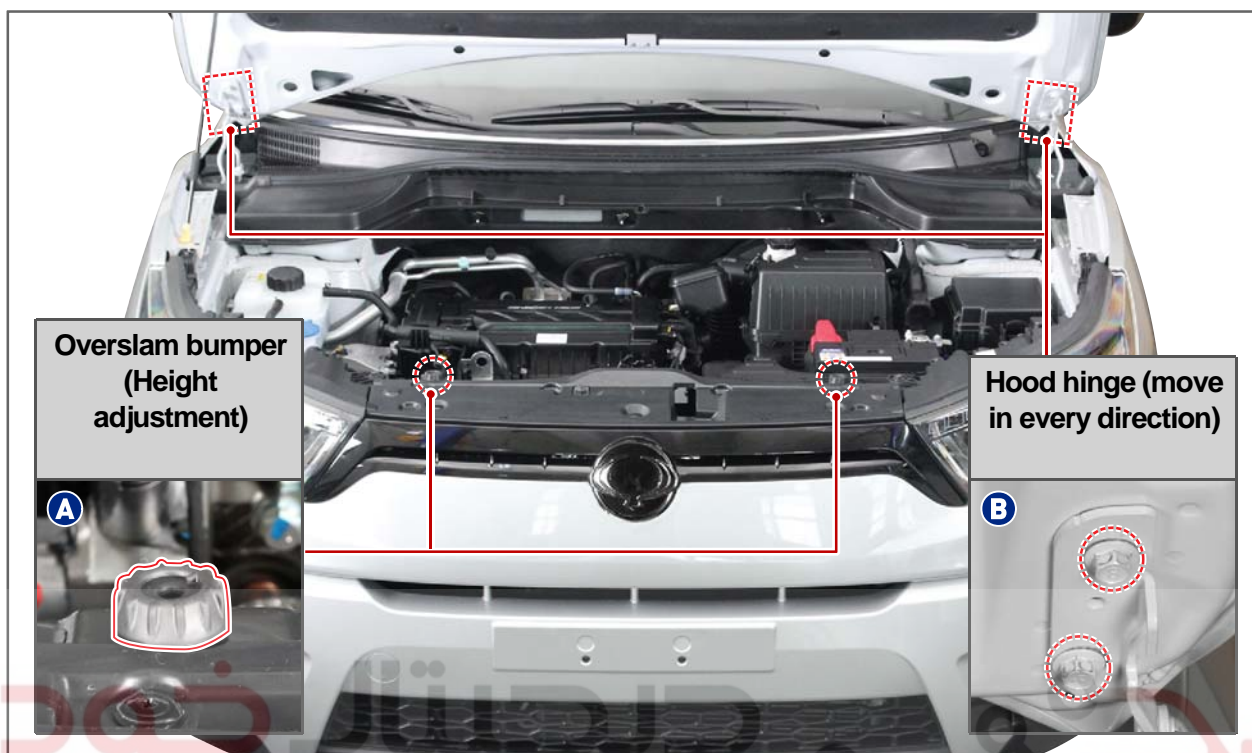
► Hood panel adjustment

A. Raise or lower the front side of the hood panel assembly by adjusting the overslam bumpers on each side.

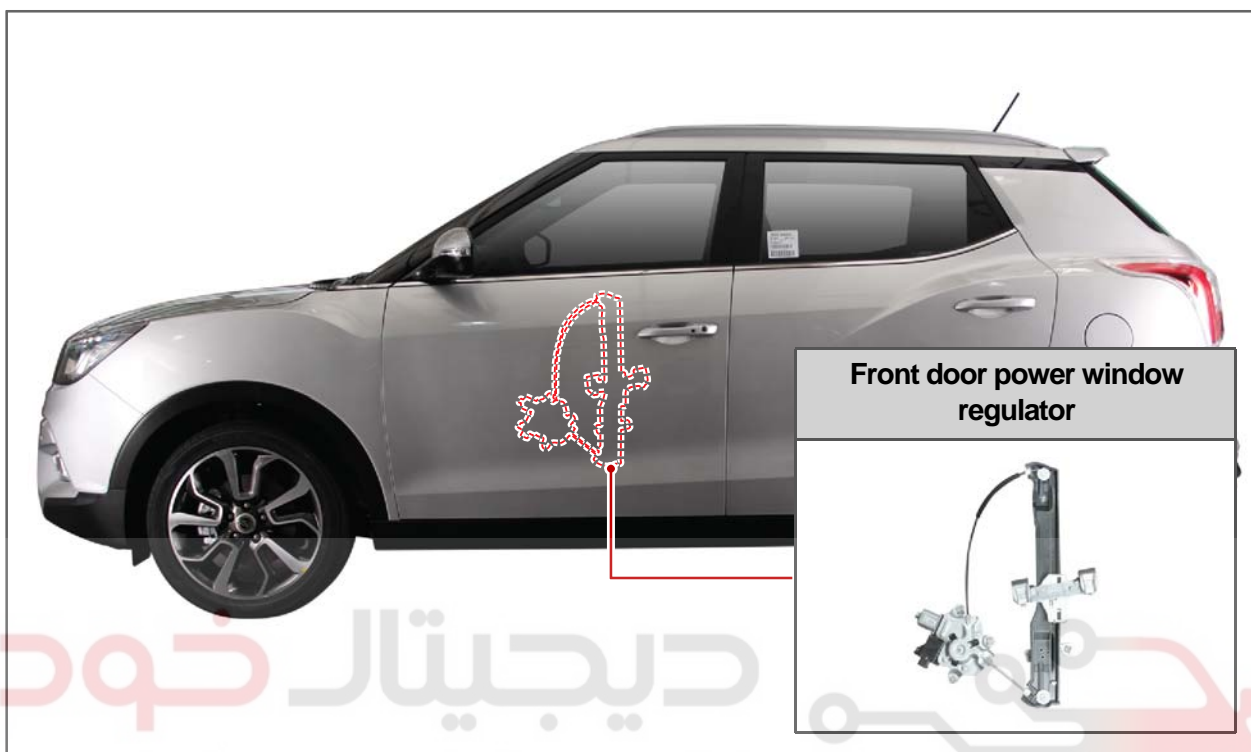
1. Adjust the window glass height so that the window glass is visible by 11 ± 0.5 cm, as shown in the figure. (measure at B-pillar)

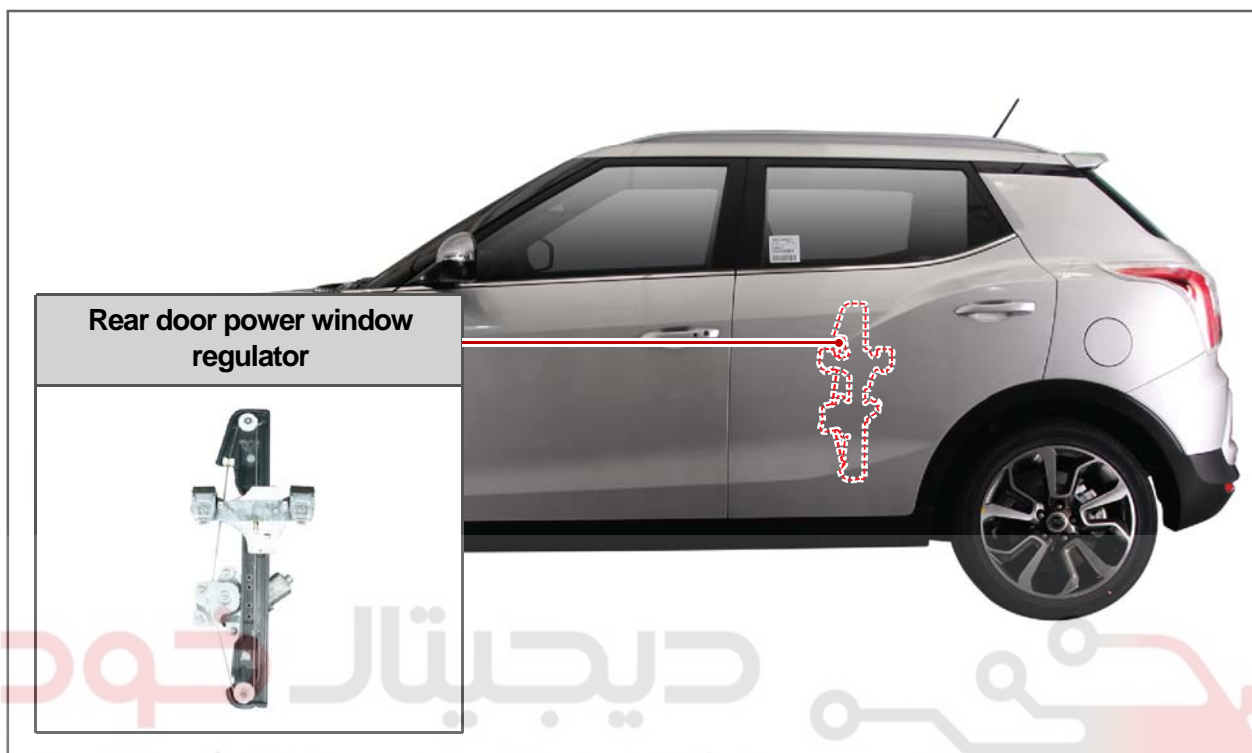
1. Lower the window glass so that the window glass is visible by 23 ± 0.5 cm, as shown in the figure. (measure at B-pillar)

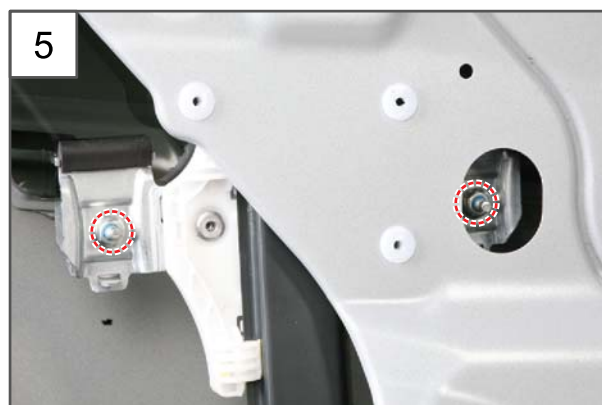
5. Loosen the 2 clamp grip mounting nuts (10 mm) only to the extent that the window glass can be separated, and lift the window glass into place.

Tightening torque 5.8 ~ 7.8Nm

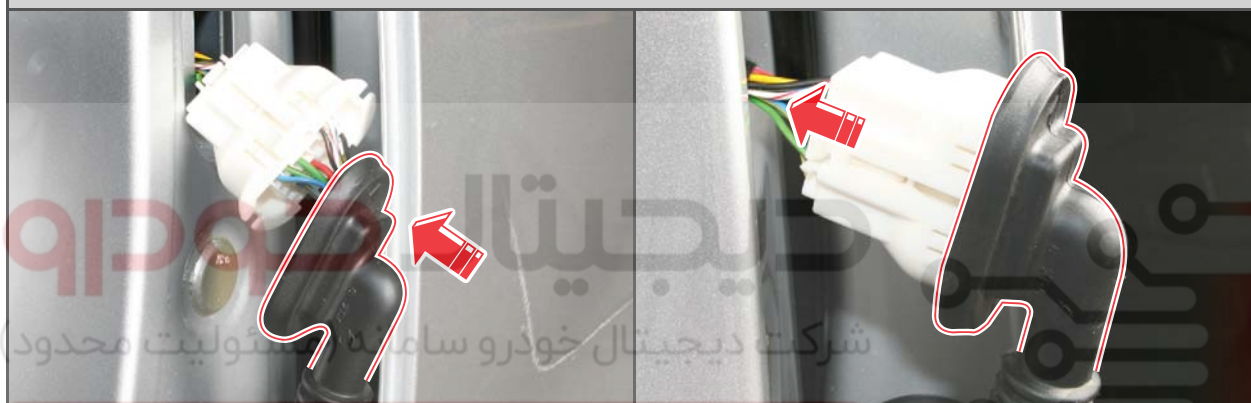
Cautions For Installation

Connect the rear door main wiring connector. After that, fit the connector cover before fitting the B-pillar.

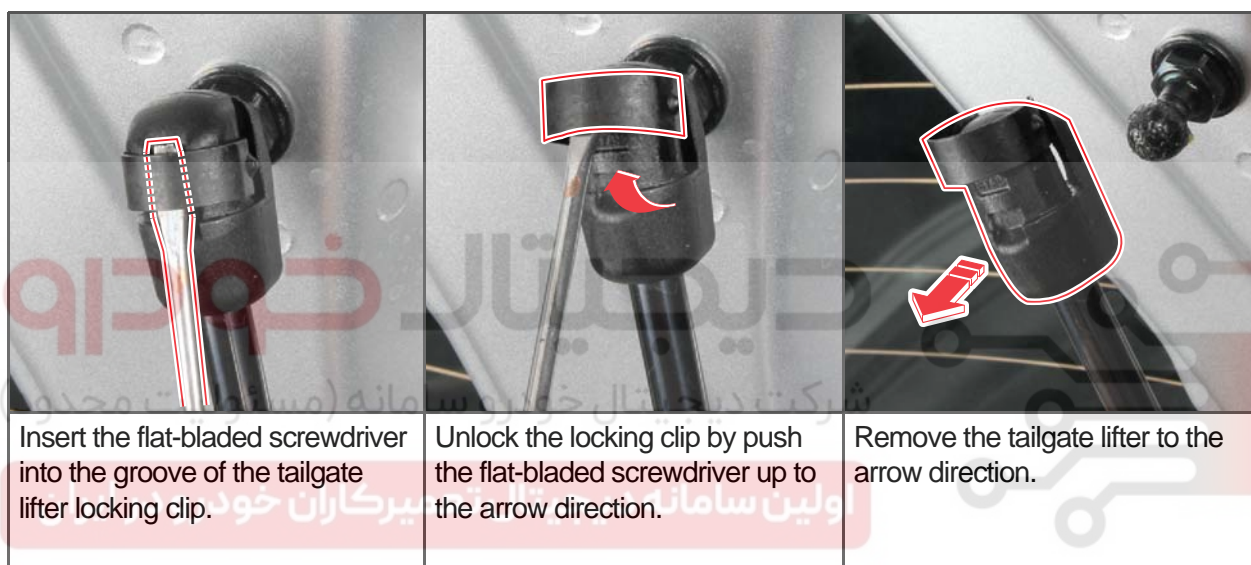
Insert the flat-bladed screwdriver into the groove of the tailgate lifter locking clip.
